**The Long-Term Effects of
BMP Implementation on
Stream Channel Stability in
Urban Watersheds**

Lisa Fraley-McNeal, CWP
Byron Madigan, Carroll County
Deb Caraco, CWP
Sami Khan, CWP
Bill Stack, CWP

Chesapeake Bay Trust Pooled Monitoring Forum
June 18, 2026

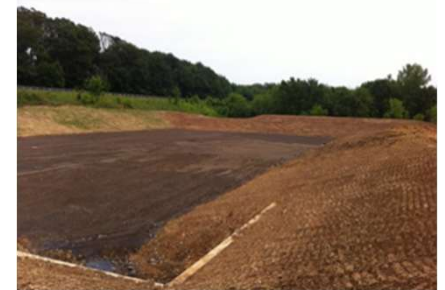
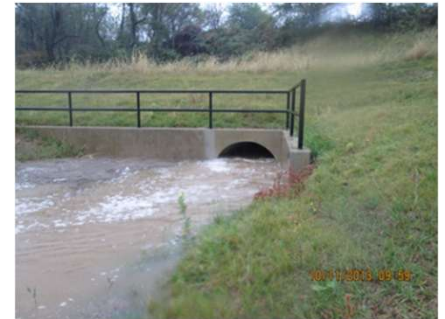
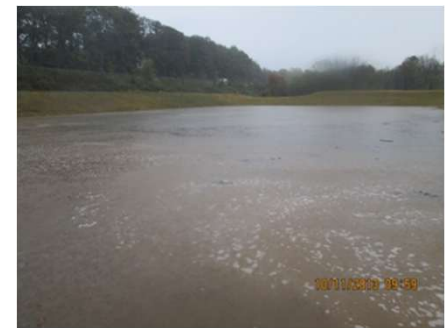
Carroll County Sand Filter Design

Unique Design Characteristics

- No Riser - all design flows through sand control
- Drop Structures and Level Pipes
 - Turbulent to laminar flow
- Total Capture of 2 year storm, “difference in 10 year runoff volume”
 - Direct runoff difference – Meadow and Impervious
- Sand layer seeded w/ MDE mix
 - Prevents cracking/short circuiting of filter

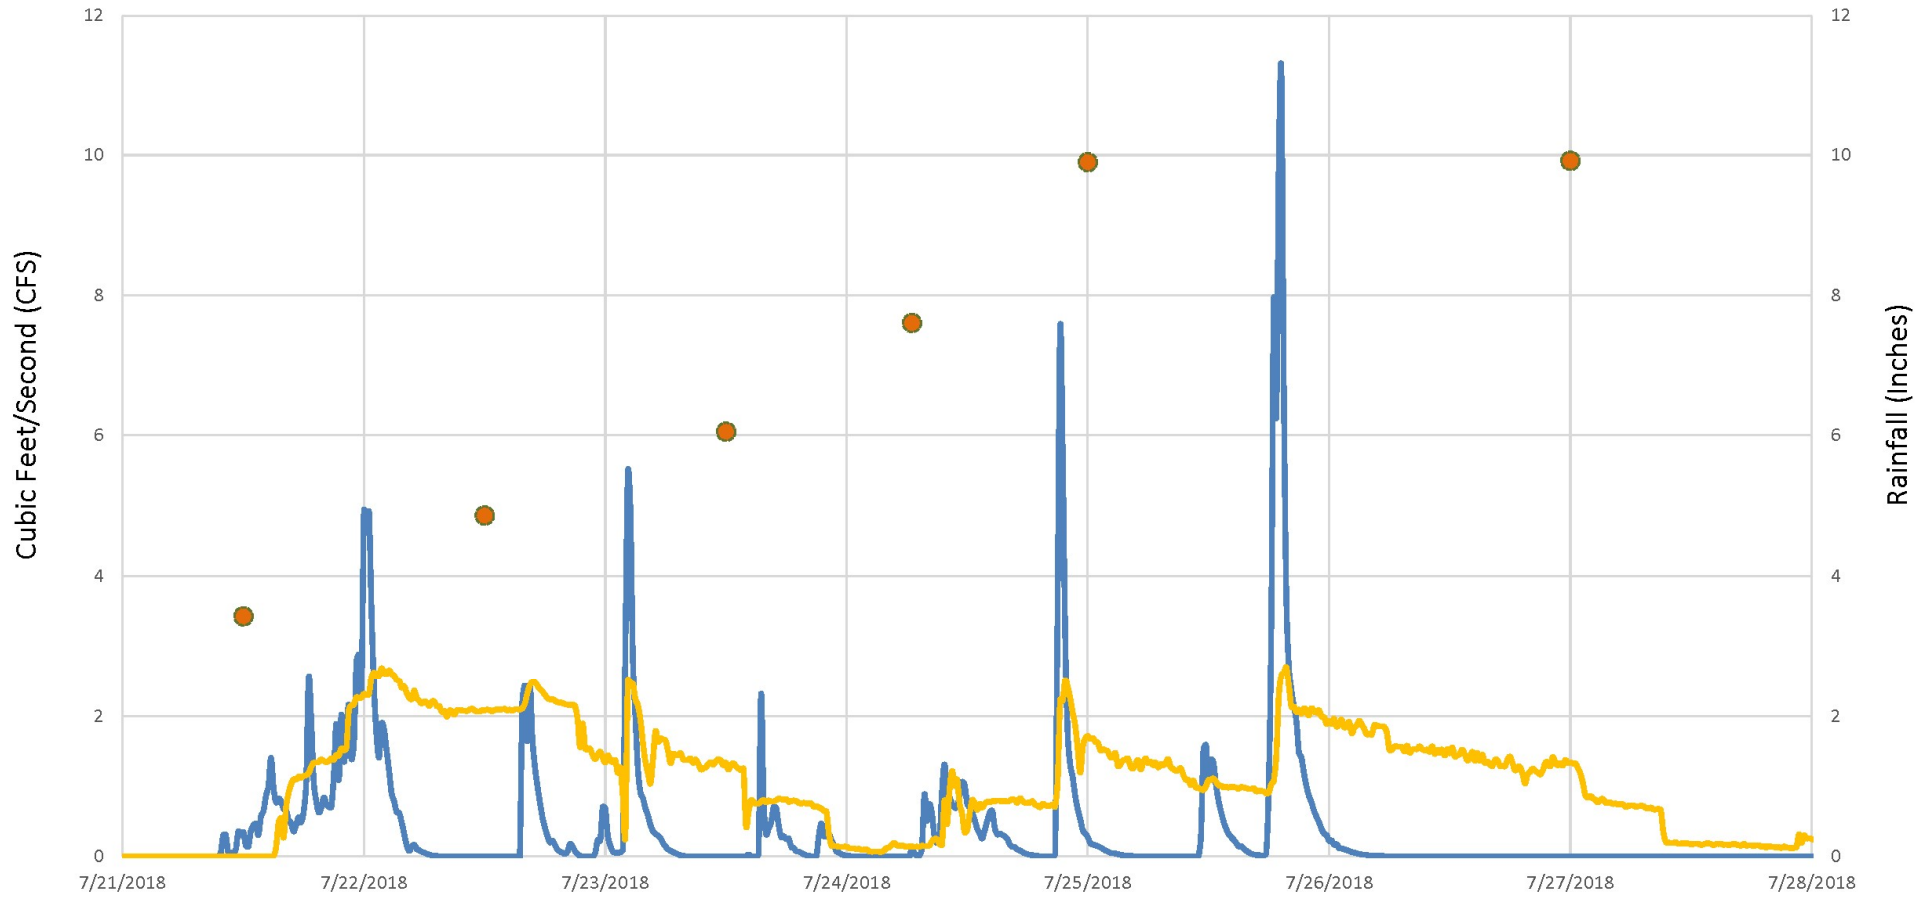
Maintenance Center
7/21/2018 - 7/28/2018
9.92" Total Rain

- Inlet
- Outfall
- Cumulative Rainfall

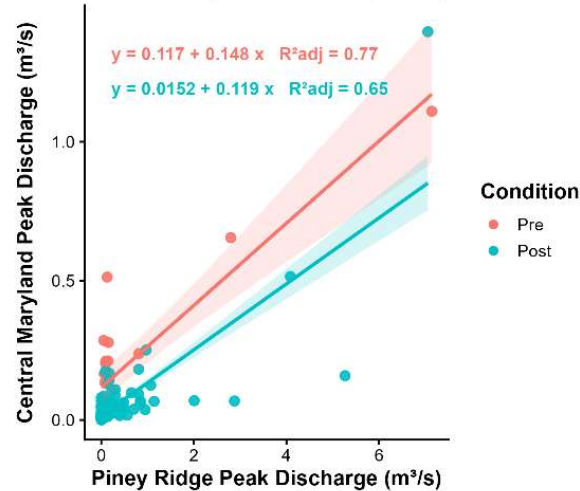
Peak Discharge Comparison
Central Maryland vs Piney Ridge

- Compared both Discharge and flow volume relationships between Control and Treatment Sites.
- In Phase 2, continued to add data to these evaluations.

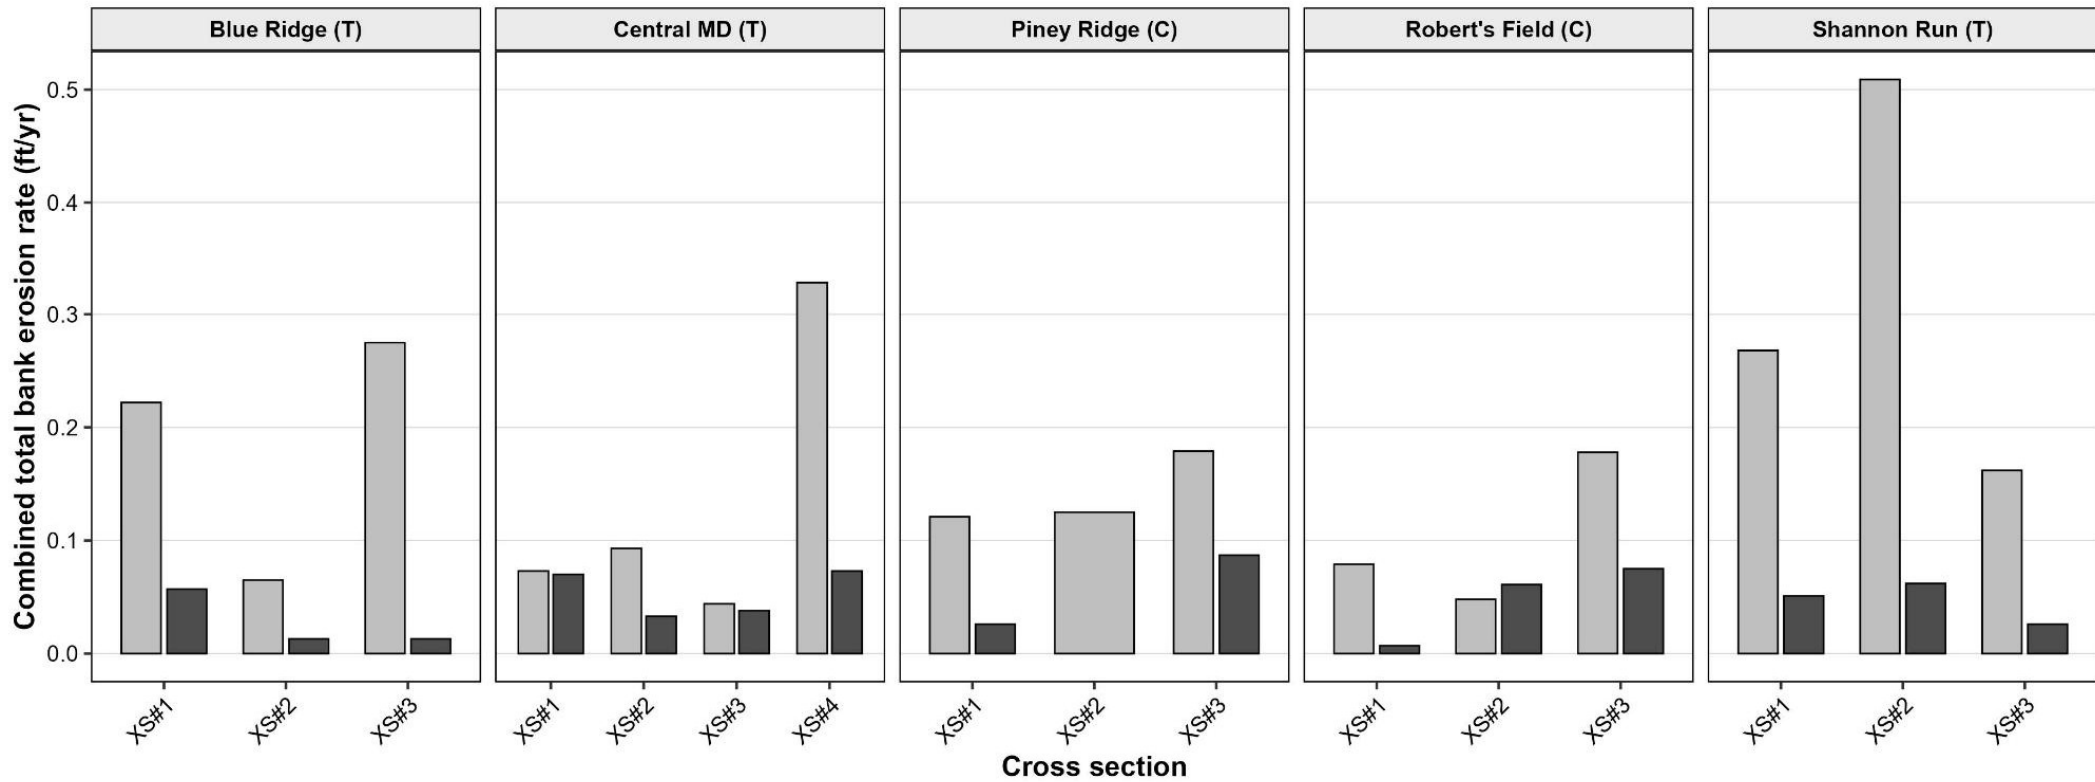
Pre- and Post-Treatment Bank Erosion Rates by Cross-Section

Each bar represents one cross-section; T = treatment, C = control

Analysis Period Pre-Treatment Post-Treatment

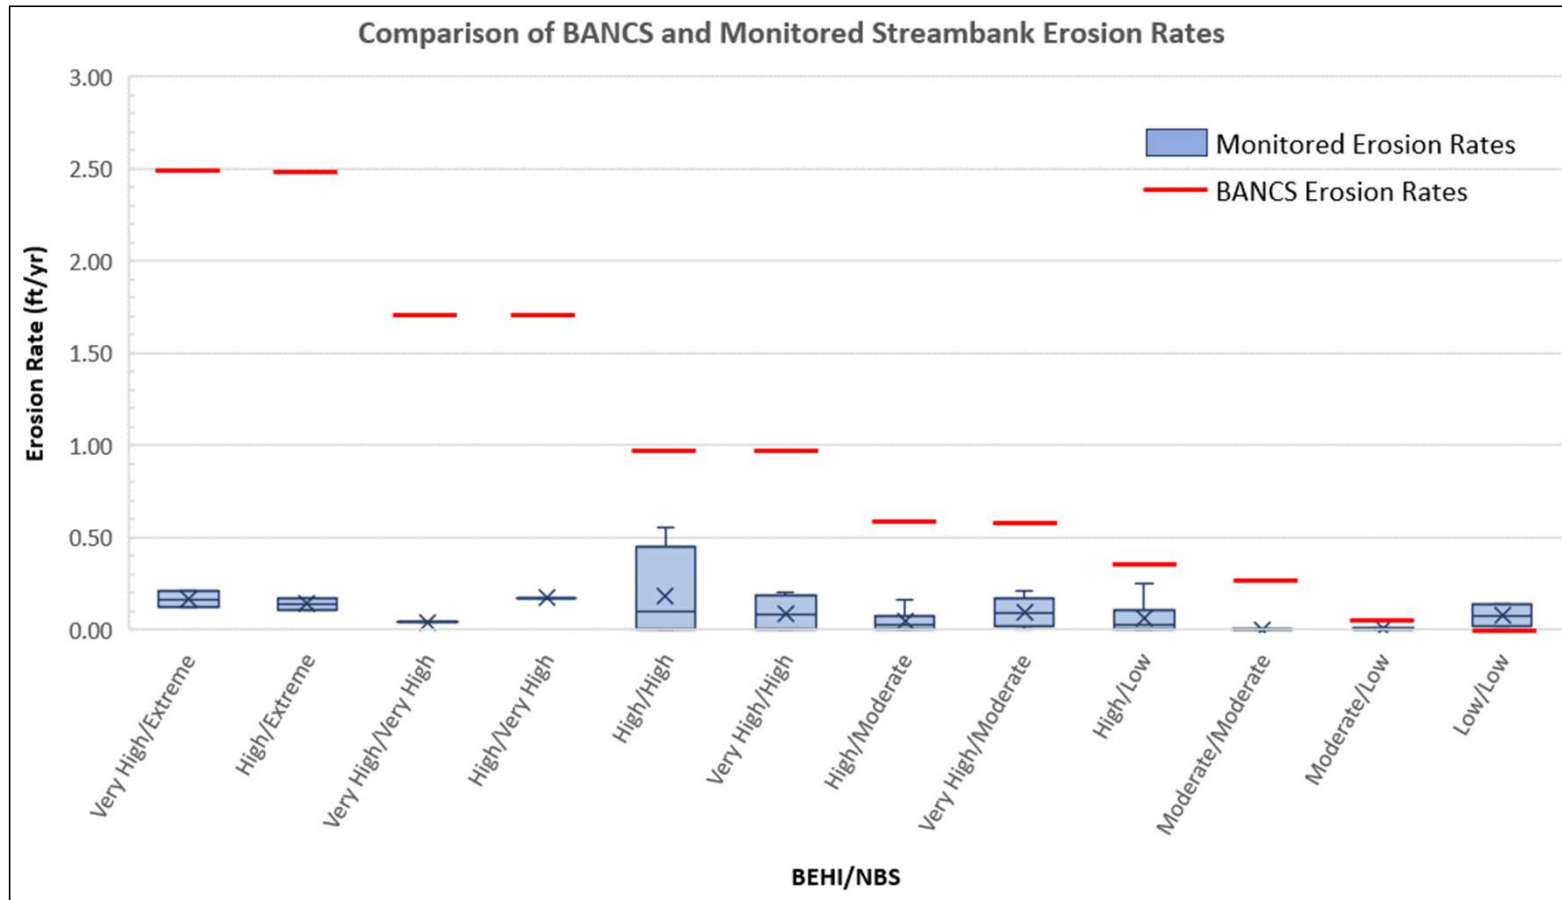
BANCS Overestimates Erosion Rates

Study Site	BANCS		Monitoring Data		
	Pretreatment Total TSS Load ¹ (tons/yr)	Post-Treatment Total TSS Load ¹ (tons/yr)	Pretreatment TSS Load (tons/yr)	Post-Treatment TSS Load (tons/yr)	% of Total Bank Length with Representative Monitoring Location ²
Central MD SVC (T)	42.11	45.04	3.42	8.92	89.8%
Piney Ridge (C)	59.25	75.9	0.72	0.40	31.3%
Shannon Run (T)	54.49	56.54	11.06	7.35	52.5%
Robert's Field (C)	24.26	27.21	1.01	1.83	91.5%
