Detecting and understanding hydrologic change in developing watersheds: role of ESD

Pooled Monitoring Forum: June 16, 2022

Keith N. Eshleman
UMCES/AL

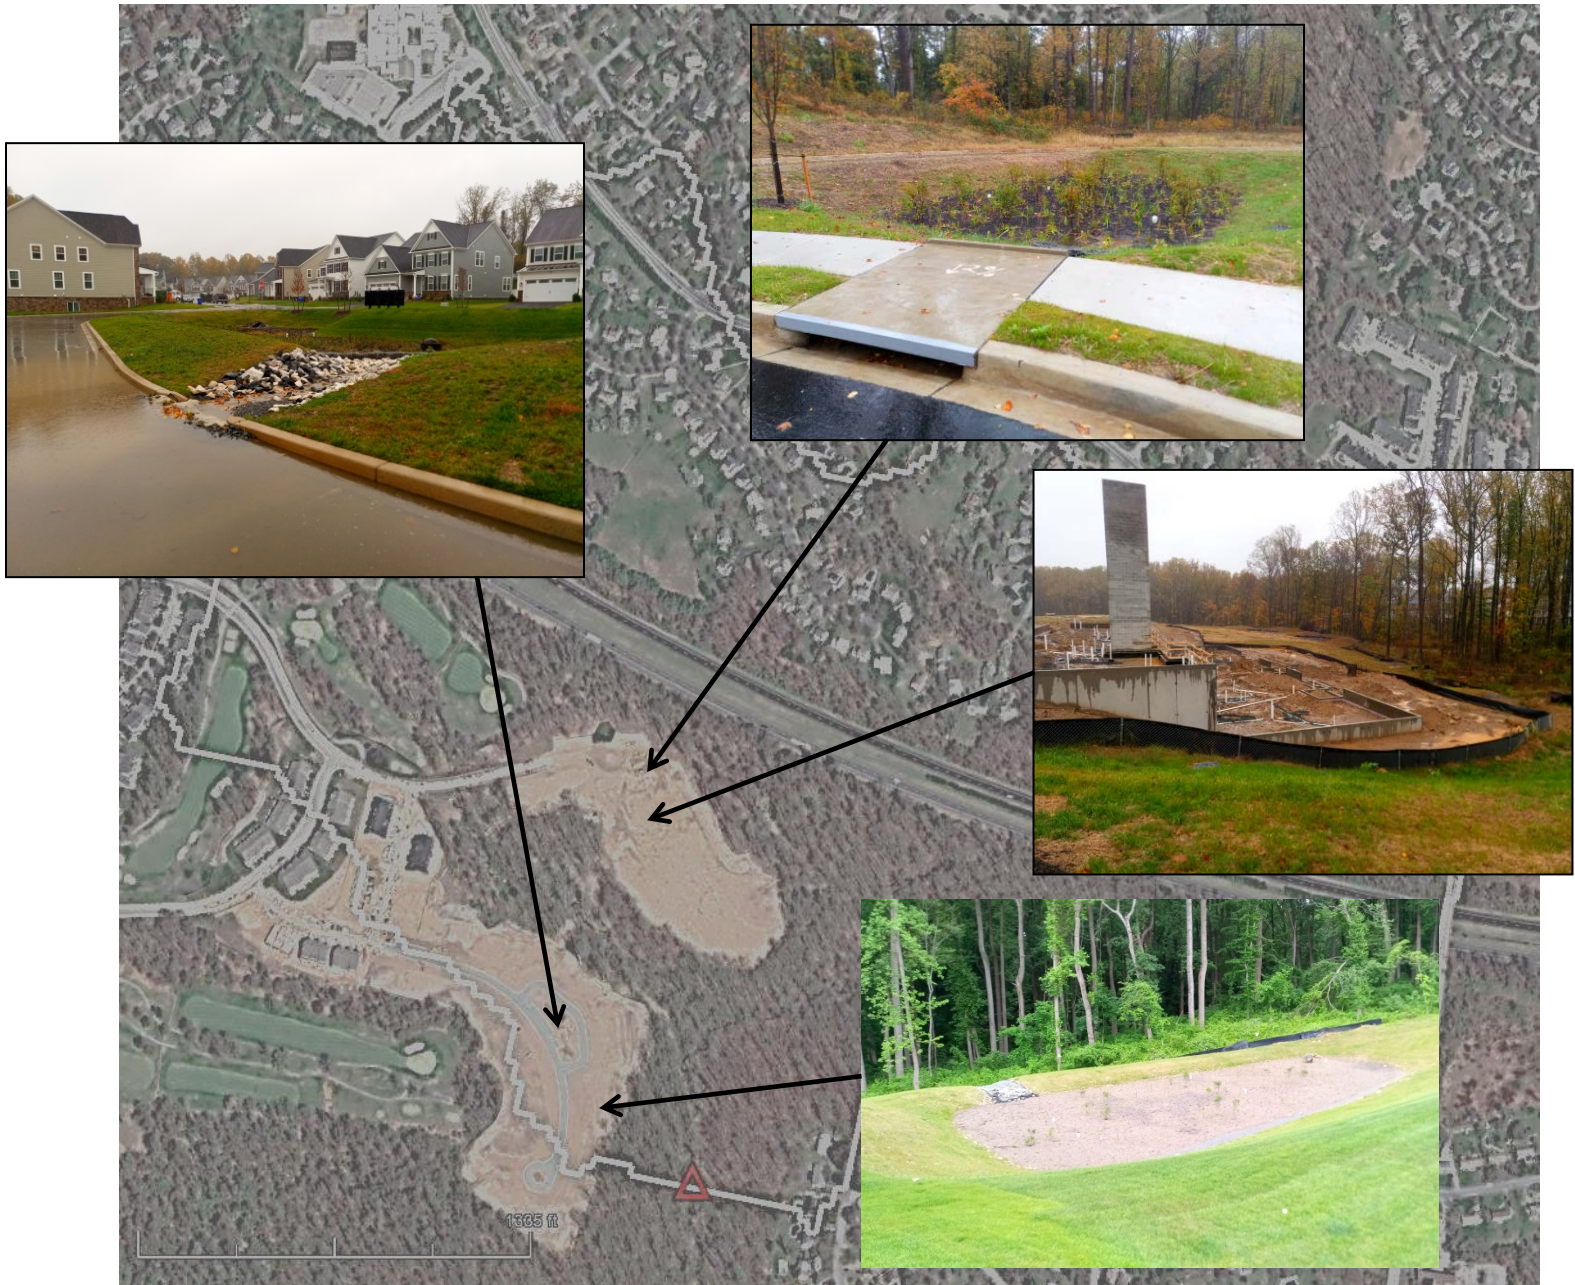
UTLP Watershed Development status (Spring 2022): imagery from April 2020

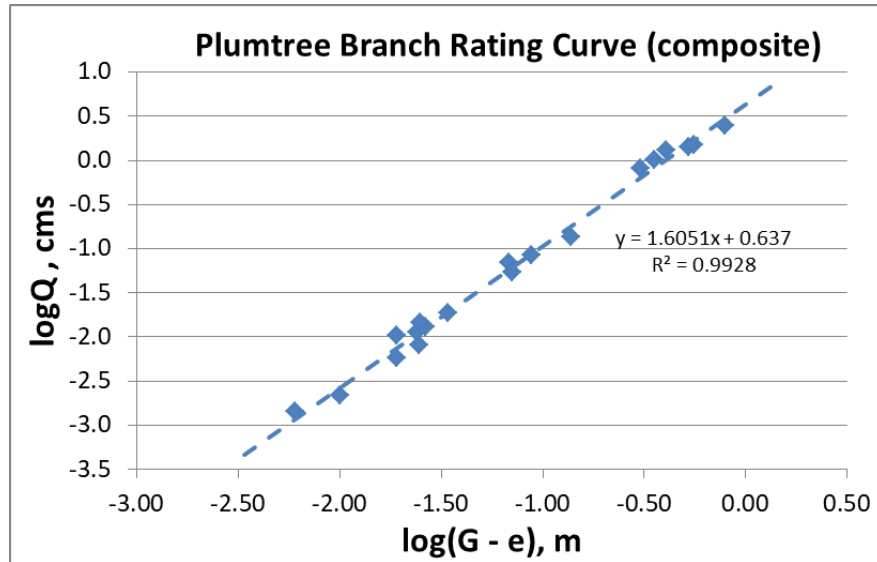
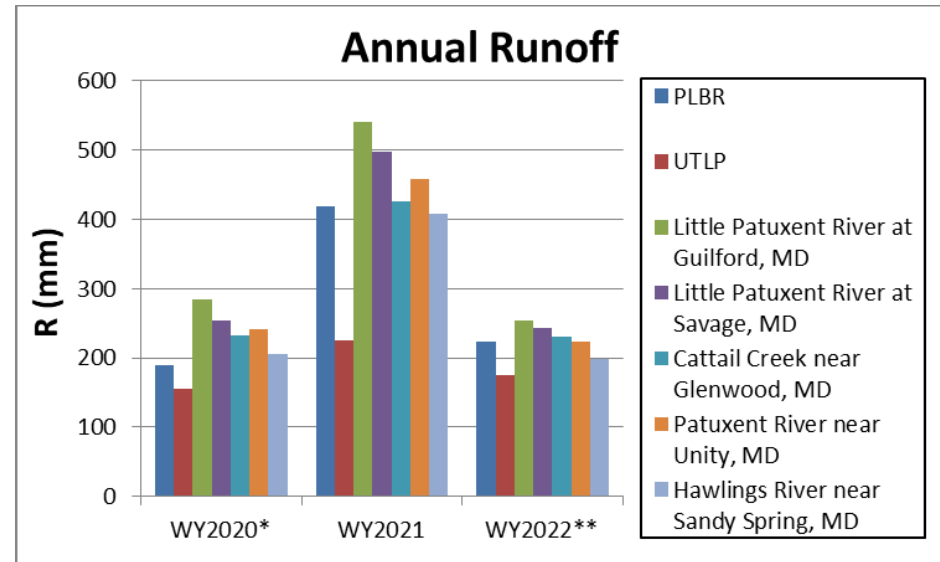
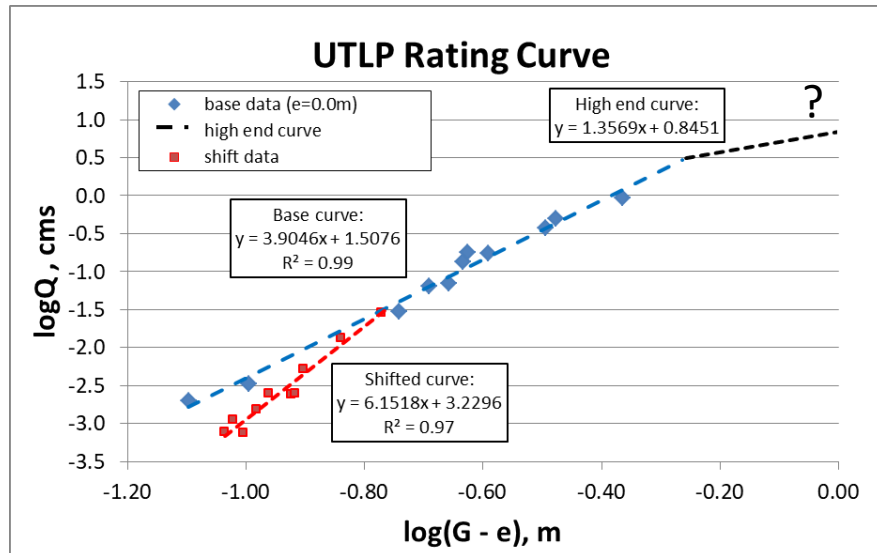
Rating Curves/Water Balances

- Highly flashy streams gaged over 3 orders of magnitude
- Highest discharge measurements exceeded <0.05% of the time!
- PLBR annual runoff agrees well with data from nearby USGS watersheds
- UTLP runoff is much lower (esp. in WY'21)

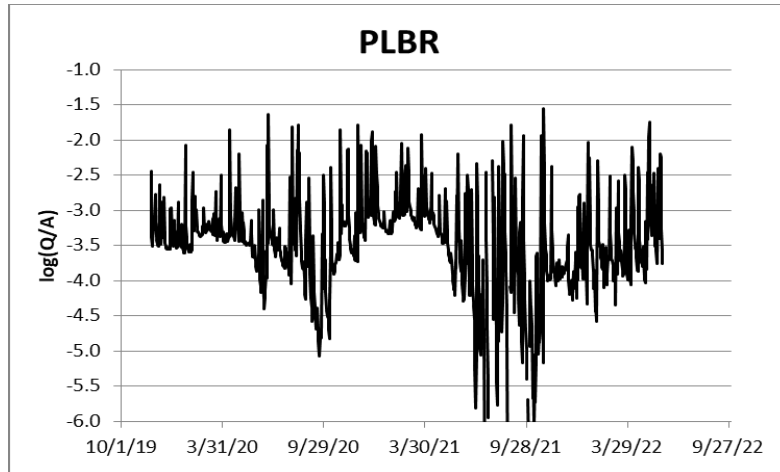
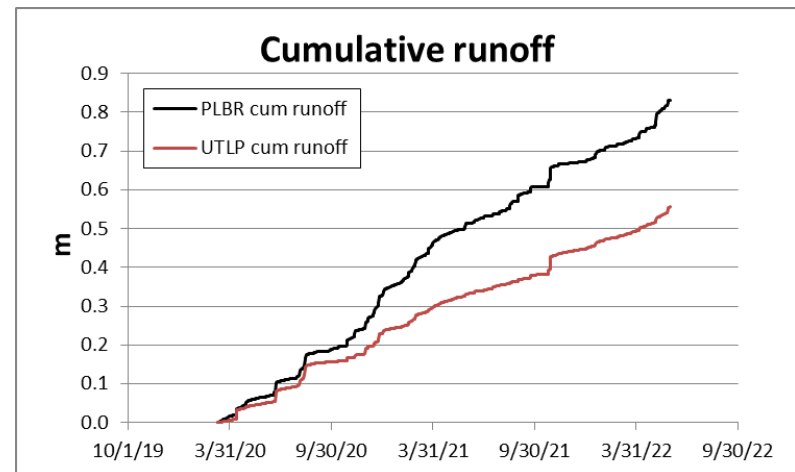
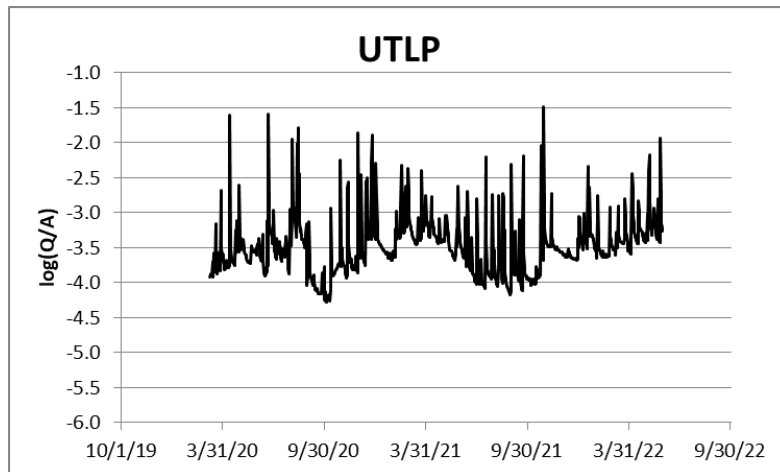
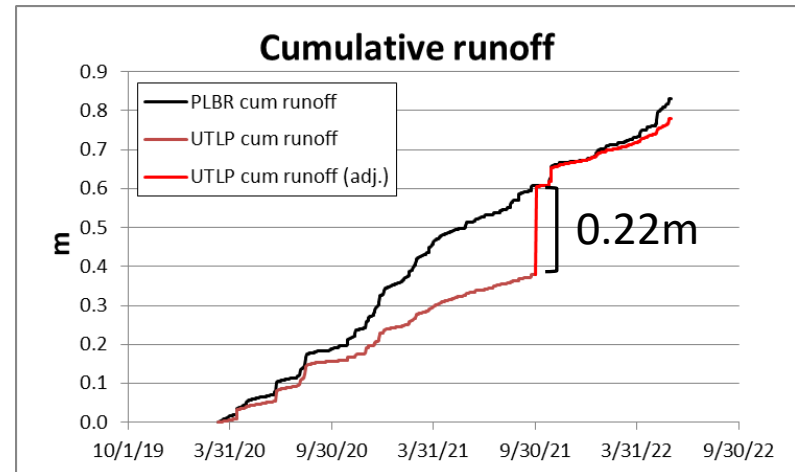
Hydrographs/runoff anomaly

- Similar hydrographs: area-normalized mean daily discharge (log scale)
- Slightly greater range at PLBR mostly due to lower summer baseflows
- Large UTLP runoff anomaly of -22 cm in WY'21

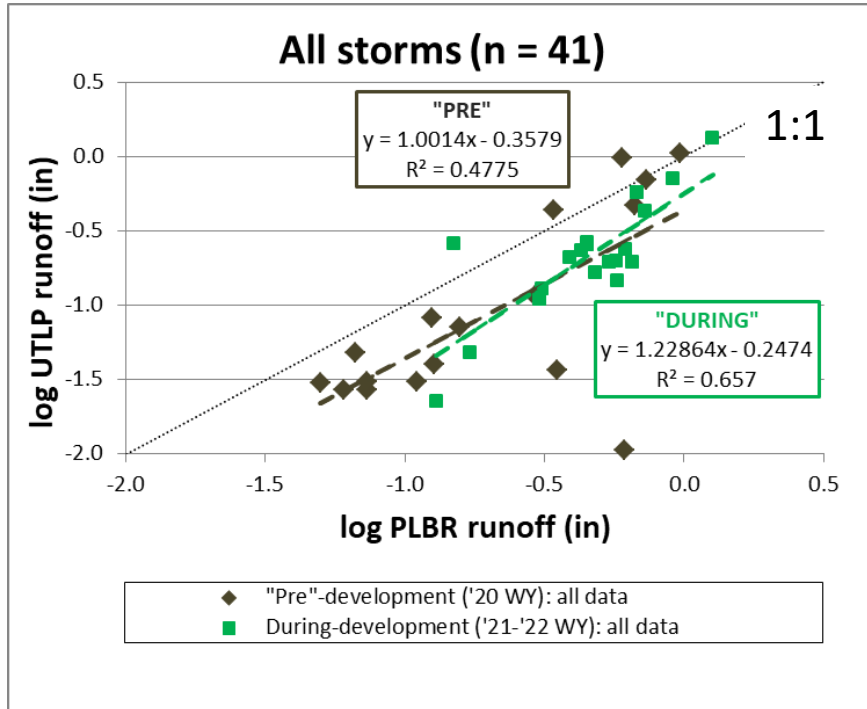
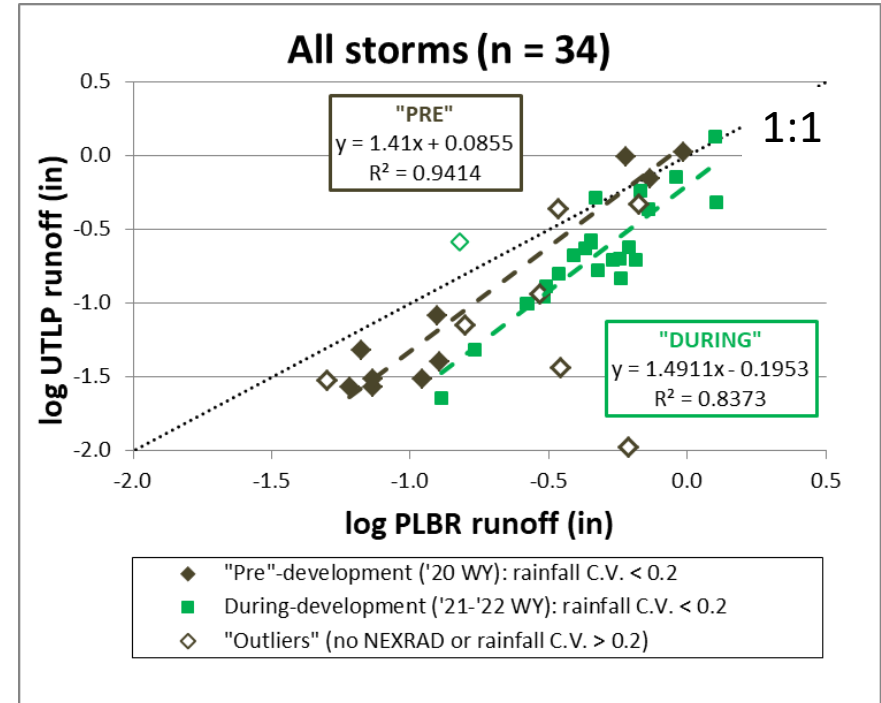
Storm Event Runoff

One way ANCOVA: $p = 0.92$ (NS)

One way ANCOVA: $p < 0.001$

- Paired data analysis (ANCOVA) with/without 7 "outlier" events
- Statistically significant difference in adjusted mean event runoff (UTLP < PLBR) in WY'21 and '22 compared to the "pre"-development period ONLY with "outliers" removed

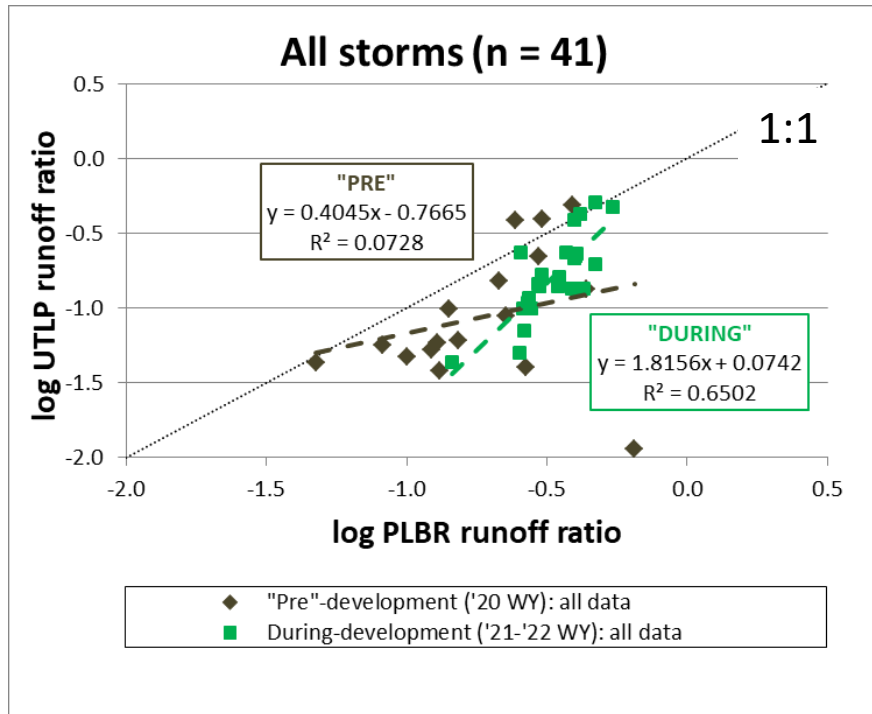
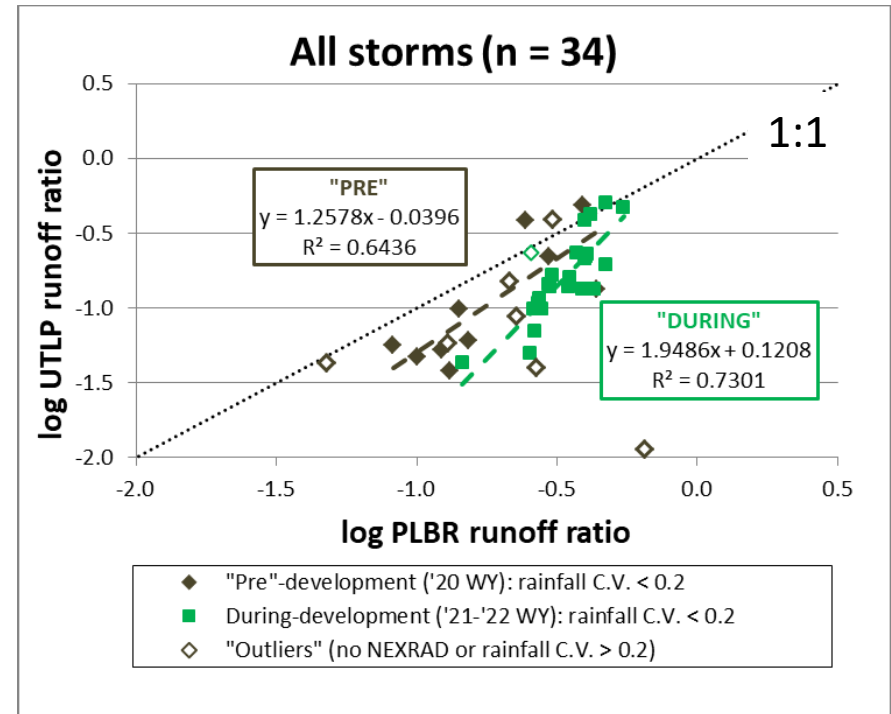
Storm Event Runoff Ratio

One way ANCOVA: $p = 0.37$ (NS)

One way ANCOVA: $p = 0.03$

- Same statistical result as for storm event runoff

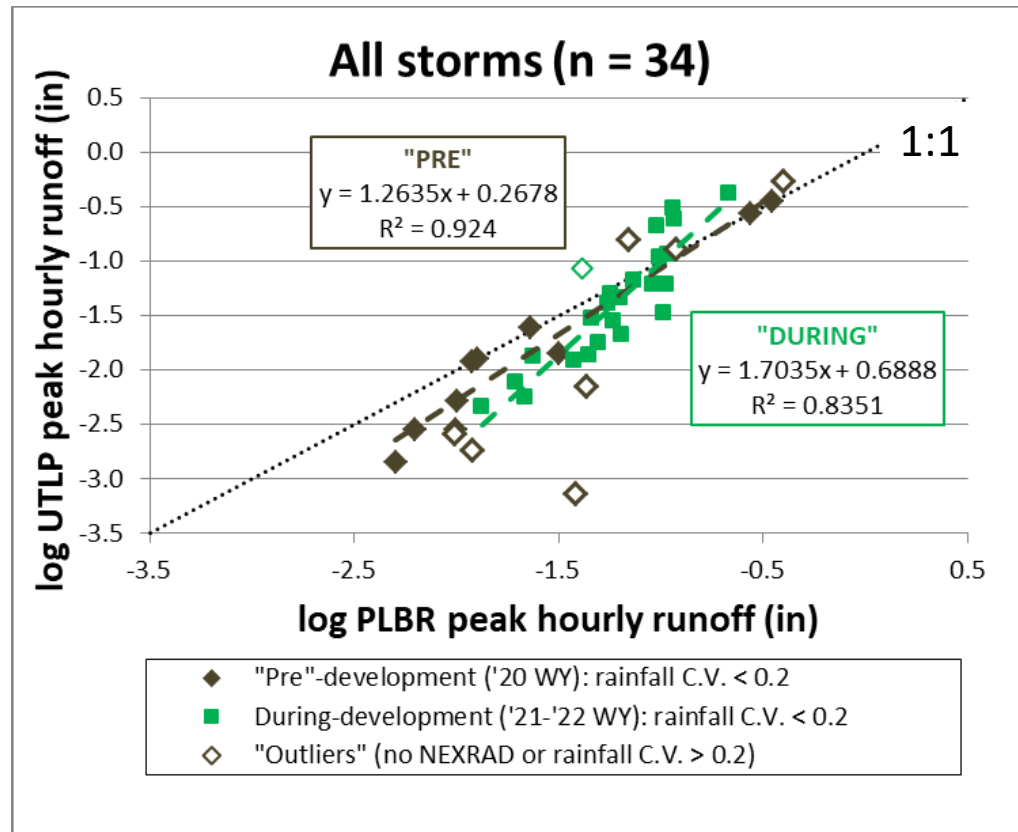
Peak Mean Hourly Runoff

One way ANCOVA: $p = 0.86$ (NS)

- No statistically significant difference in adjusted means even with "outlier" events removed

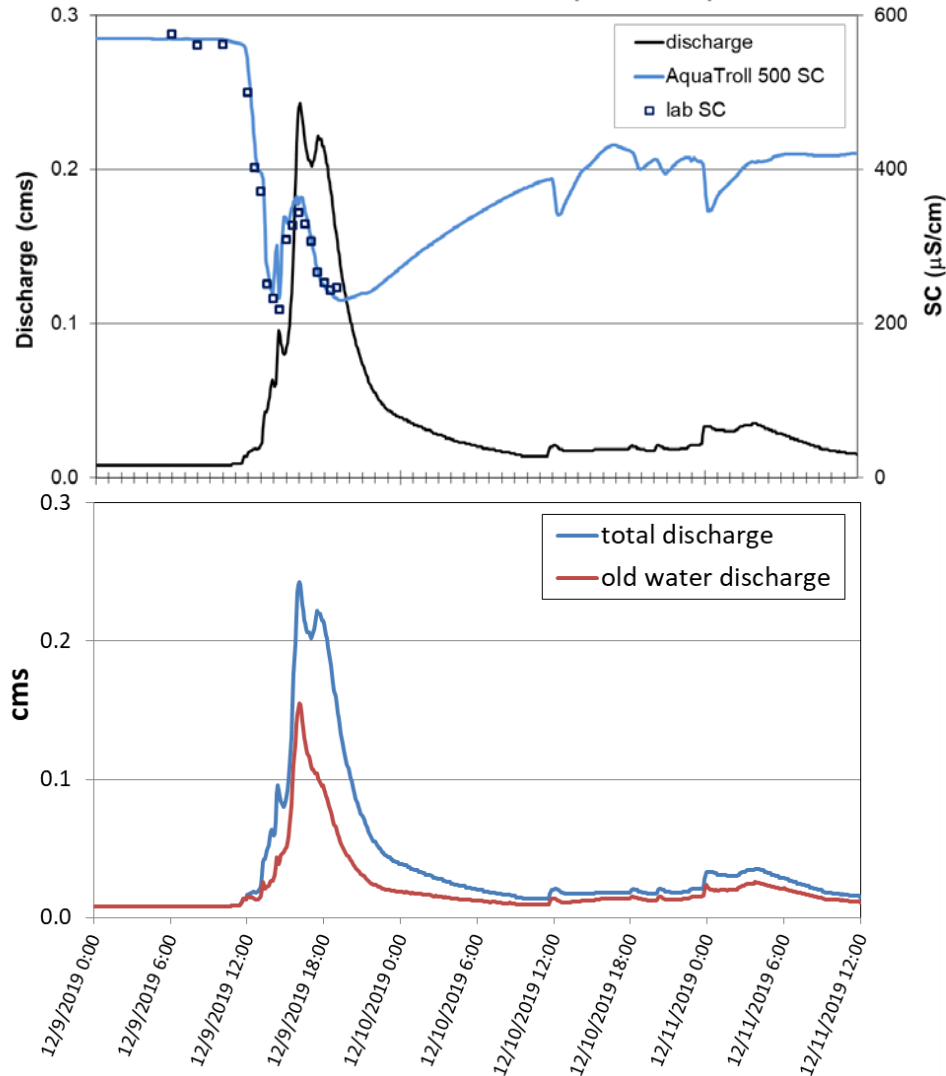
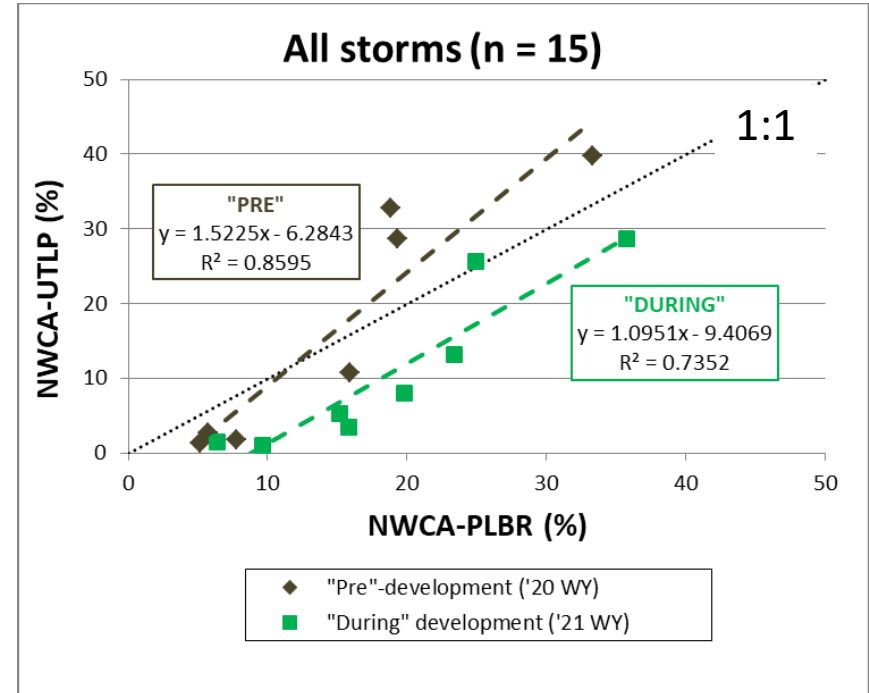
New Water Contributing Areas (NWCA's)

Plumtree Branch (Event A)

One way ANCOVA: $p < 0.01$

- Same statistically significant difference as for event runoff and runoff ratio (UTLP < PLBR during development)
- %NWCA's often much larger than %IA's

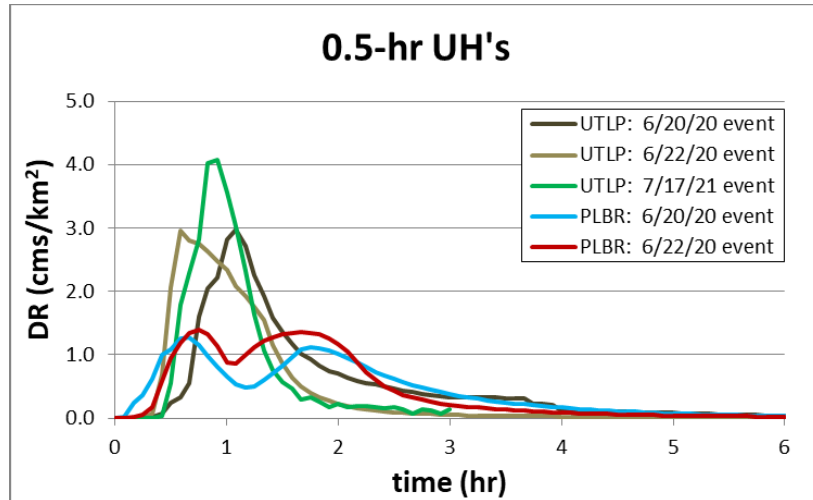
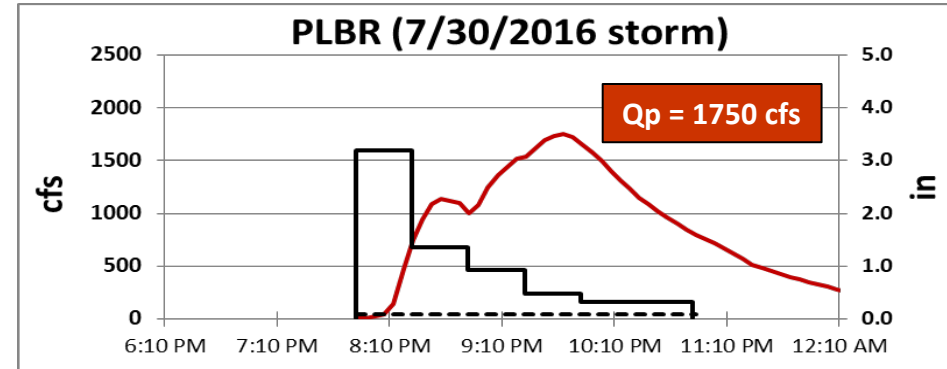
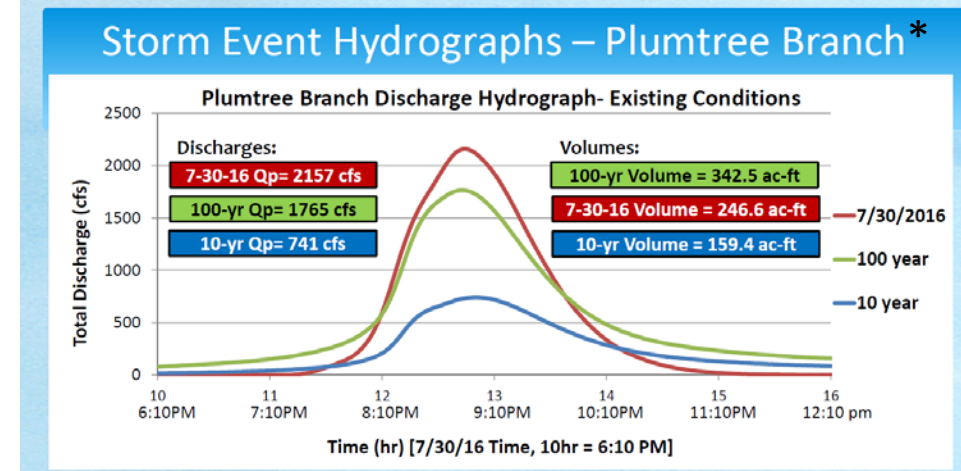
Unit Hydrographs (UH's)

*From 2017 Valley Mede Drainage Study: HEC-RAS

- PLBR unit-graph is double-peaked: two different sources of overland flow (“new” water)?
- Area-normalized unit-graphs based on field data: PLBR is more attenuated than UTLP
- Greater attenuation than synthetic hydrograph for 7/30/2016 event from HEC-RAS

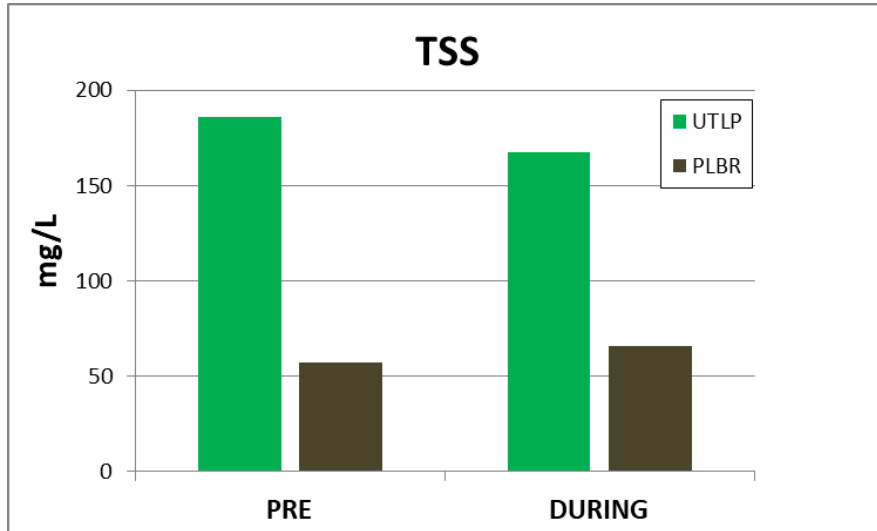
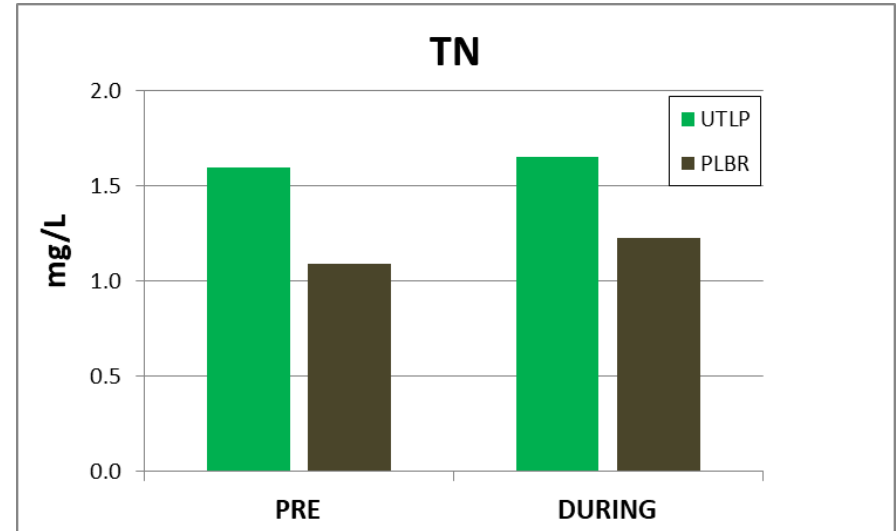
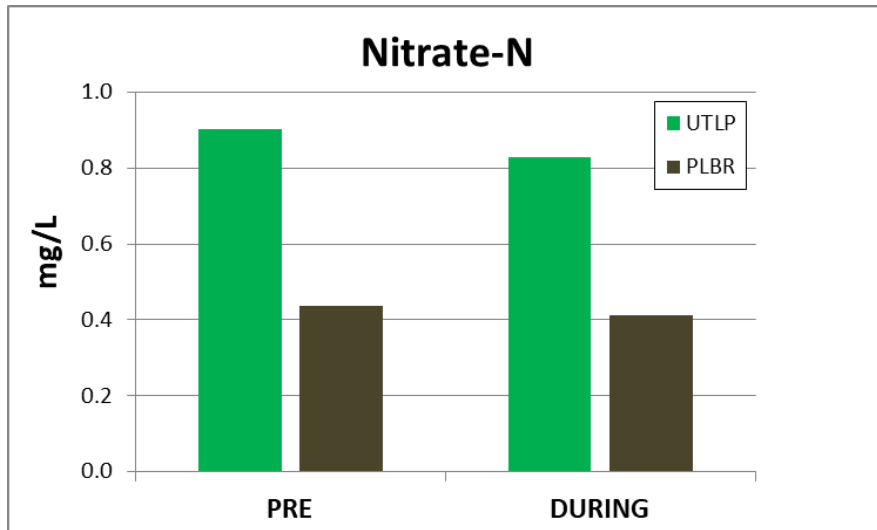
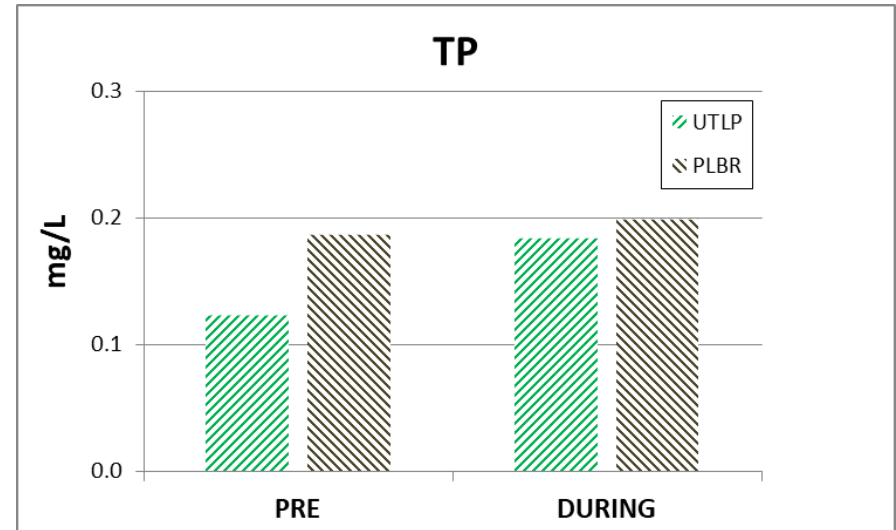
EMC's

- Insufficient no. of events for “pre” period to use ANCOVA
- Statistically significant differences in median TSS, TN, and nitrate-N between watersheds

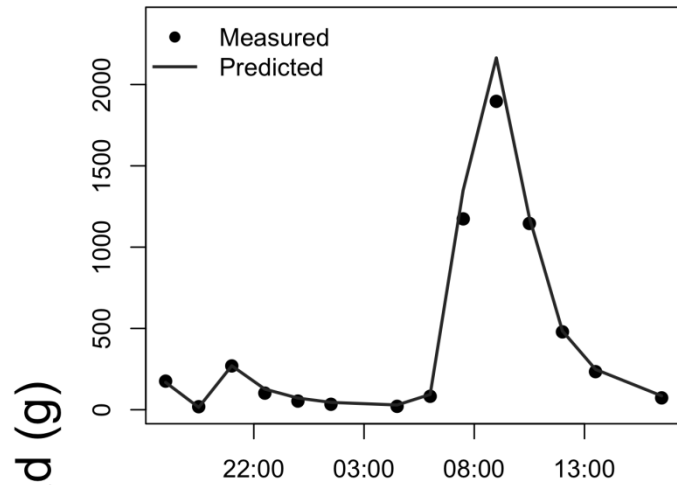
Event V

N Load Modeling

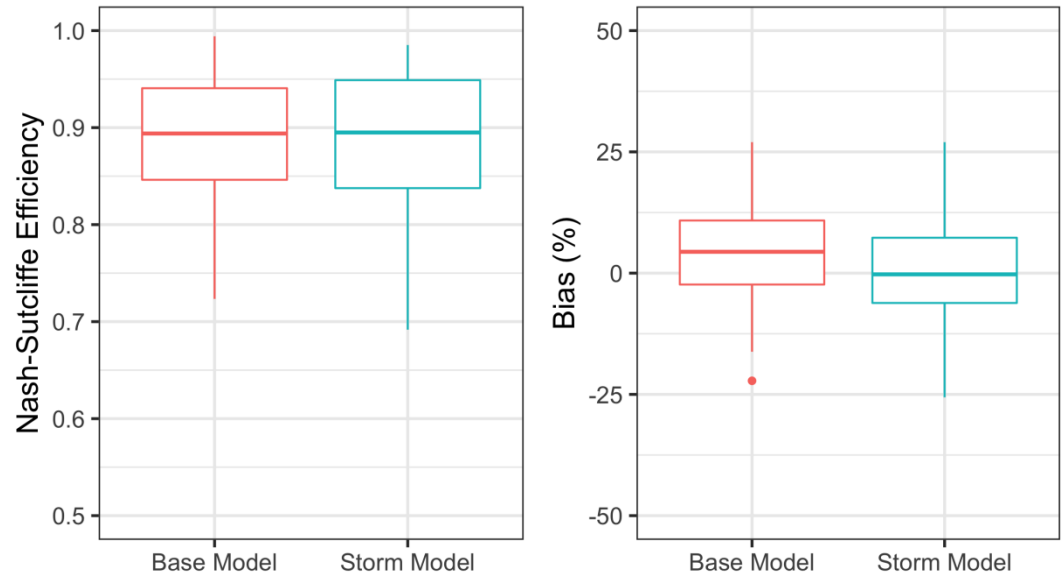
PLBR TN Models

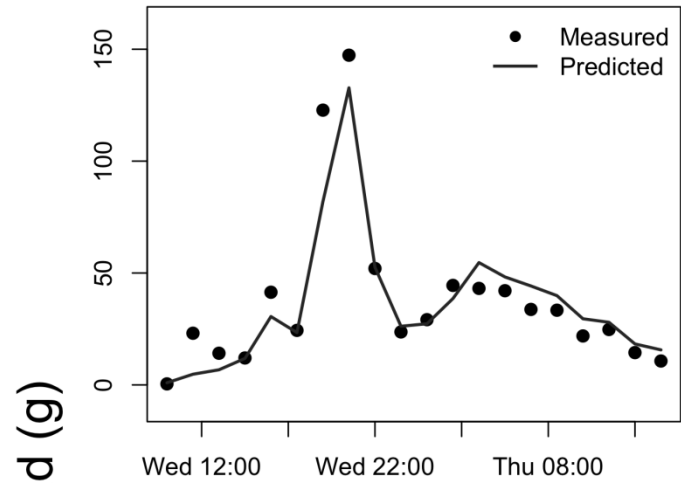
Event K

P Load Modeling
