An Evaluation of Forest Impacts Compared To Benefits Associated with Stream Restoration

***Chesapeake Bay Trust
Restoration Research Award Program***

Drew Budelis
Lauren McDonald
Steve Schreiner
Versar, Inc.

February 2020

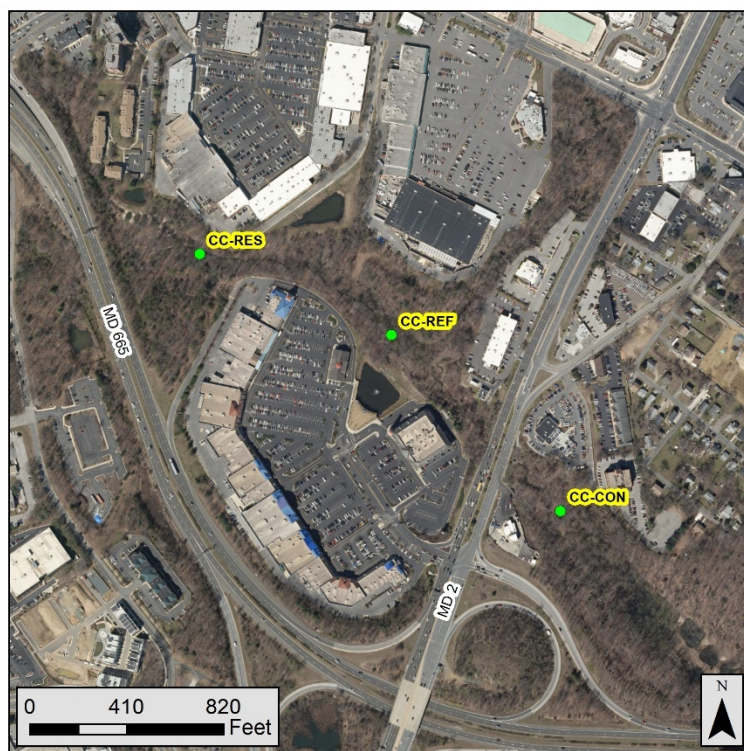
Figure 3. Church Creek Study Site

Church Creek (CC) restoration took place during 2015 and into early 2016. This study site is situated north of MD 665, on either side of MD 2, in Annapolis. The South River Federation (now Arundel Rivers), in cooperation with Anne Arundel County, undertook restoration of this portion of Church Creek near the County's current biological, physical, and chemical monitoring stations. This work consisted of 1,500 linear feet of stream restoration, step-pool storm conveyance, riffle weirs, and grade control structures to improve habitat and increase floodplain connectivity.

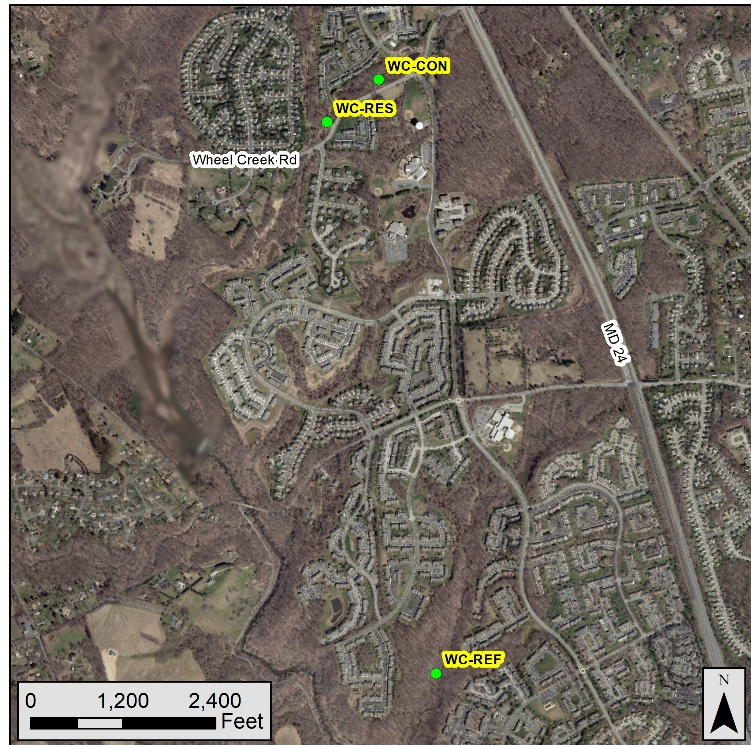
Figure 6. Wheel Creek Study Site

Wheel Creek (WC) restoration took place from December 2015 through February 2016. Several stream restoration projects have occurred along Wheel Creek. The study site used for this project is located in the west quadrant of S Tollgate Road and W Wheel Creek Road, in Belair. This site has been continuously monitored by Harford County DPW, Maryland DNR, USGS, Versar, and KCI.

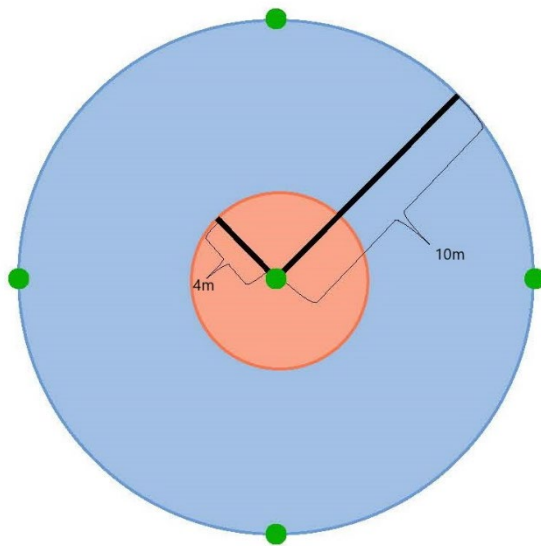
Figure 7. Layout of 4-meter sub-plots and 10-meter Plots at Each Treatment Area. Green Dots Represent the Center and Four Cardinal Directions on the Plot.

After taking pictures of the plot, field crews delineated 4-meter sub-plots and 10-meter plots. Using a pre-measured rope, crews placed one end of the rope around the center rebar using a carabiner and stretched the rope across the plot. The rope indicated 4-meter and 10-meter lengths, and crews marked dashed lines at these points around the plot. The result was a plot resembling the image in Figure 7. Crews used a compass to determine the

four cardinal directions and placed wired flags at these points along the edge of the 10-meter plot.

¹ Floodplain must be wide enough for three plots (See Figure 7)

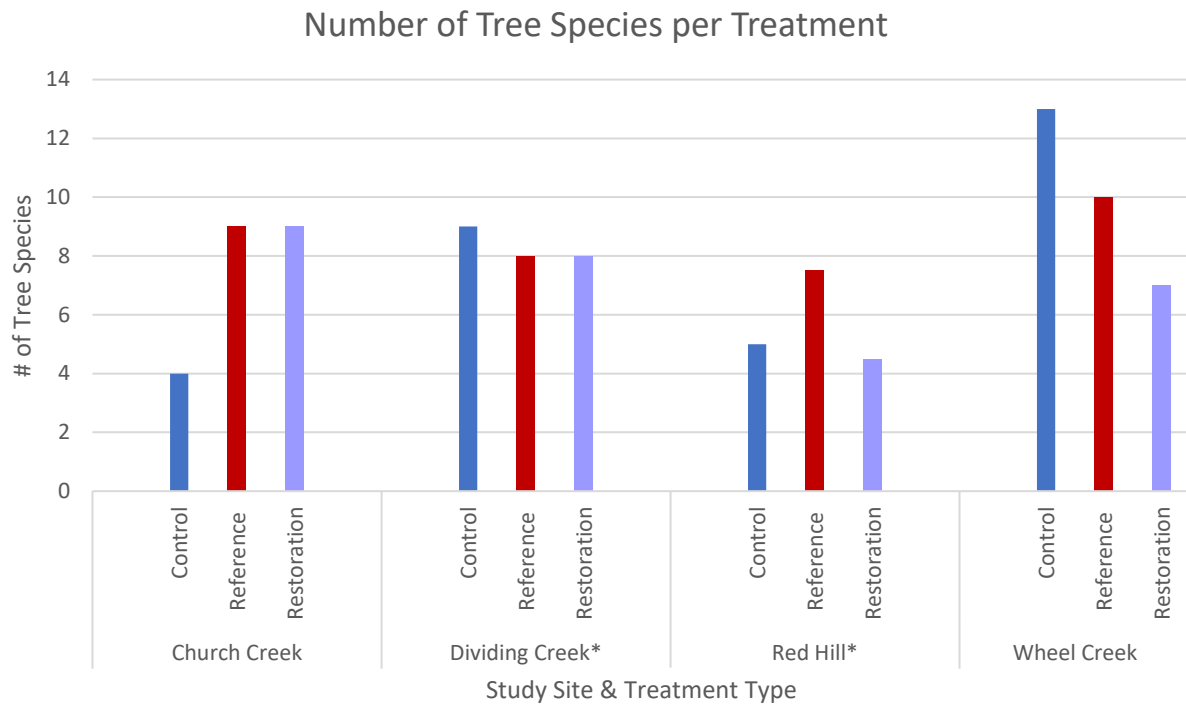
Figure 8. Graph of Tree Species Per Treatment

As indicated in Figure 8 (# of species) and Figure 9 (basal area), there is no consistent pattern across study sites. The species count is highest in the control treatment at Wheel Creek, while it is lowest in the control treatment at Church Creek. The restoration treatment matches the reference treatment for number of species at Church Creek and Dividing Creek, while it is lower than either reference or control at Red Hill Branch and Wheel Creek (See Appendix B).

If it is assumed, for preliminary analysis, that species composition at the study sites is drawn from the same underlying pool, (which has not been tested and may not be true), the average and standard deviation species count for the control treatment is 7.8 +/- 3.6; the reference treatment 8.6 +/- 0.96; and the restoration treatment 7.1 +/- 1.7. Because the means are within one (1) standard deviation, it is unlikely that the treatment type could be demonstrated to have any effect on species diversity.

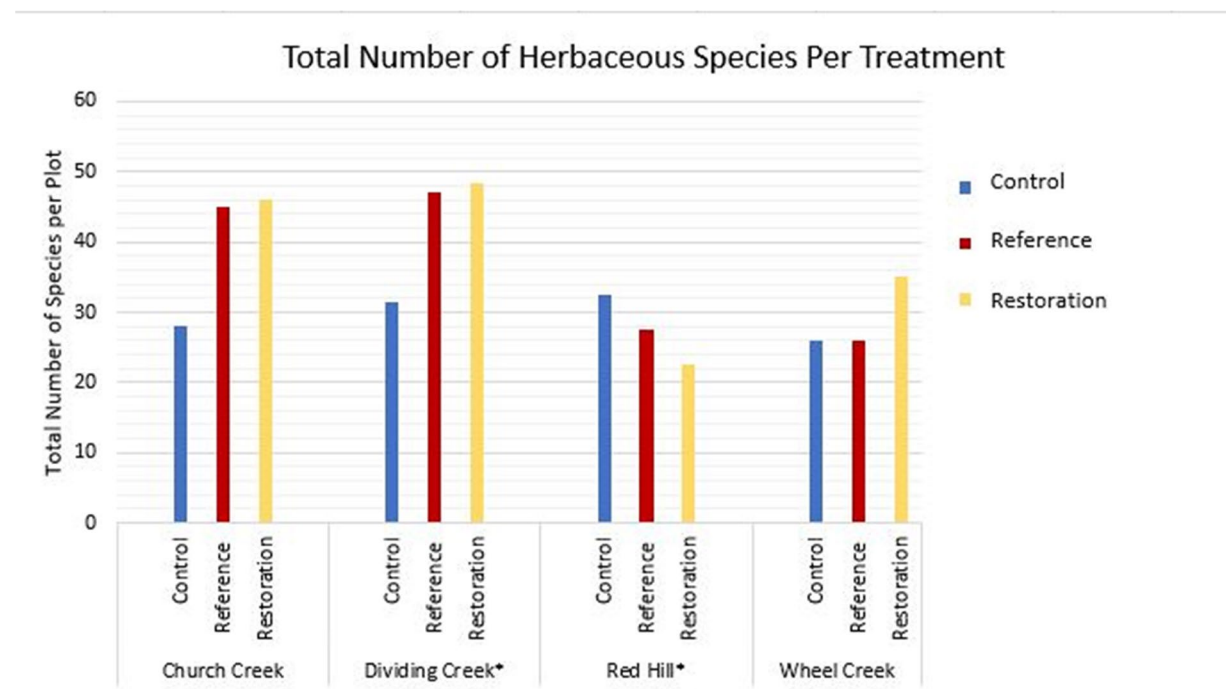
Figure 10. *Graph Herbaceous Species Per Treatment*

For herbaceous plants, Dividing Creek had the highest number of herbaceous species per treatment, Wheel Creek had the fewest (See Table 6). In general, across all study sites, the restoration treatment had more herbaceous plant species than the reference or control treatments, with a total of 117 species found. There was a total of 181 herbaceous plant species found across all sites and all years (See Appendix C).

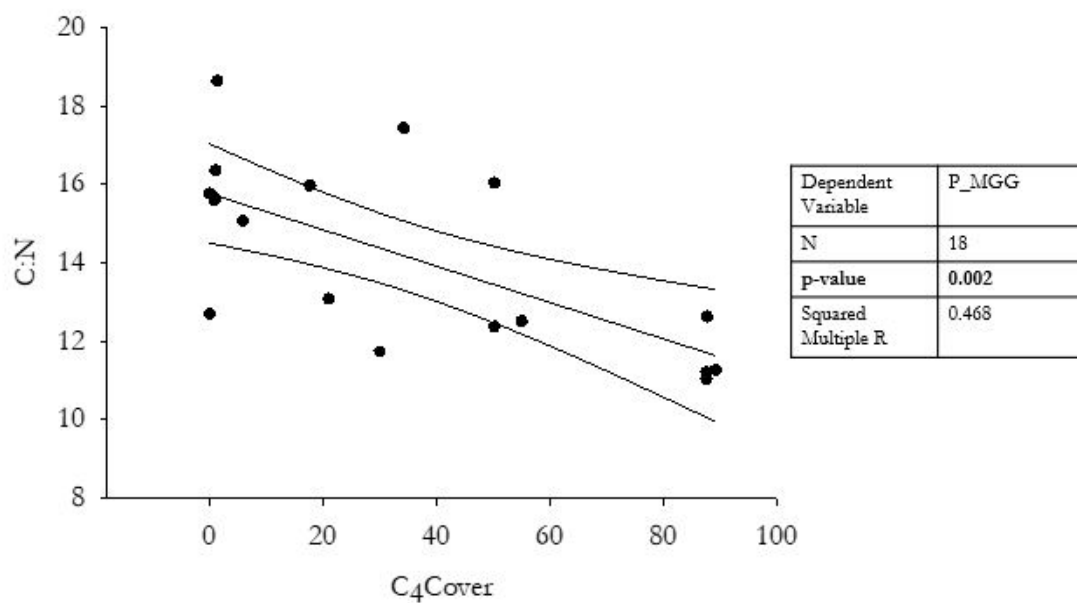
Figure 12. C₄ Cover and C:N Ratio

- **P Stocks** – correlated with higher C4/invasive species cover (Japanese Stiltgrass)
- **C:N** – declined as C4 cover increases
- **C:N** – increased as woody cover increases

The full set of Pearson Correlations is shown Figure 11, with selected regressions in Figures 12 and 13. Note that in Figure 11, there are only two correlations with magnitude above 0.6 – C:N ratio vs. C4 Cover, and C:N ratio vs. woody cover. Scattergrams with regression lines for these two cases are shown in Figures 12 and 13. These are very weak statistical results, with r^2 values (% variance explained) less than 0.5. As noted above, it is not unexpected to find higher C:N ratios in forested areas; the wide scatter shown in the graphs suggest that local conditions and site history are of greater importance than the amount of vegetation.
