Evaluation of Legacy Sediment Removal and Floodplain Reconnection as a Restoration Technique

Vanessa B. Beauchamp and Joel Moore
Towson University

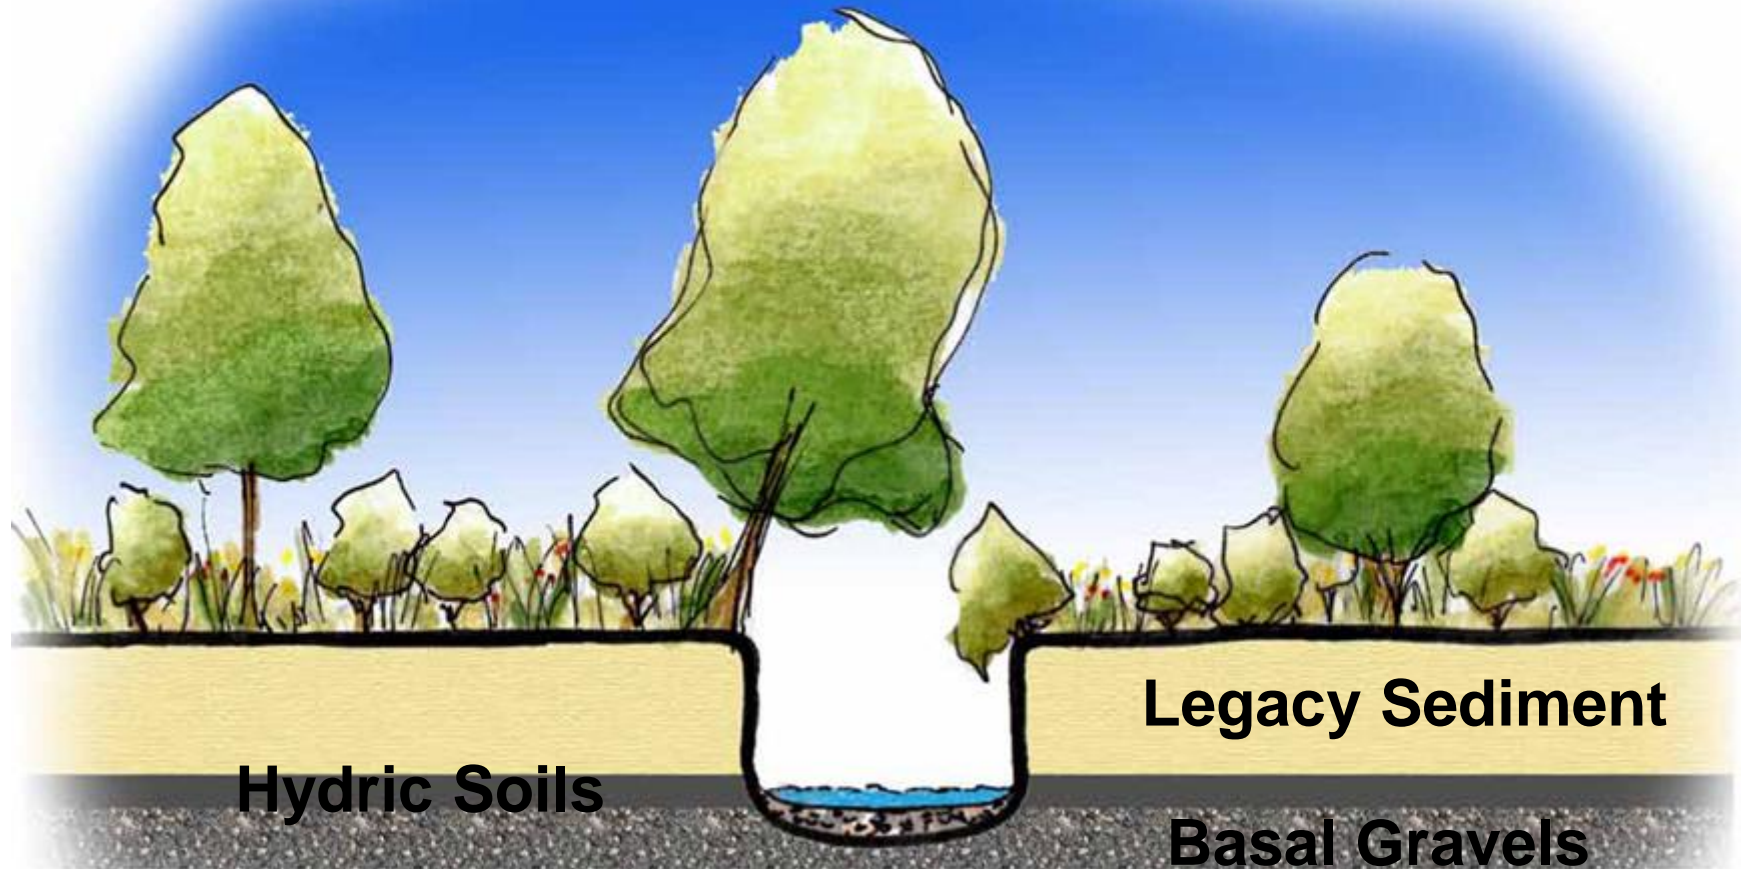
Existing Conditions

Legacy Sediment is the impairment to the aquatic resource

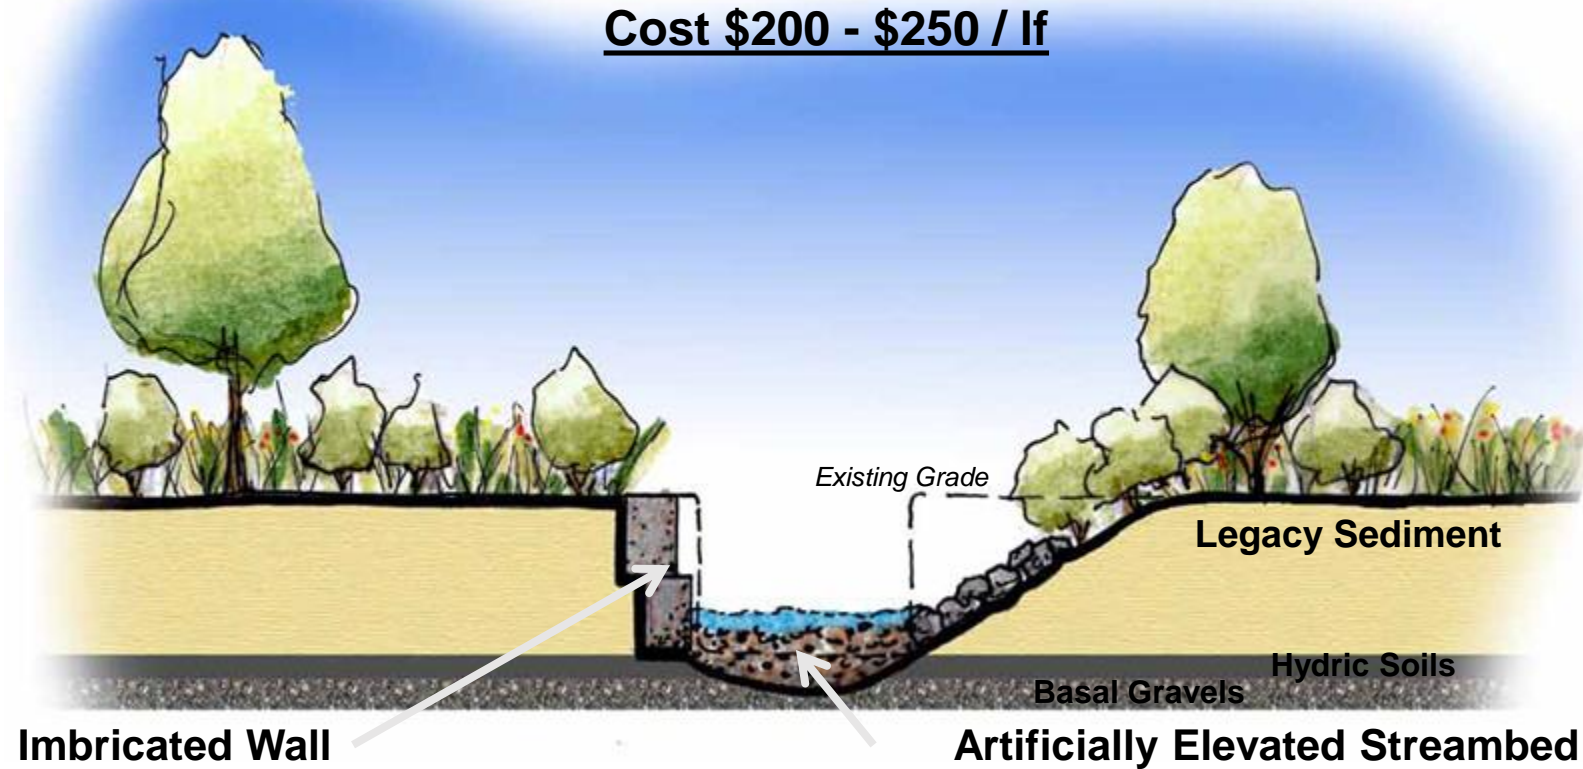
Hard Armor Approach

Short Term Benefit

- Reduced erosion of impairment
- Minimal improvement to aquatic resource

Long Term Risk

- Failure of armoring resulting in renewed erosion of impairment

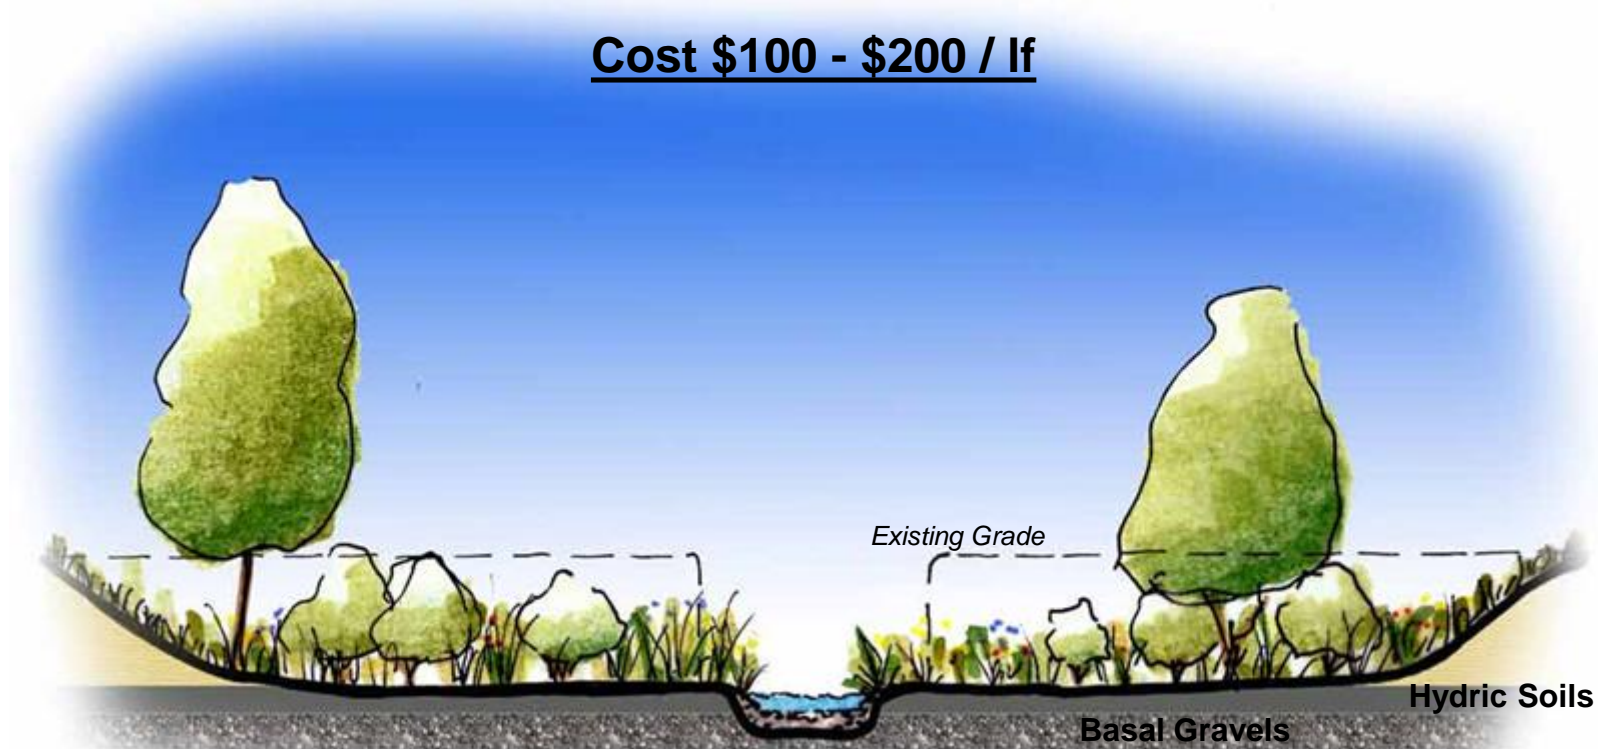
Floodplain Restoration

Cost \$100 - \$200 / lf

Short & Long Term Benefit

- Removal of impairment
- Restored function of aquatic resource

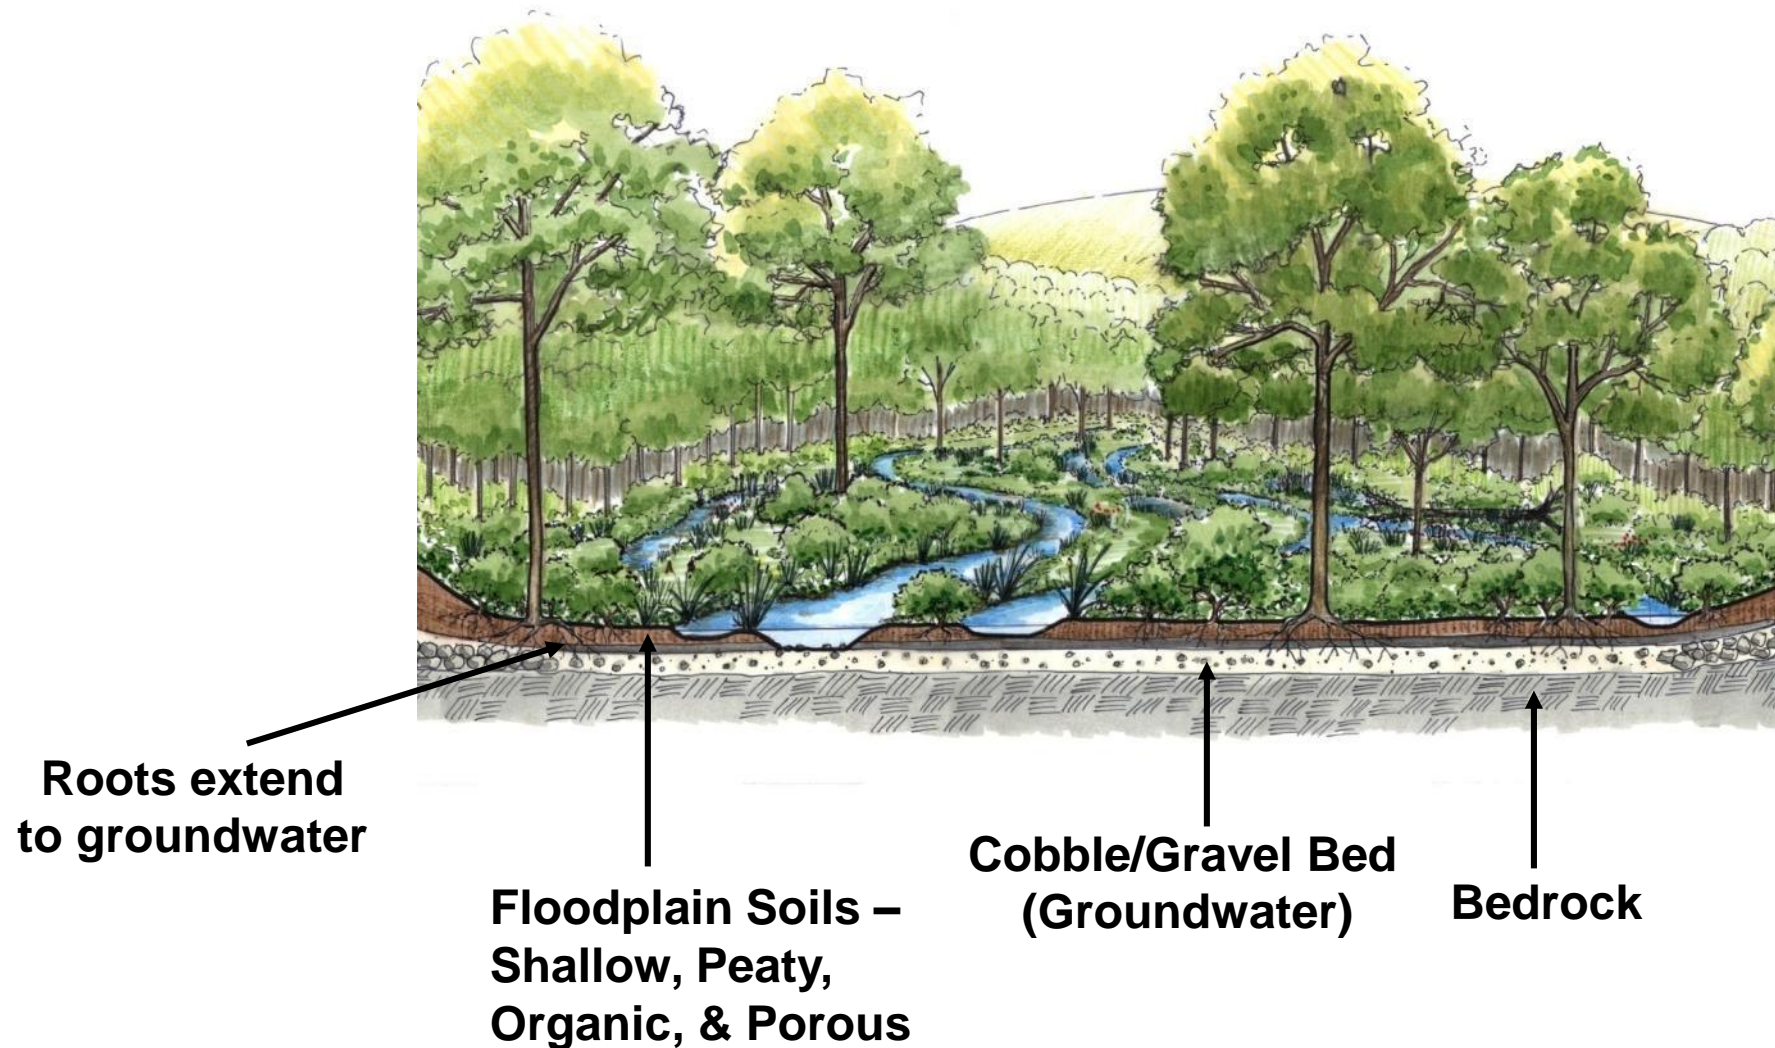
Natural Piedmont Stream Valley

Connectivity between rooting zone, groundwater, and stream flow

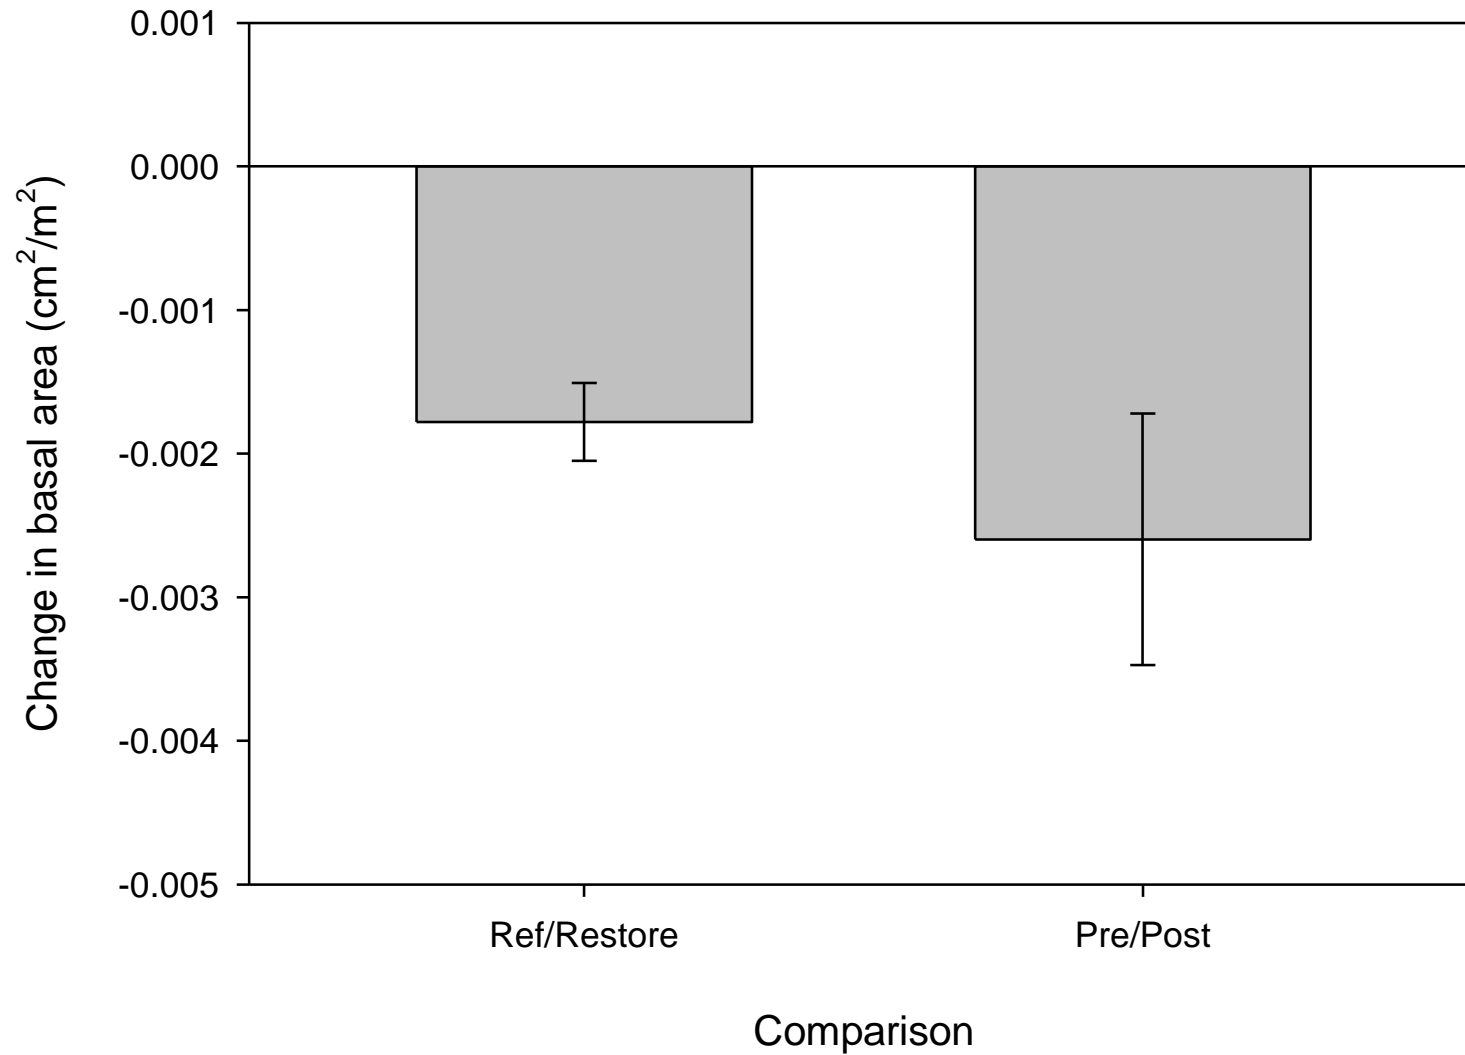
Average 81% DECREASE in basal area

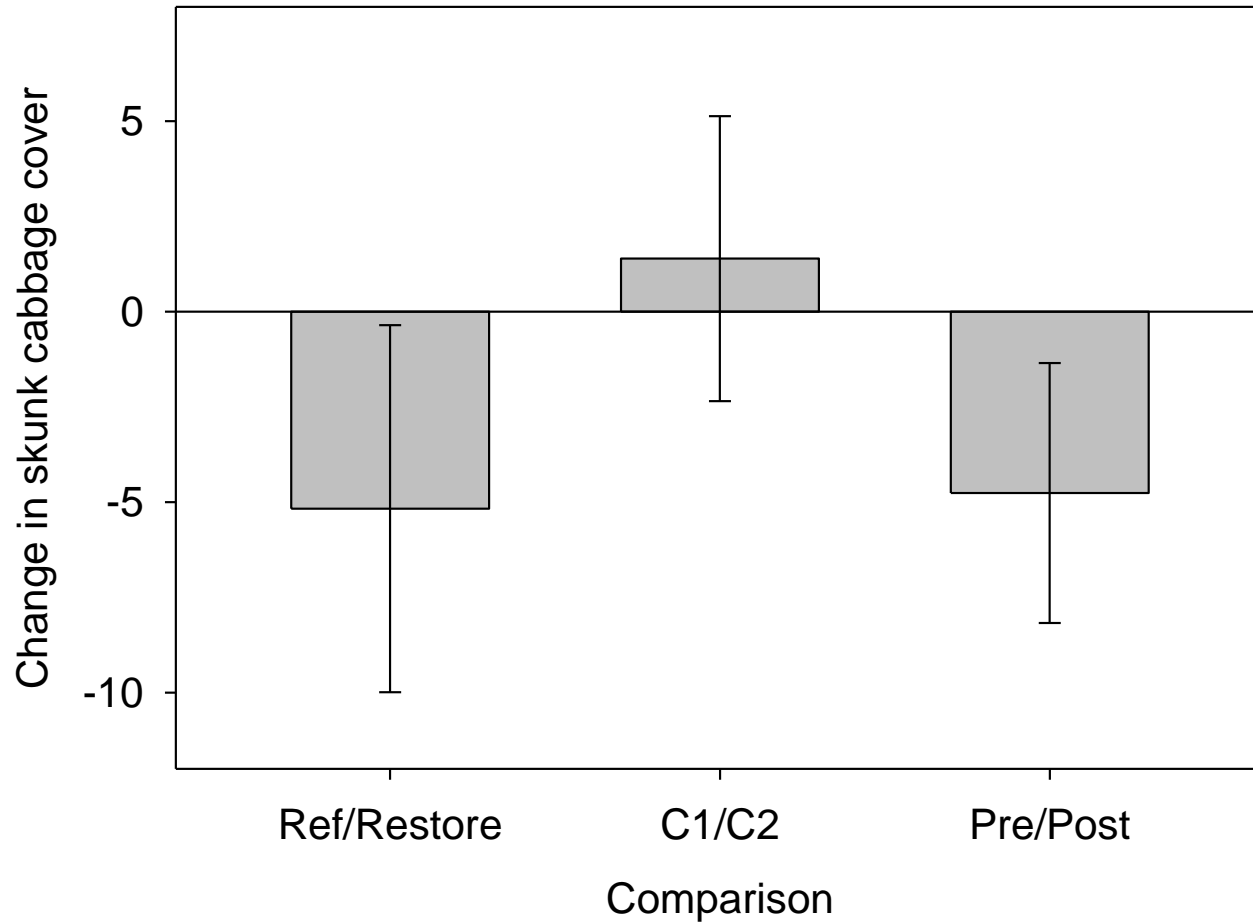
Average 79% DECREASE in skunk cabbage cover

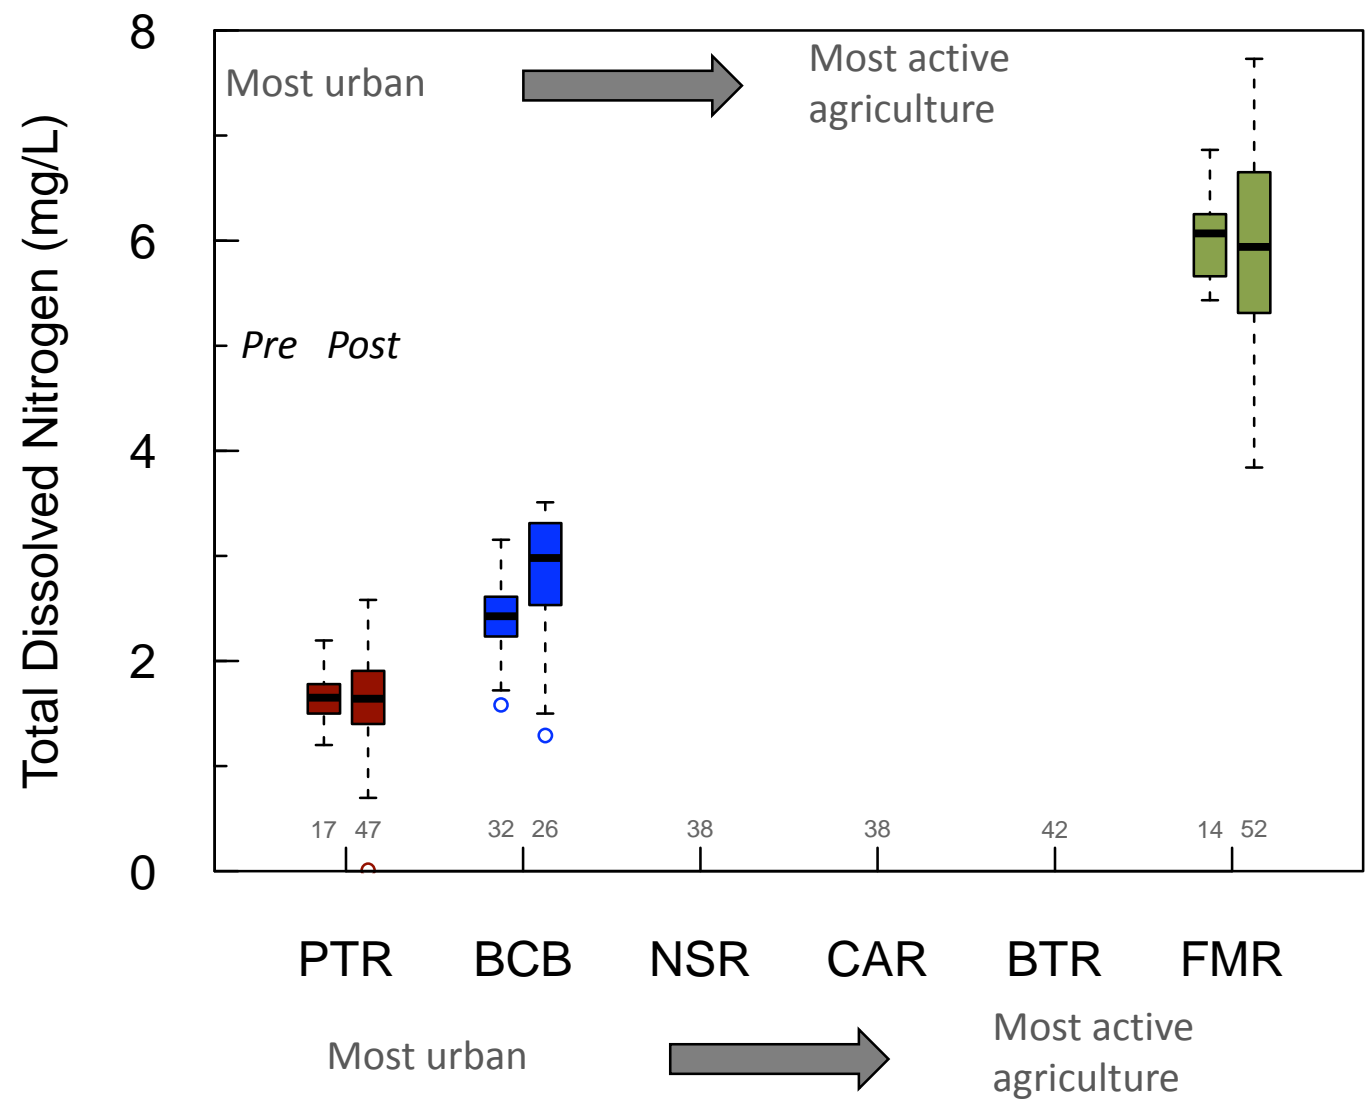
Biggest control for N: land use
Pre-/Post-restoration: no significant difference (yet)

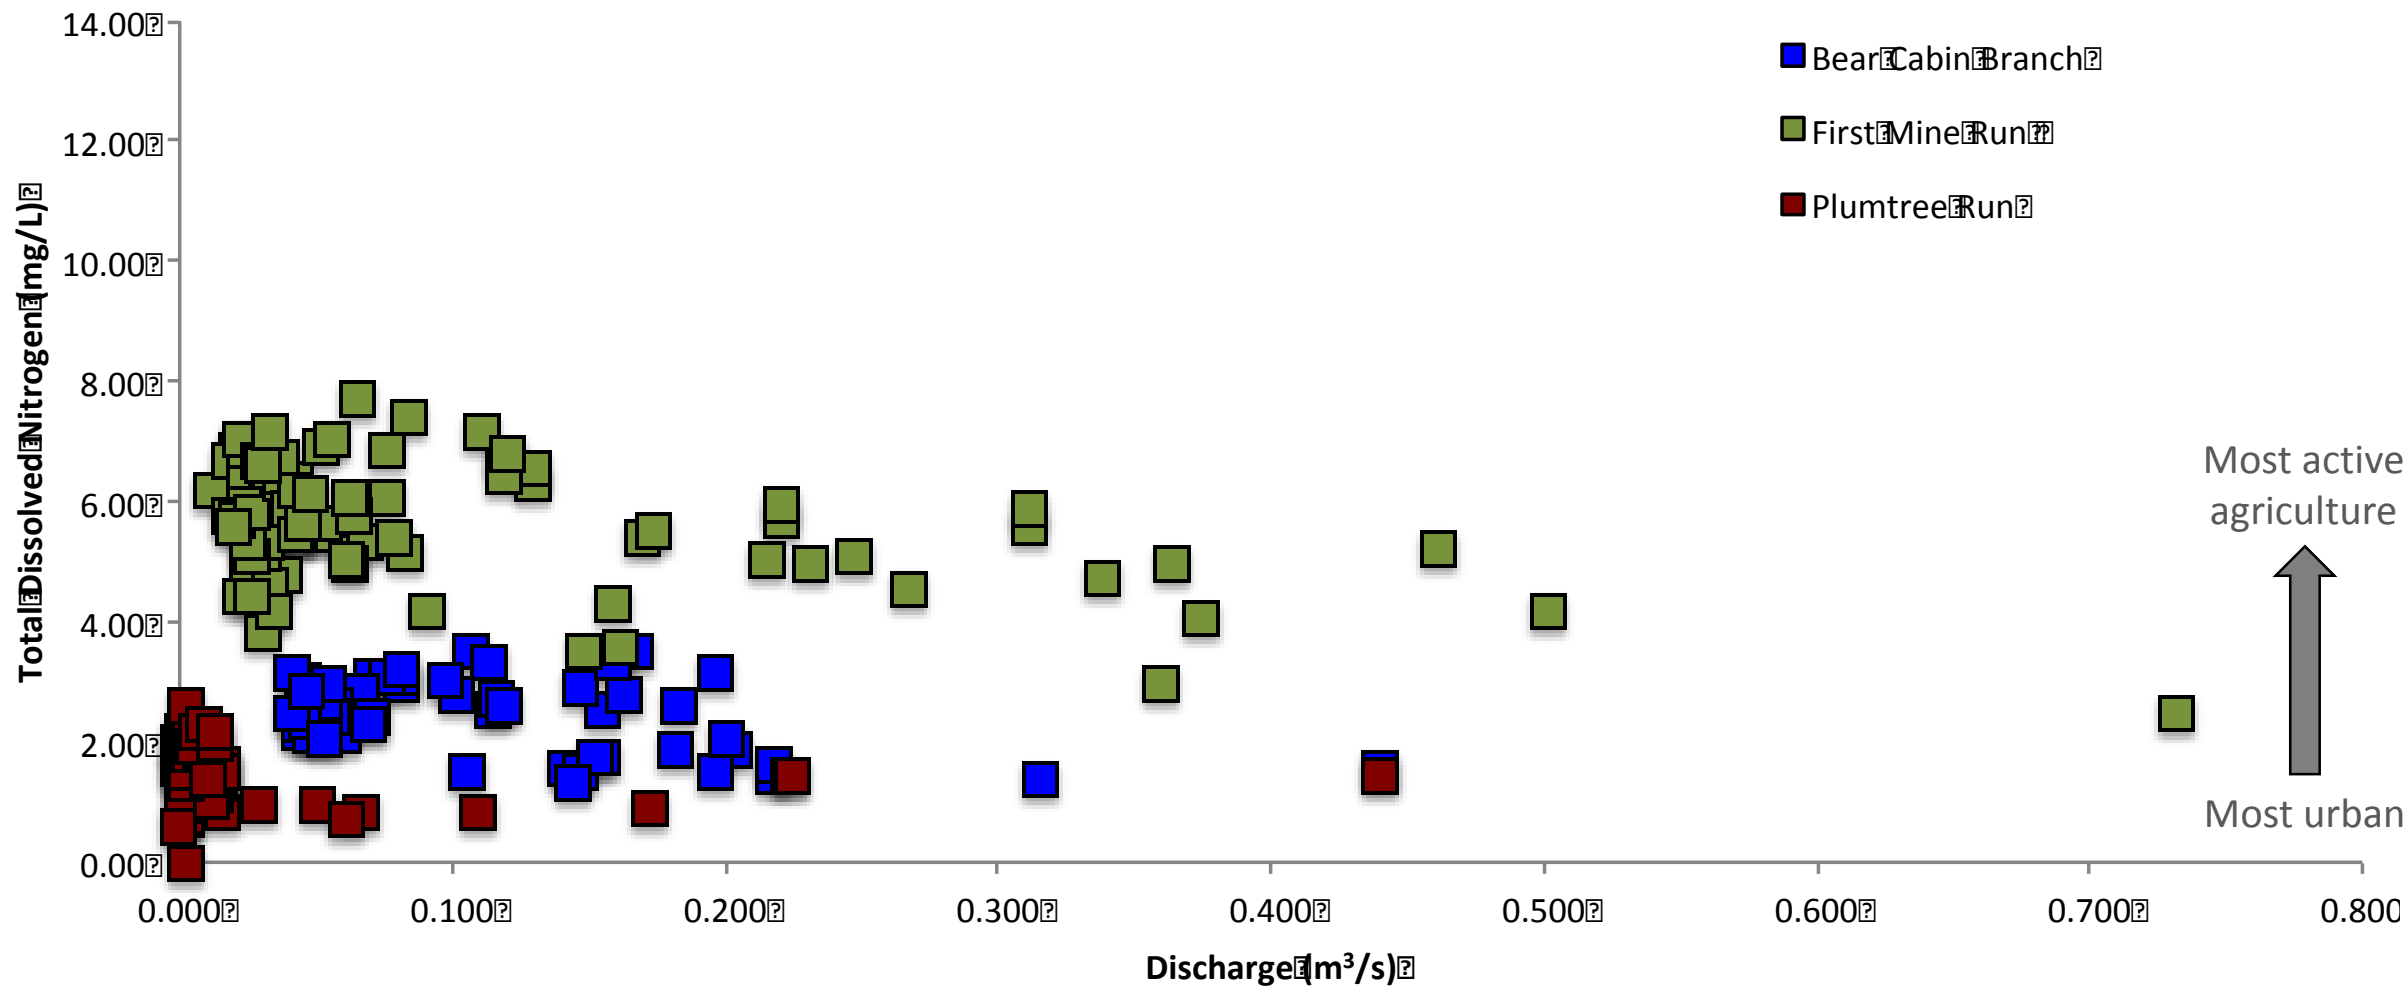
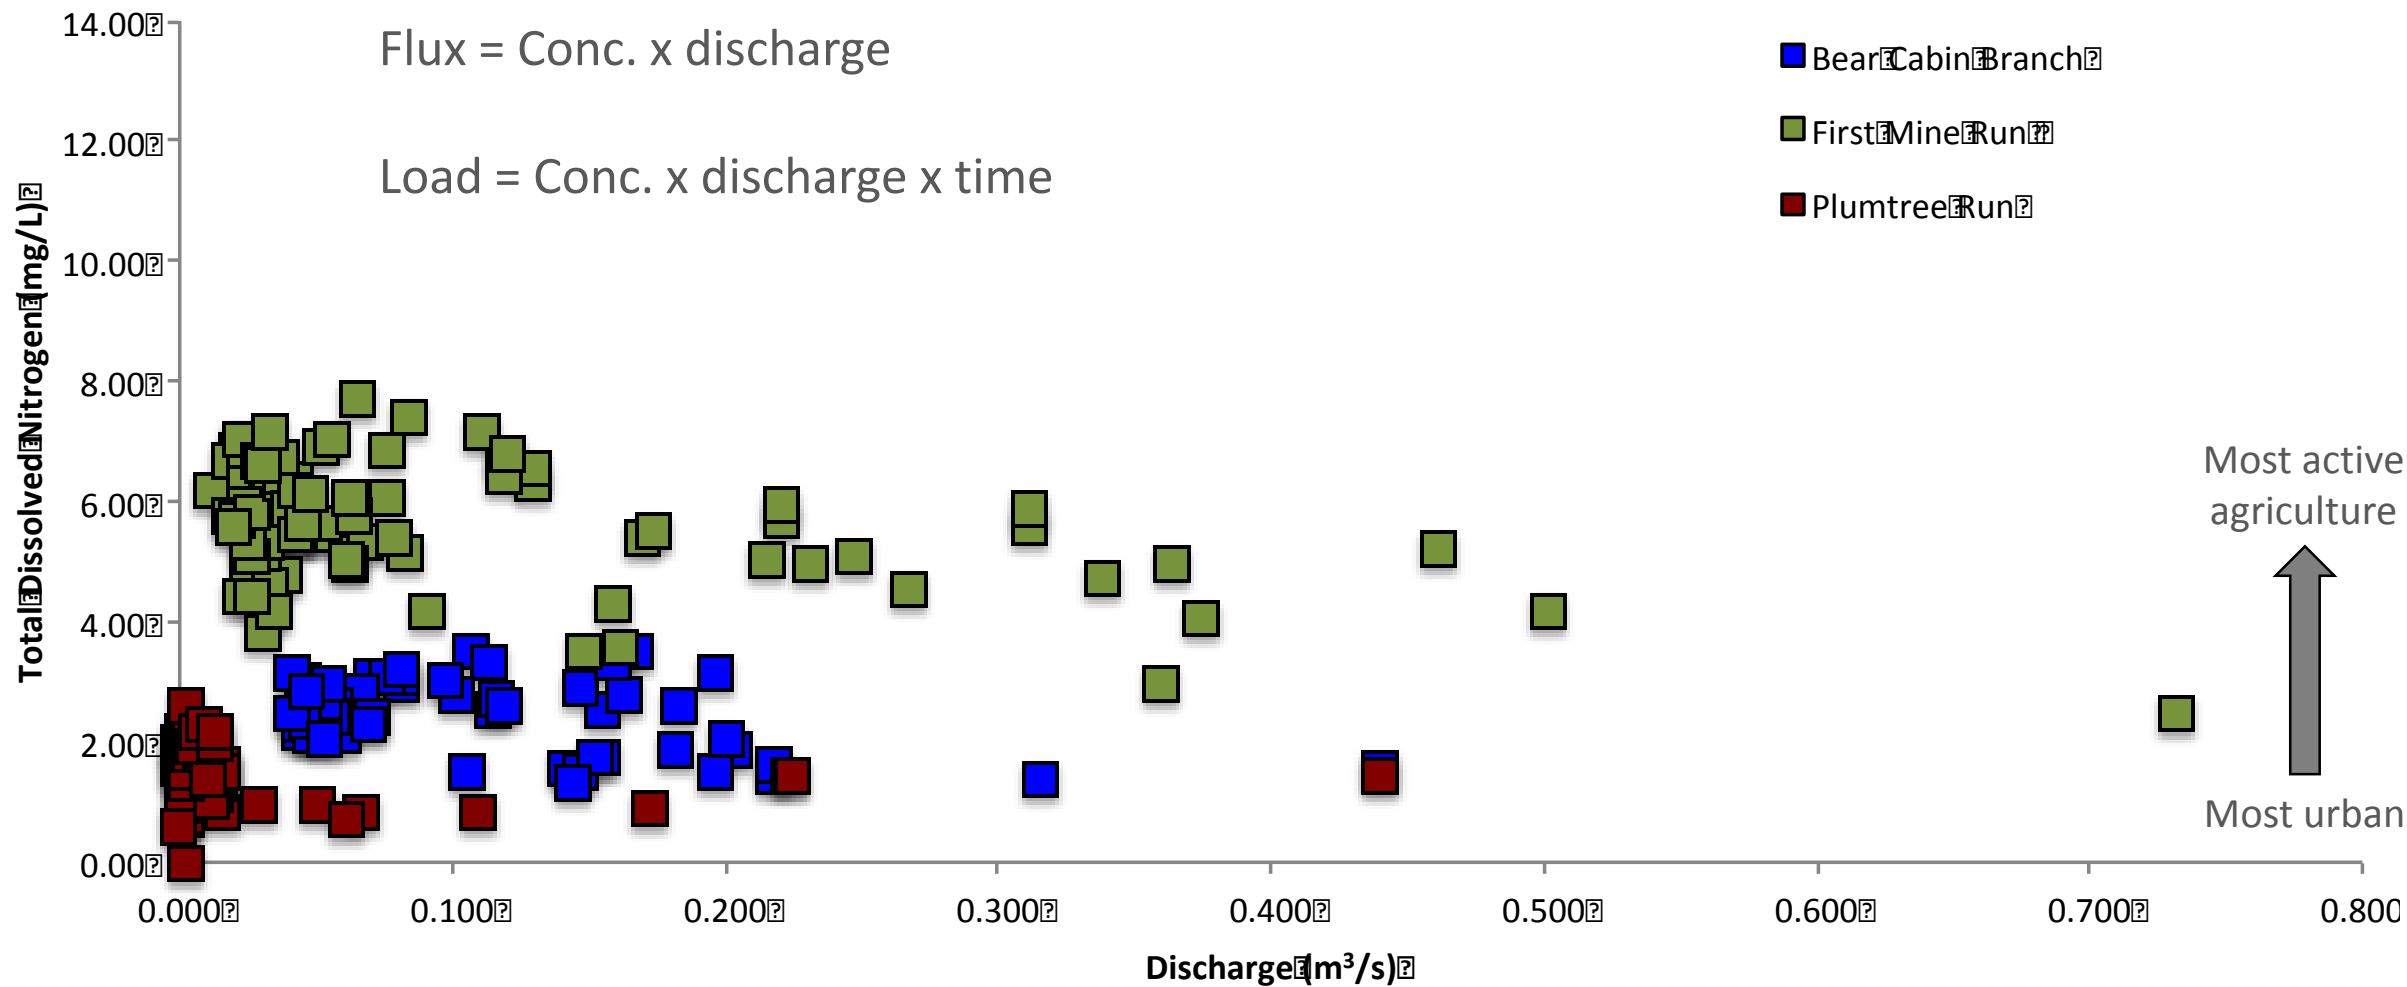
Little dilution of N with increased discharge. Result is substantial loads

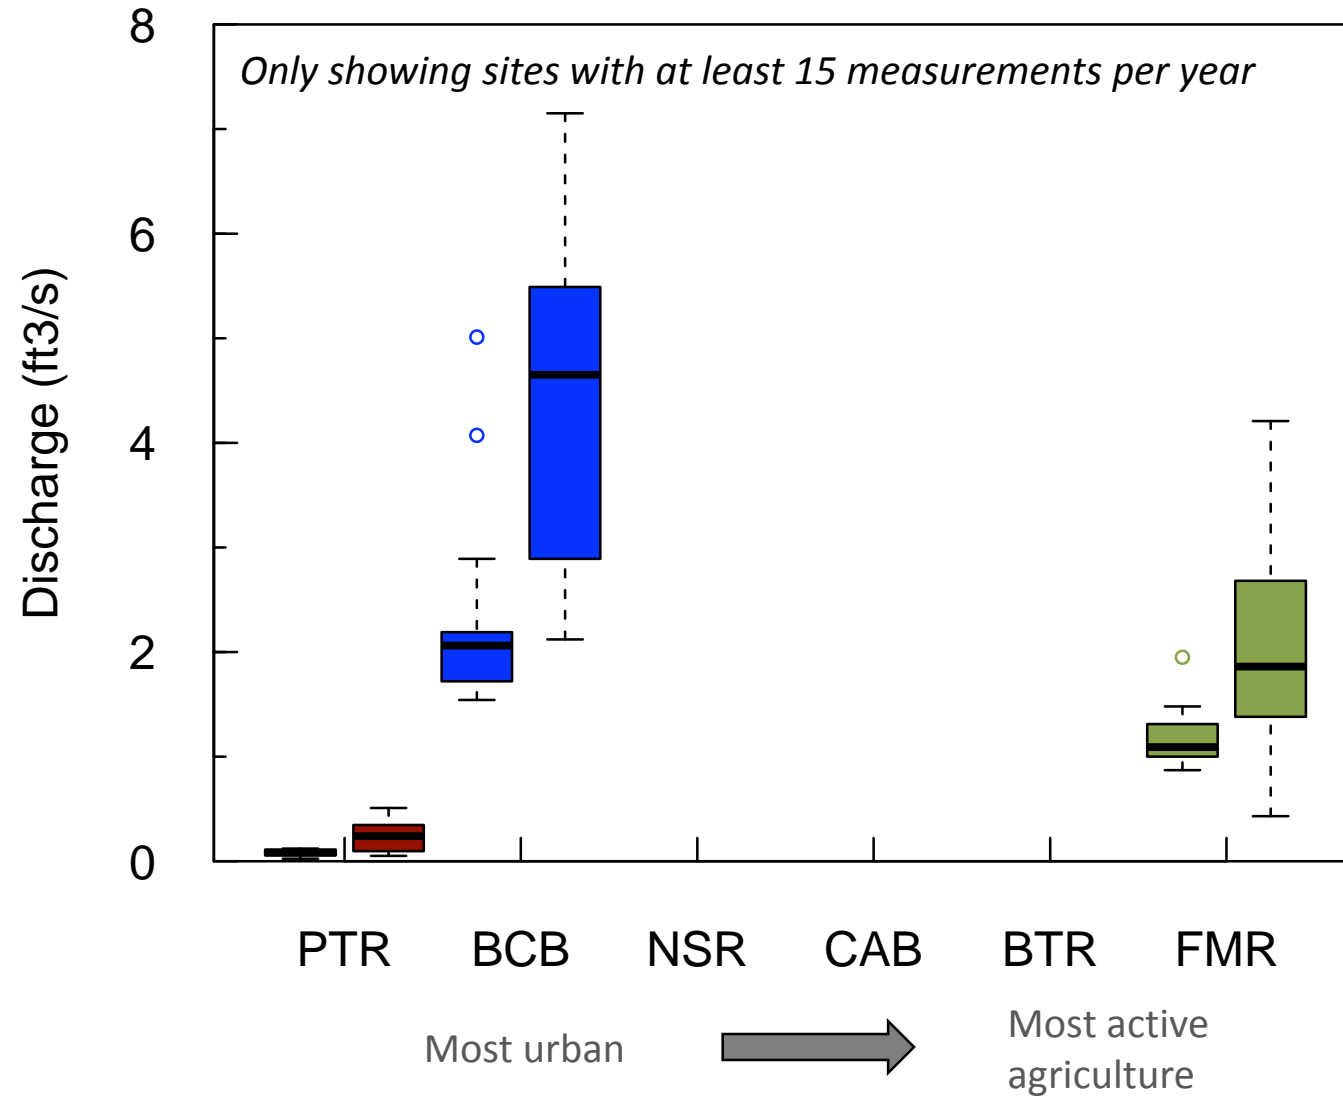
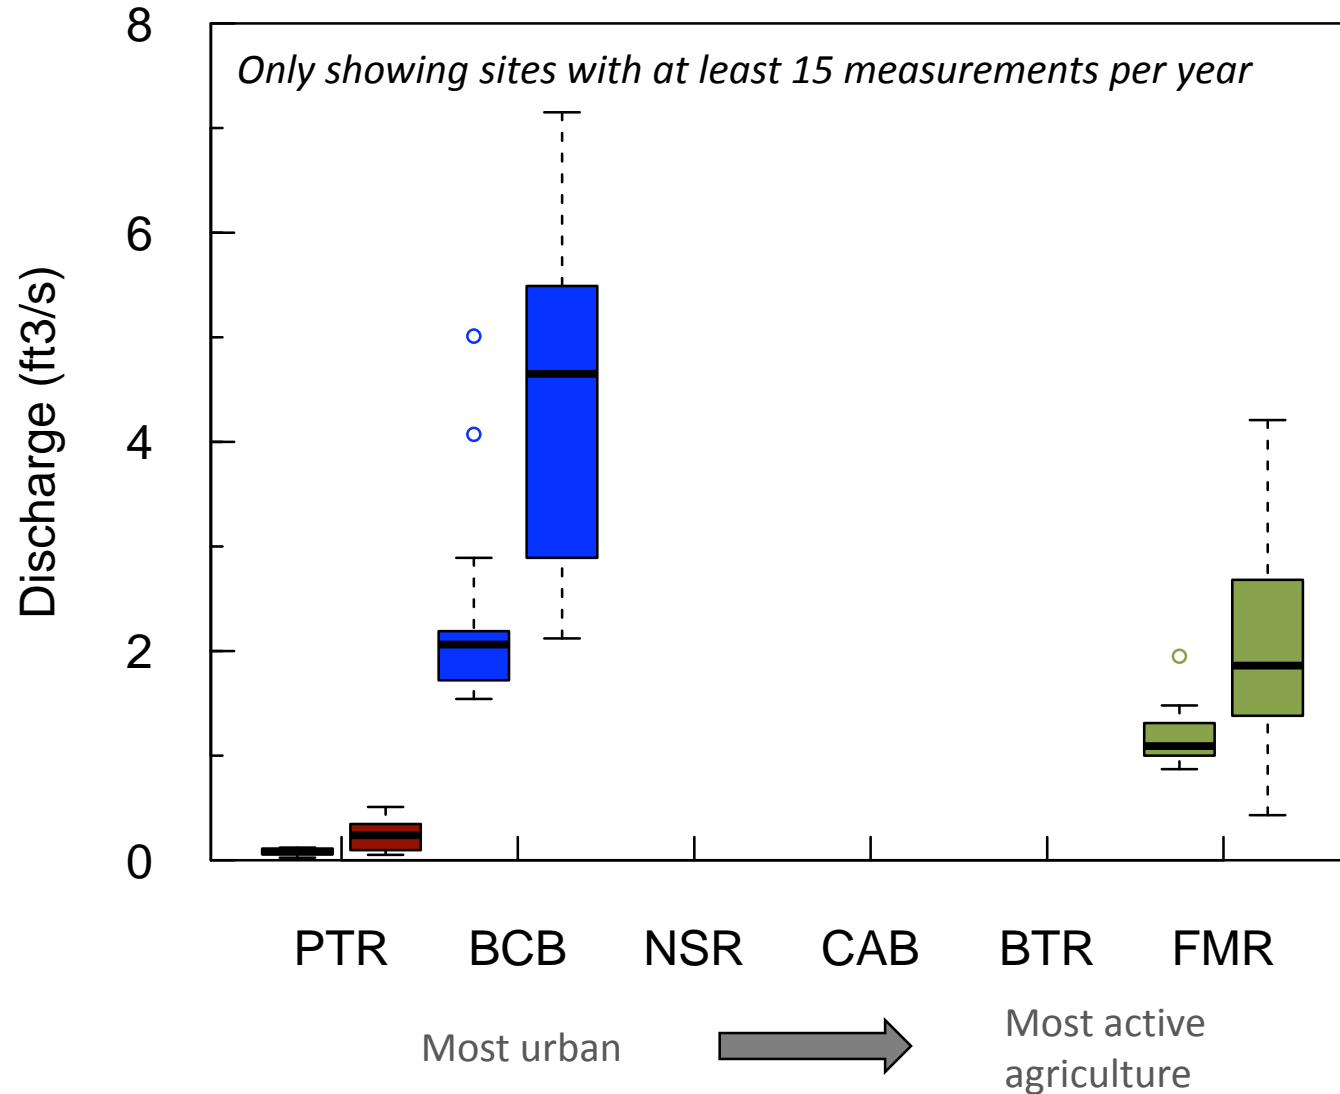
2017 vs 2018 baseflow discharge

2018 was high precipitation & discharge year – so higher fluxes/loads quite likely
