Evaluation of Legacy Sediment Removal and Floodplain Reconnection as a Restoration Technique

Vanessa B. Beauchamp and Joel Moore
Towson University

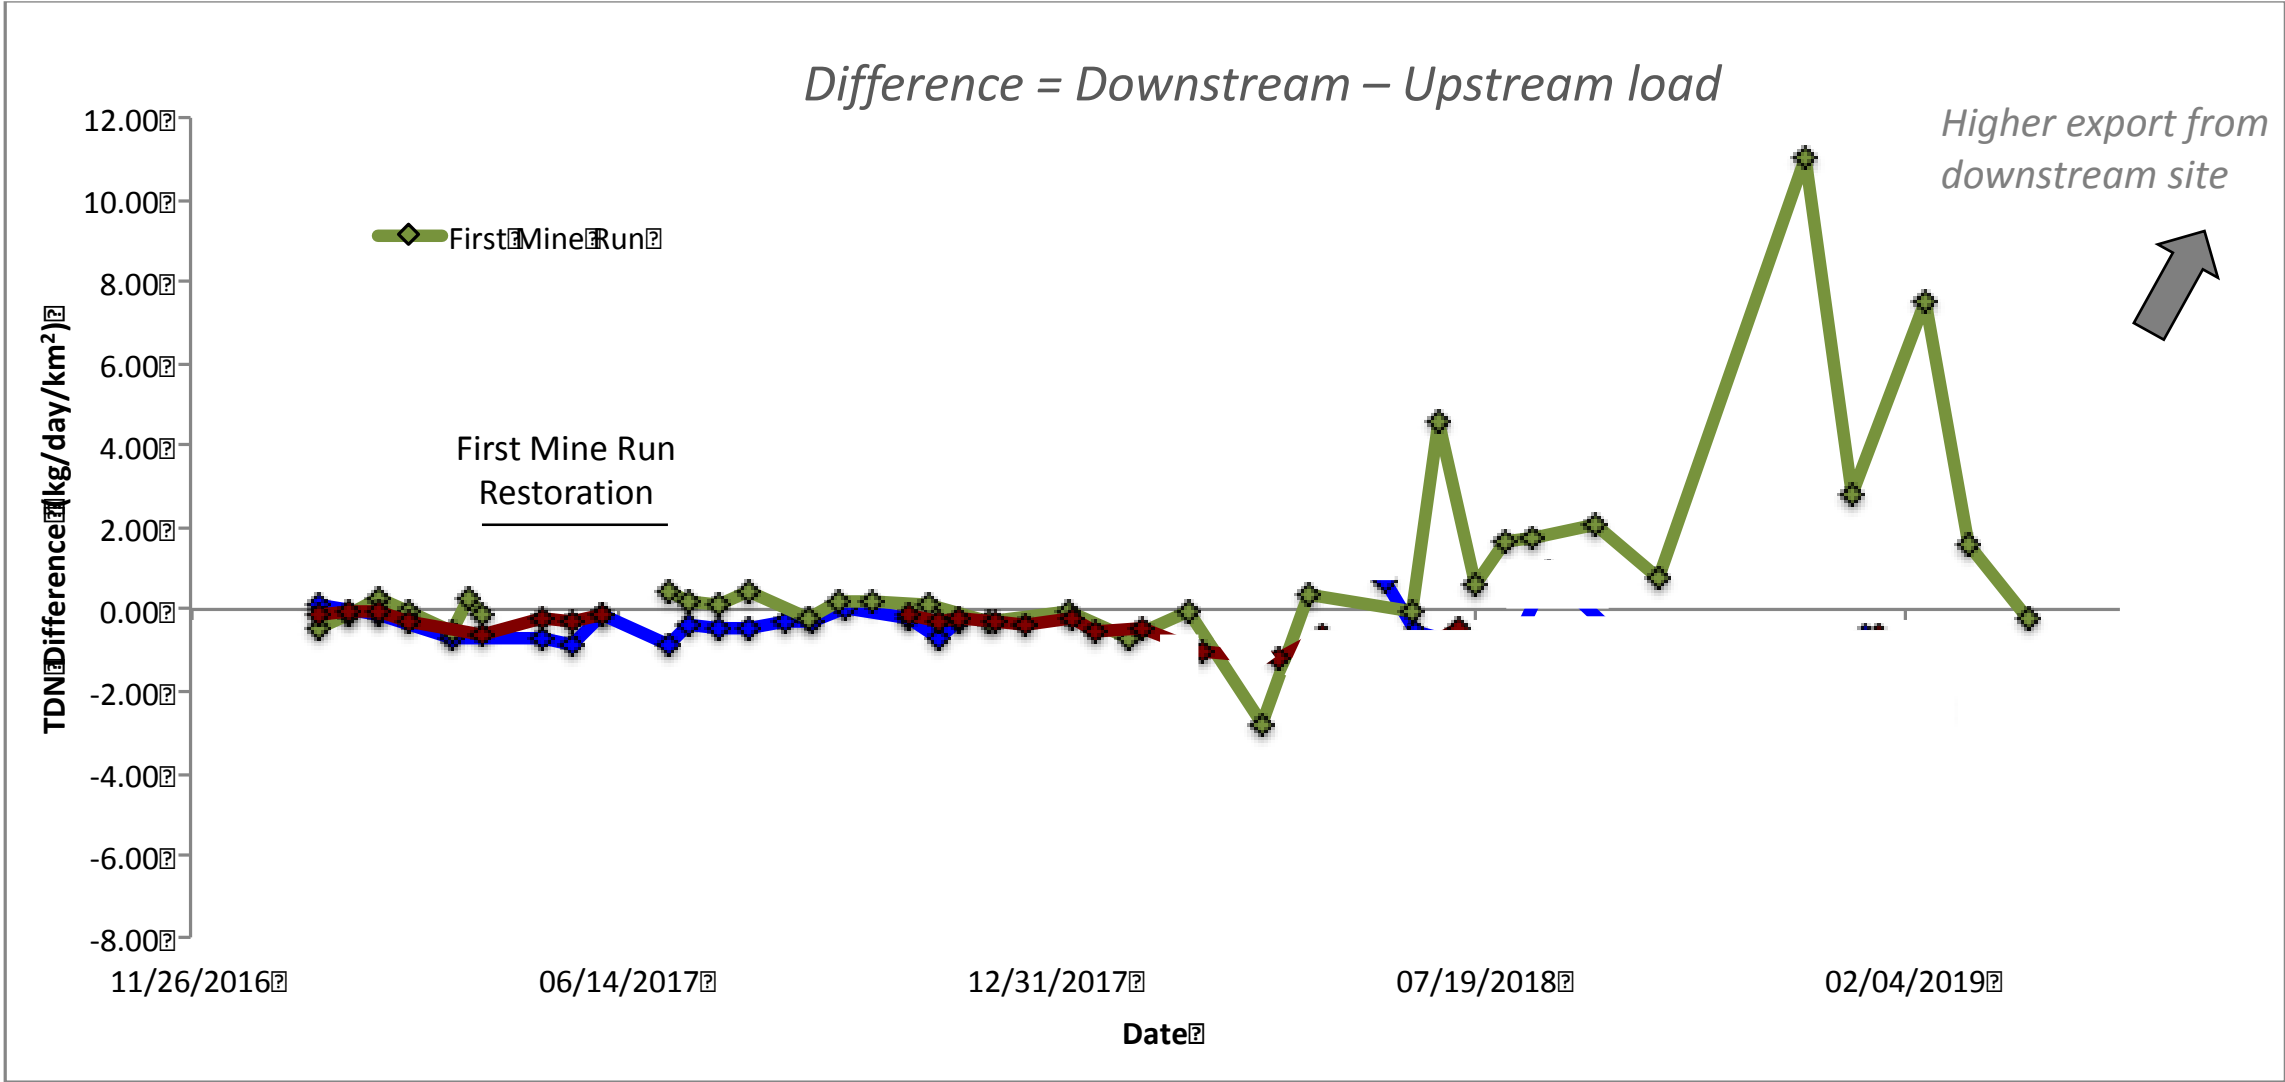
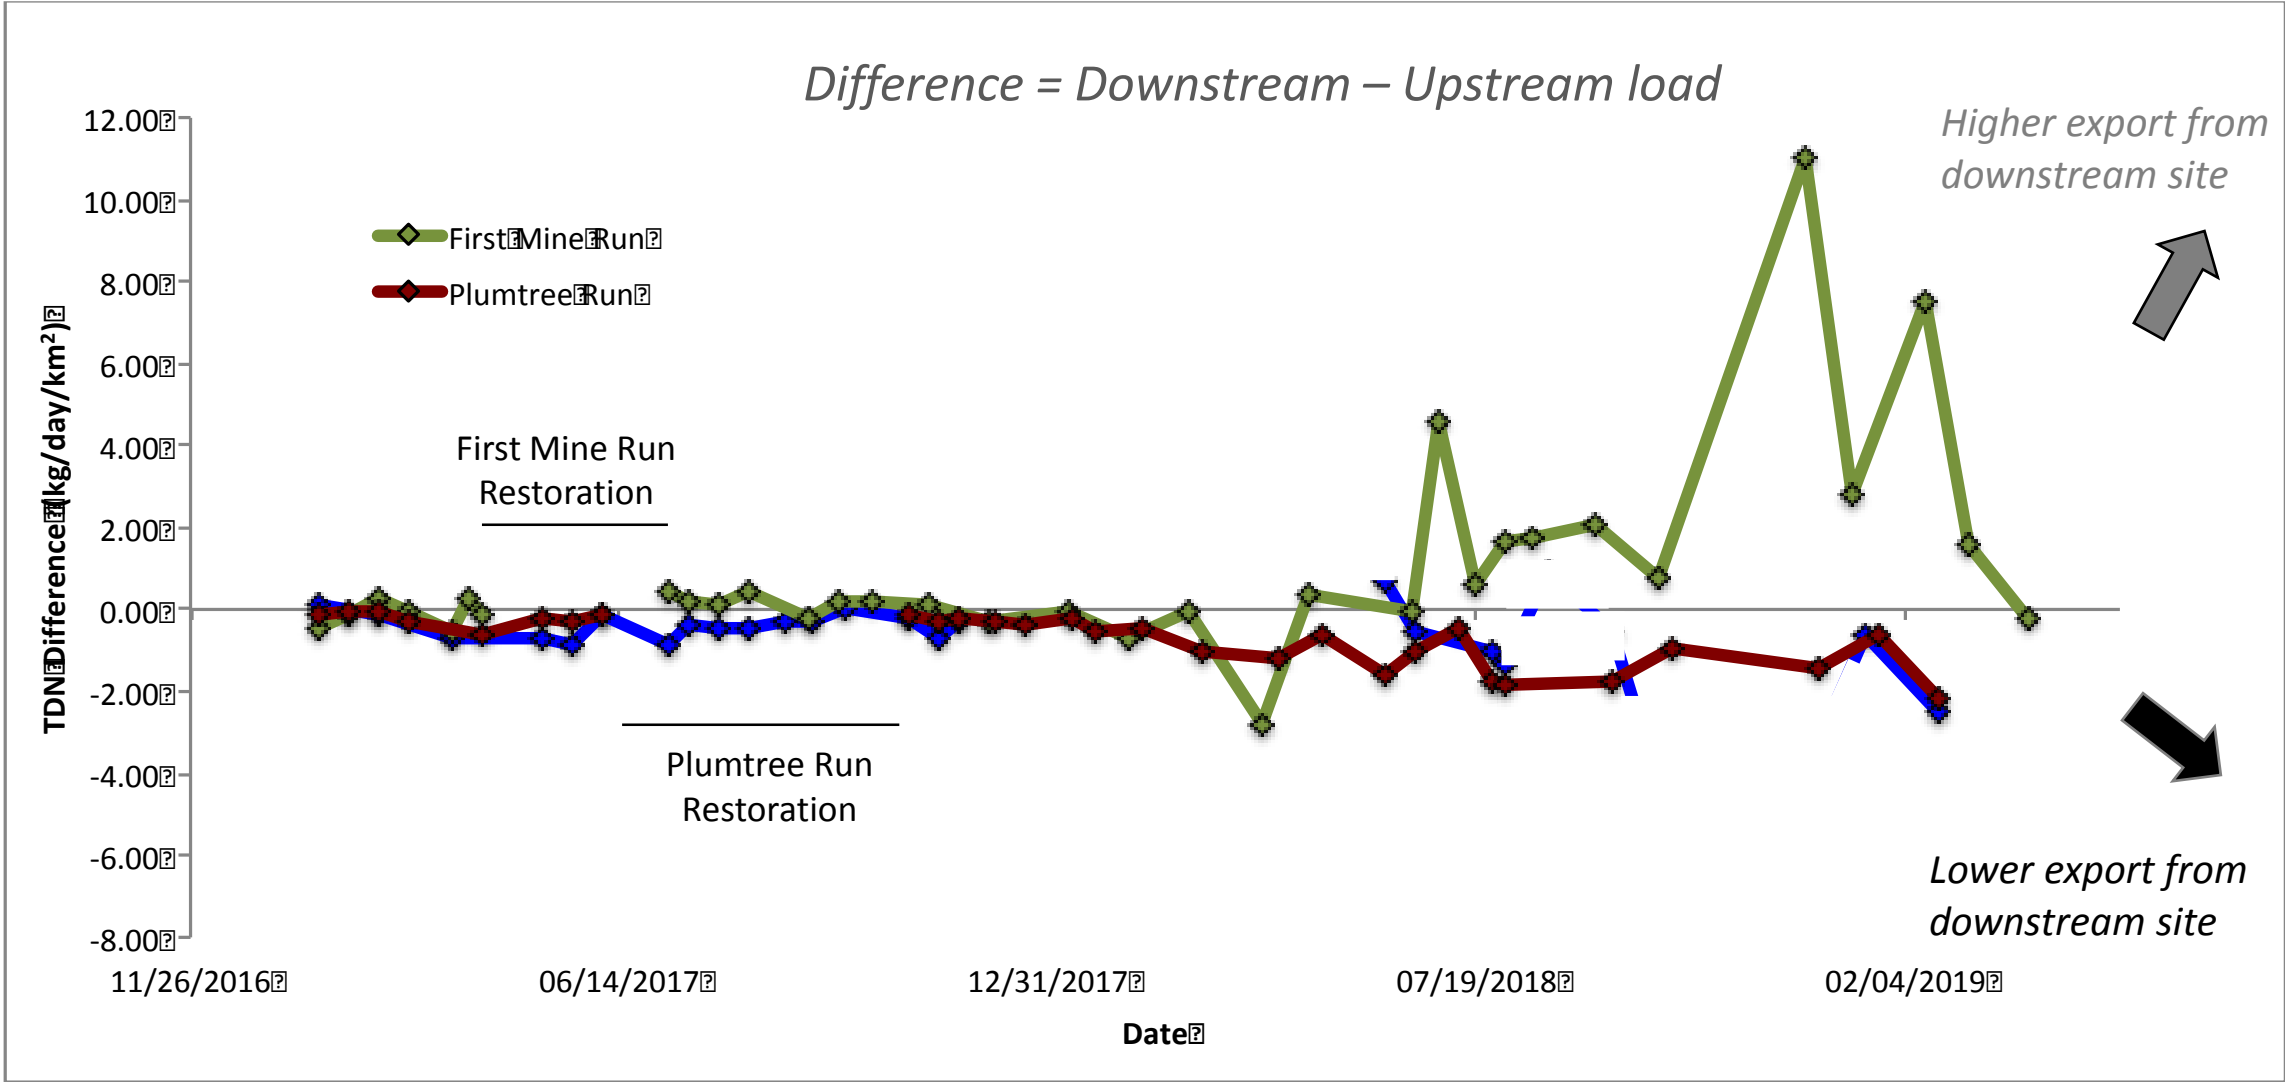
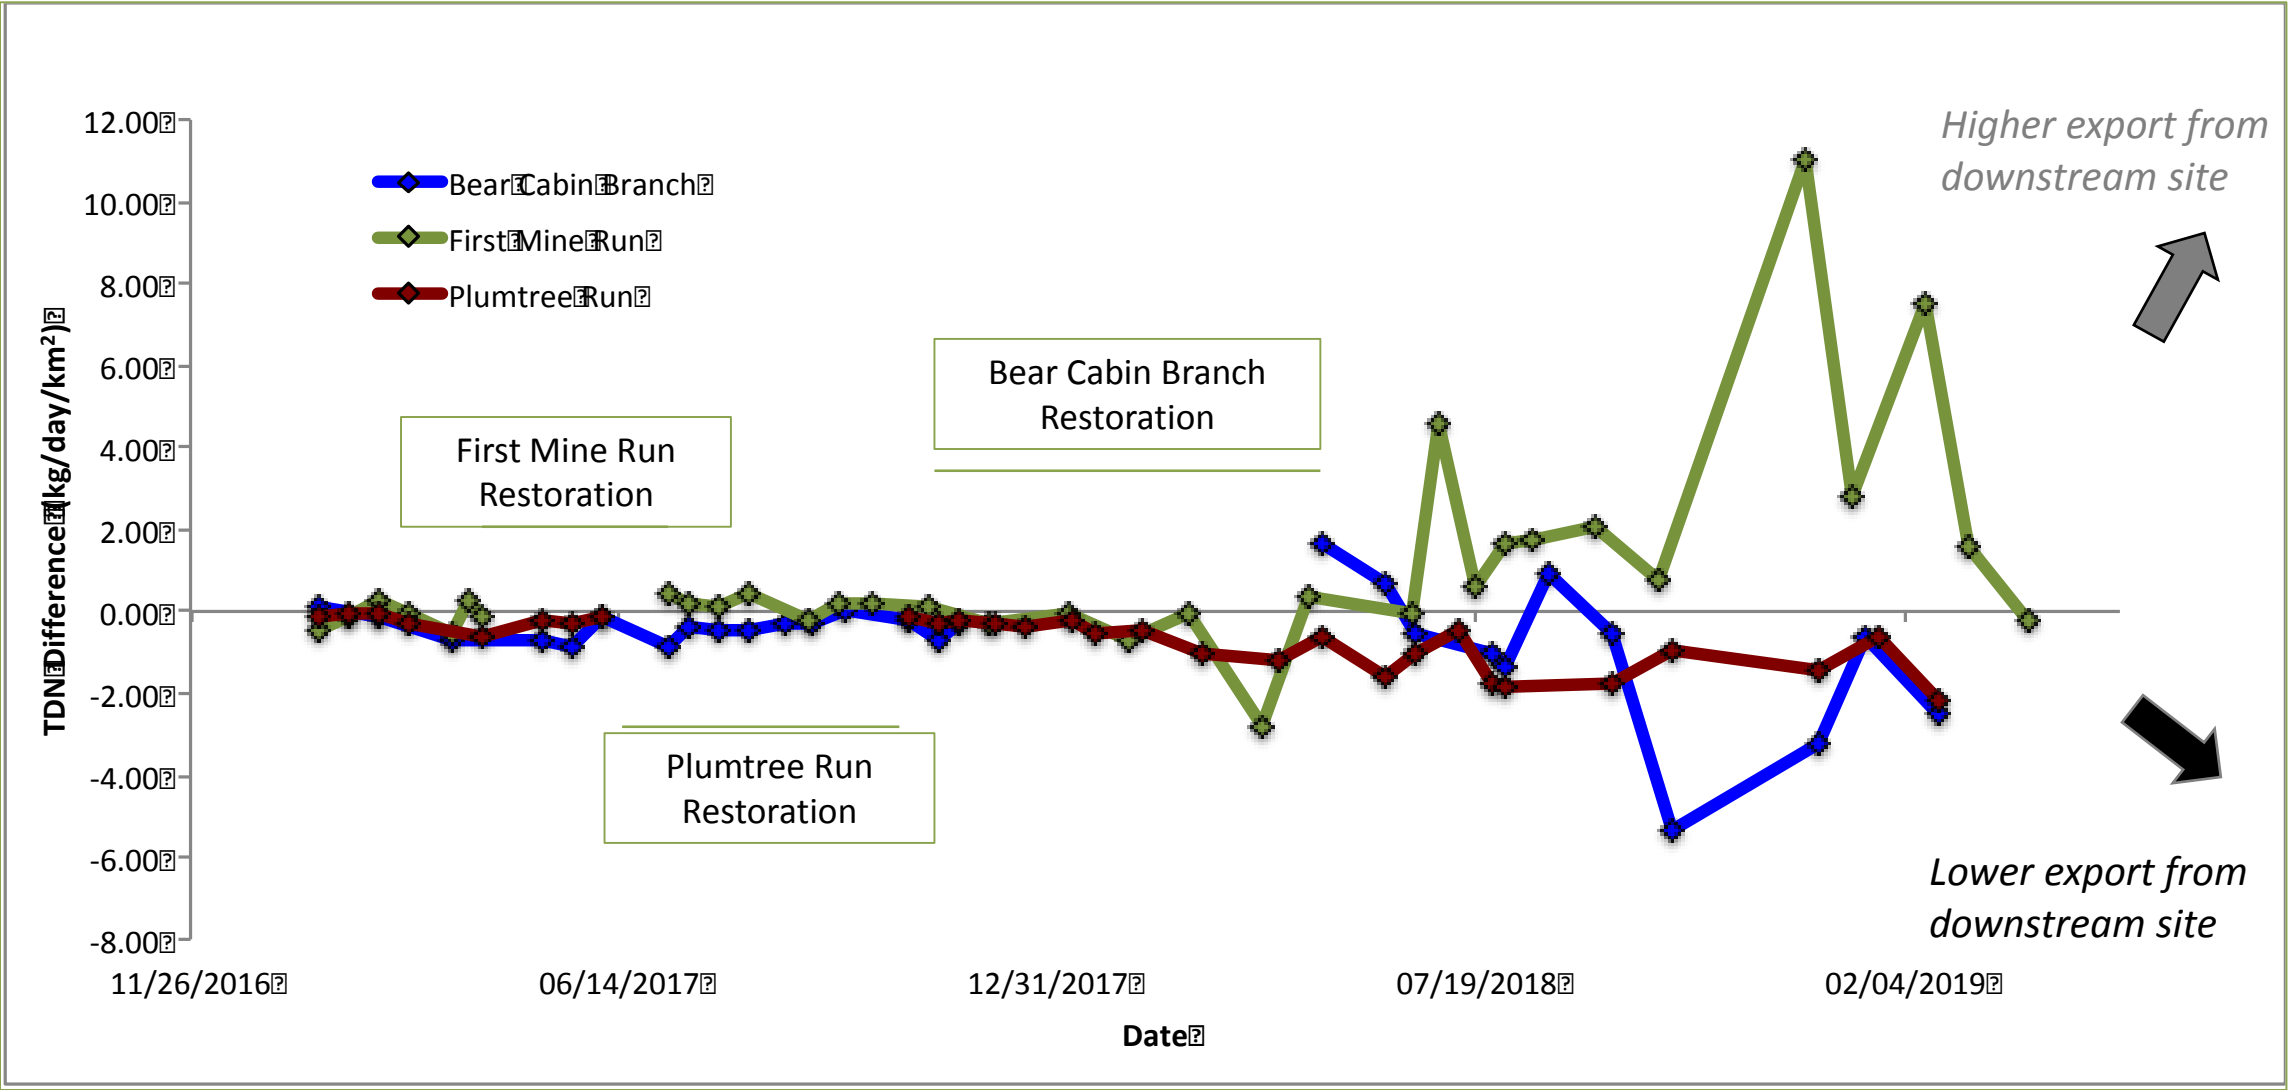
Baseflow fluxes seem to have changed post-restoration

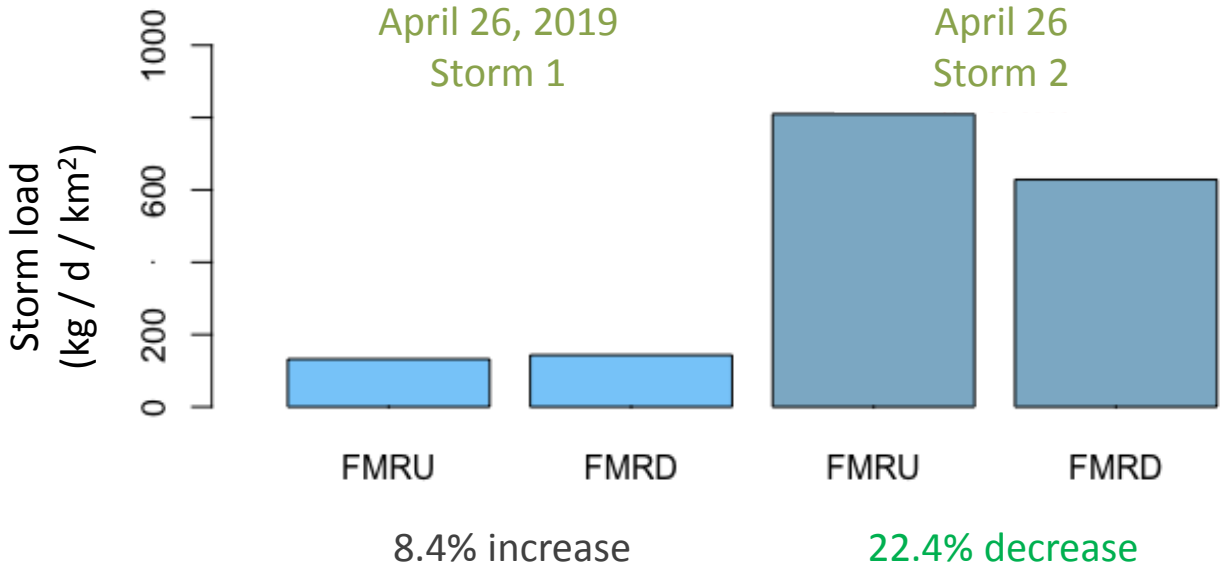
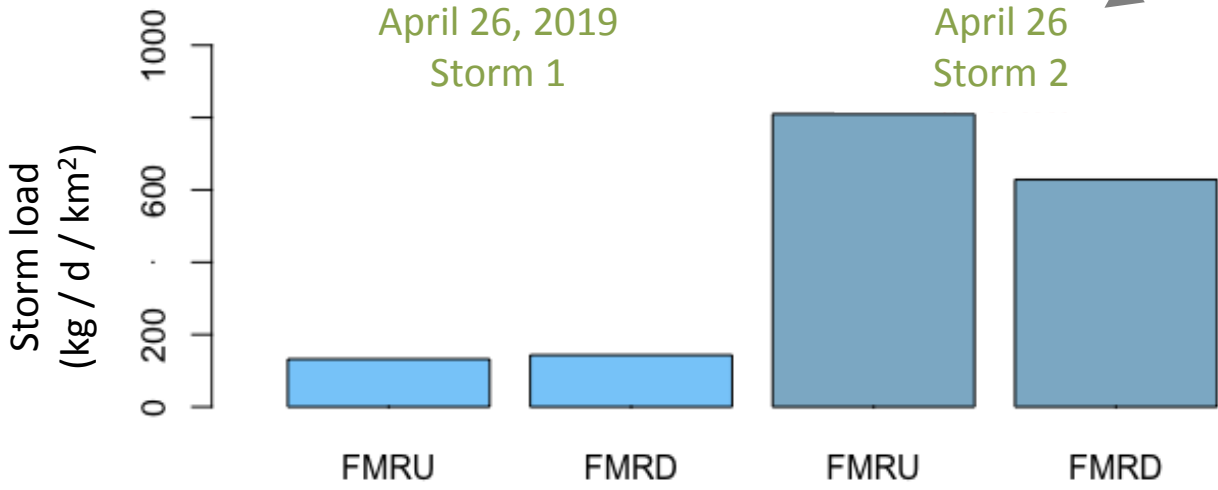
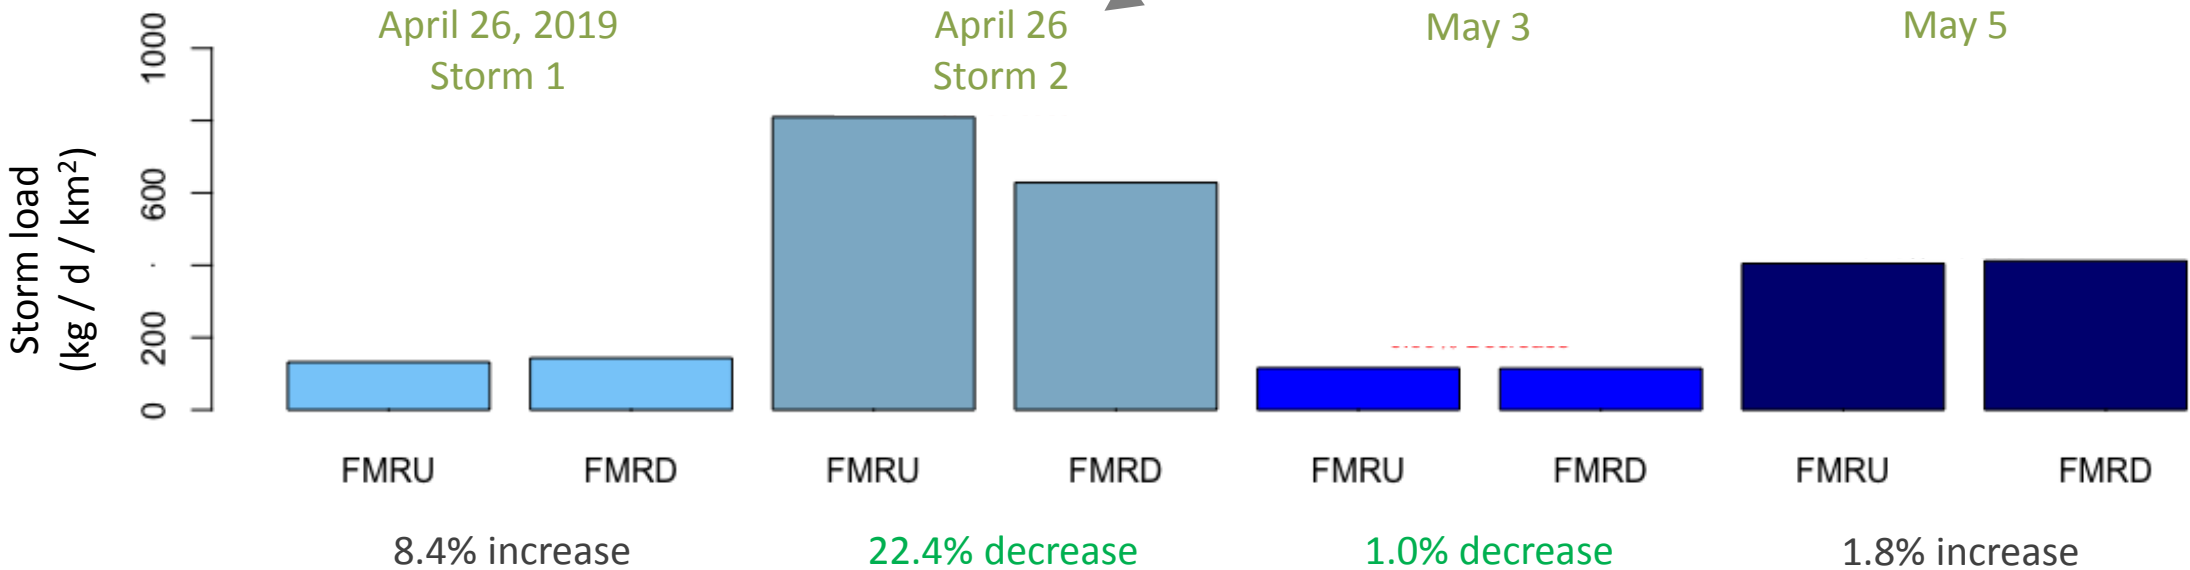
Suspended sediment load shows a decrease in bigger storms

FMR: Site with highest agricultural intensity

Perhaps overtopping banks & reaching floodplain

8.4% increase

22.4% decrease
