Montgomery County: Anacostia Trash TMDL Monitoring-Related Efforts FY24 Technical Memorandum

Prepared For:
**Montgomery County Department of Environmental
Protection**

Prepared By:
Samuel Groat, Aubin Maynard, Elizabeth Tyler, Phong Trieu
**Metropolitan Washington Council of Governments
Department of Environmental Programs**

July 2024

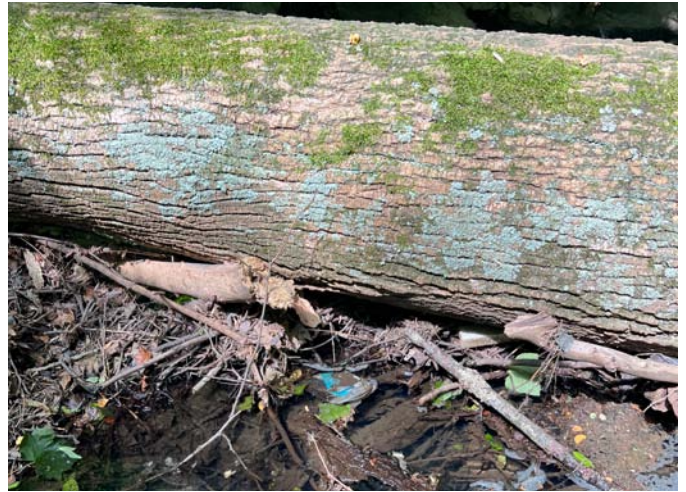
Figure 1. Strainer in Sligo Creek (SCSC204)

- PBSA100 continues to score a “High” verbal trash rating, which persisted through both survey periods. A series of exposed roots and strainers continue to collect trash at this site.

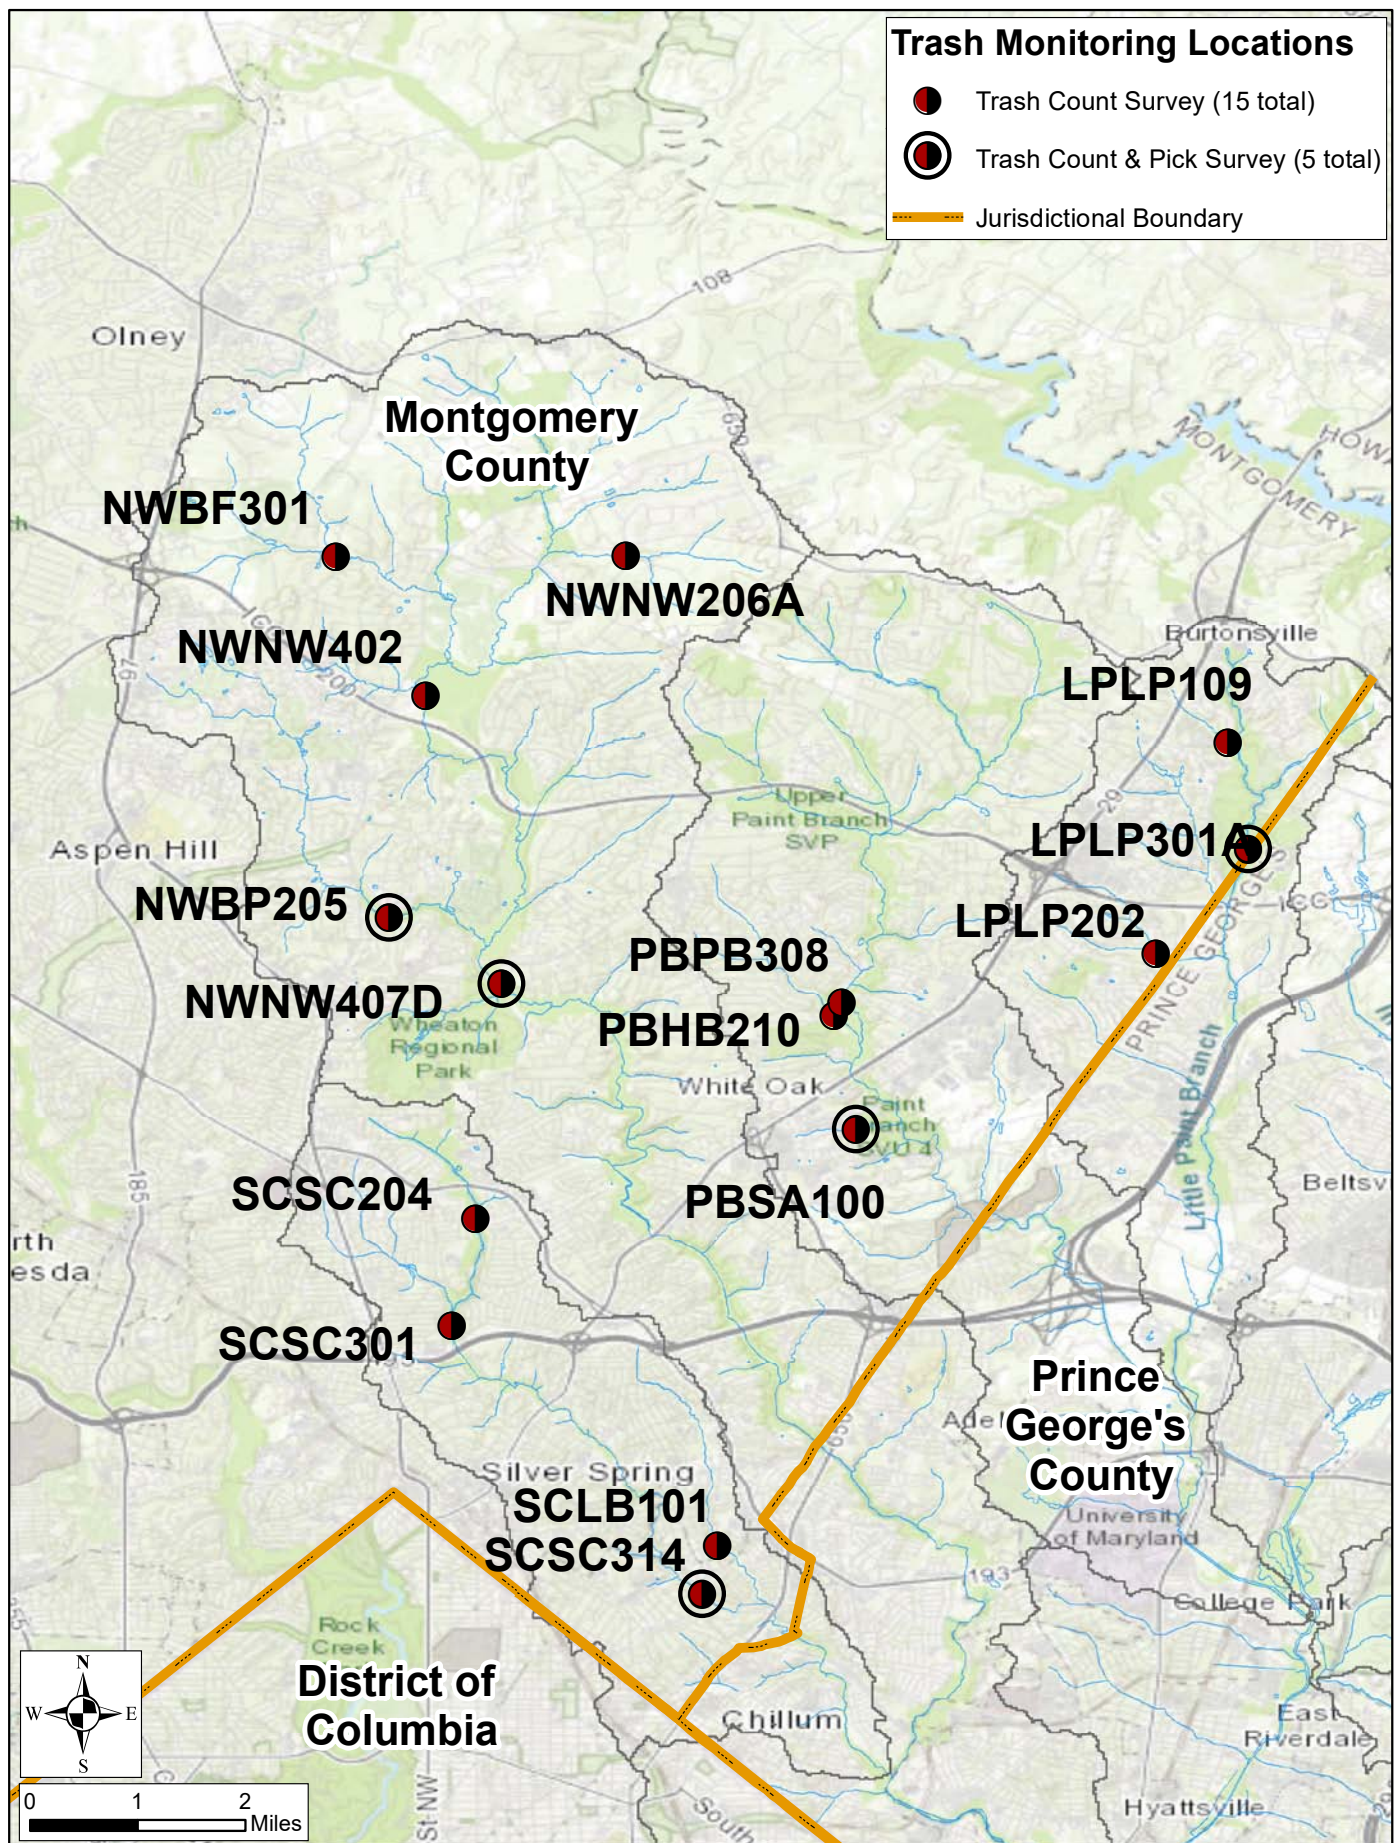
Figure 4. Montgomery County Anacostia Tributary Trash Monitoring Station Network (15 sites)

COG completed the Anacostia tributary trash surveying protocol at the 15 station locations (Figure 4). Appendix A (Table 1) provides the general site information. The trash surveying protocol was completed using the field data sheet in Appendix B to catalogue trash items. This in-stream trash survey was performed two times within the fiscal year 2024 (i.e., July 2023 through June 2024). The “count” surveys were conducted in October 2023 and June 2024. At each site, the total number of trash items within a 500 foot long stream reach was recorded and catalogued according to the protocol’s 21 trash items.

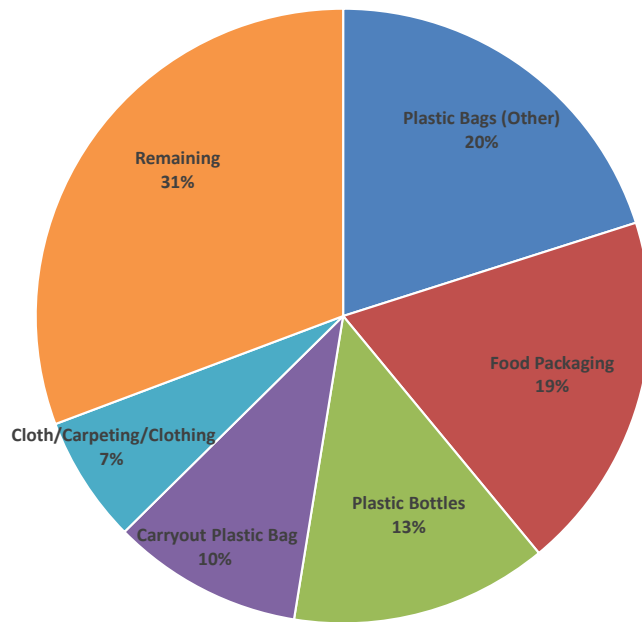
Figure 5. FY24 Count Survey - Top Five Items by Percent Count Distribution¹

- Figure 5 summarizes the FY24 count surveys’ top five trash categories as a percentage of the total number of items. Plastic bags (other), food packaging, plastic bottles, carry out plastic bags, and

cloth/carpeting (e.g., textile items) were in the order of highest to lowest for the top five trash items. Together they comprise nearly 69 percent of all items counted. The reader is referred to Appendix B (e.g., the COG trash data sheet) for the list of trash items and Appendix C, Figure 1 and Figure 2 for historical bar graphs for major trash items.

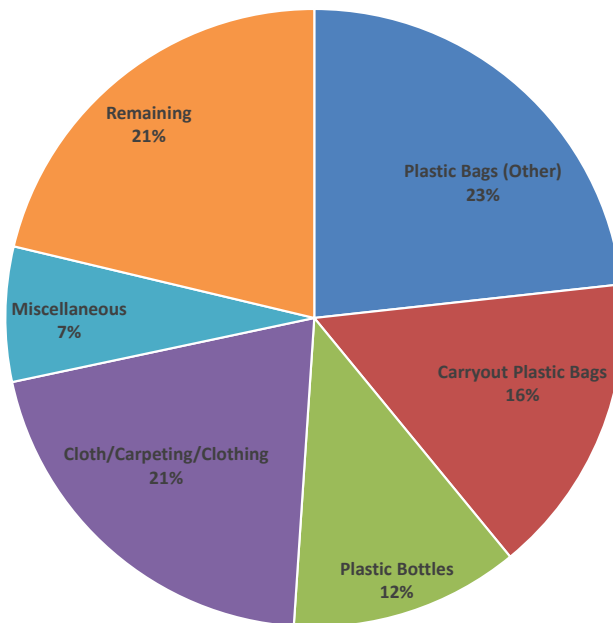
Figure 6. FY24 “Pick Sites” Survey - Top Five Items by Percent Weight Distribution¹

- Figure 6 shows the FY24 “pick” sites surveys’ top five items based on weight. Cloth/carpeting/clothing, plastic bags (other), carry out plastic bags, plastic bottles, and miscellaneous items are listed in the order of highest to lowest percent of the top five items. Together they comprise 79 percent of the total FY24 weight. The reader is reminded that the “pick” survey measures the total wet weight for each trash item and that large bulk trash items such as construction debris, bricks, etc. are not removed, therefore not weighed, during the “pick” survey.

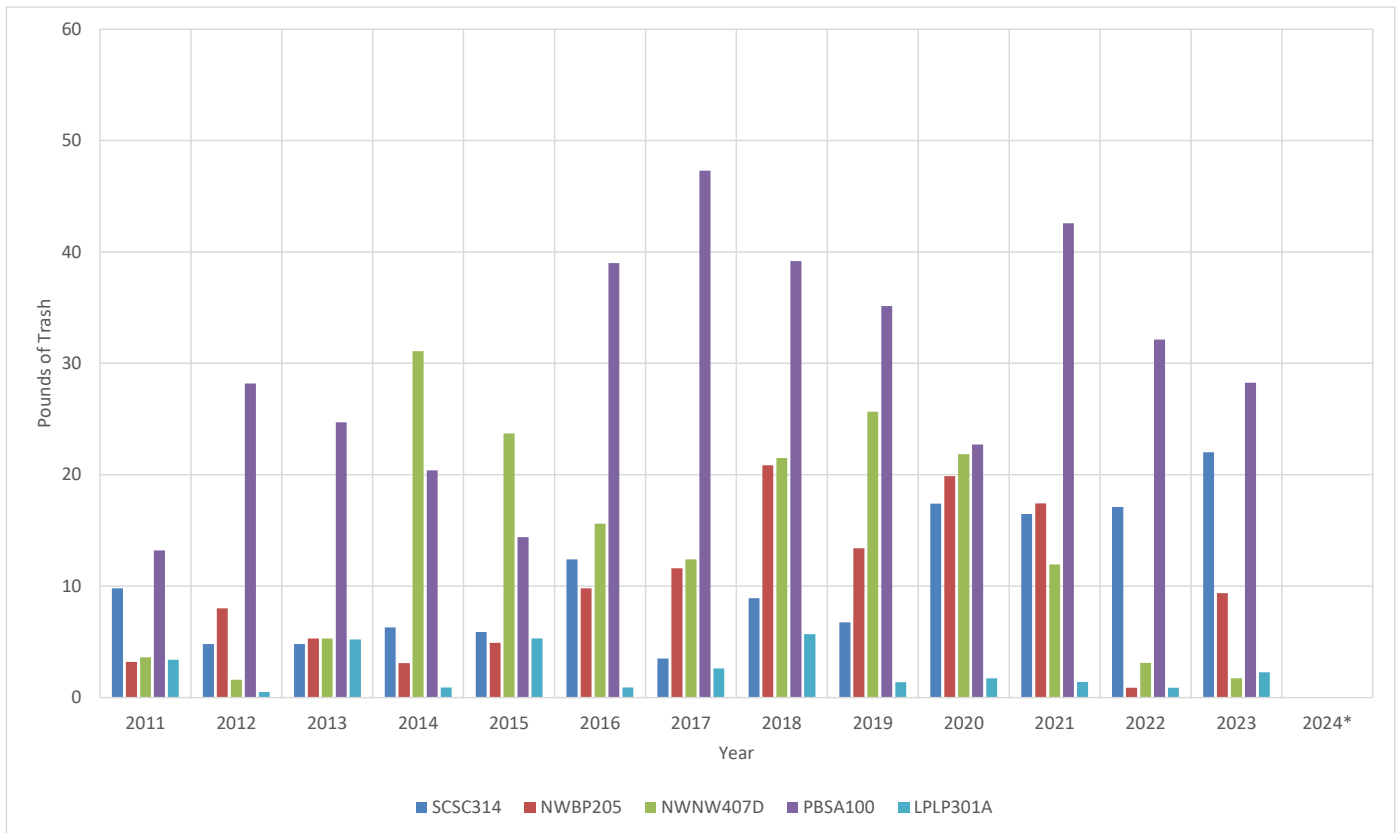
Figure 7. “Pick Sites” Summary - Pounds Removed Per Site (Fall Surveys 2011 - 2024) ¹

- Figure 7 summarizes the pounds of trash removed from each pick site during the fall sampling events from 2011 - 2023. Figure 8 summarizes the same data for the spring sampling events from 2011-2024. PBSA100 remained the site with the highest amount of trash removed at pick sites.

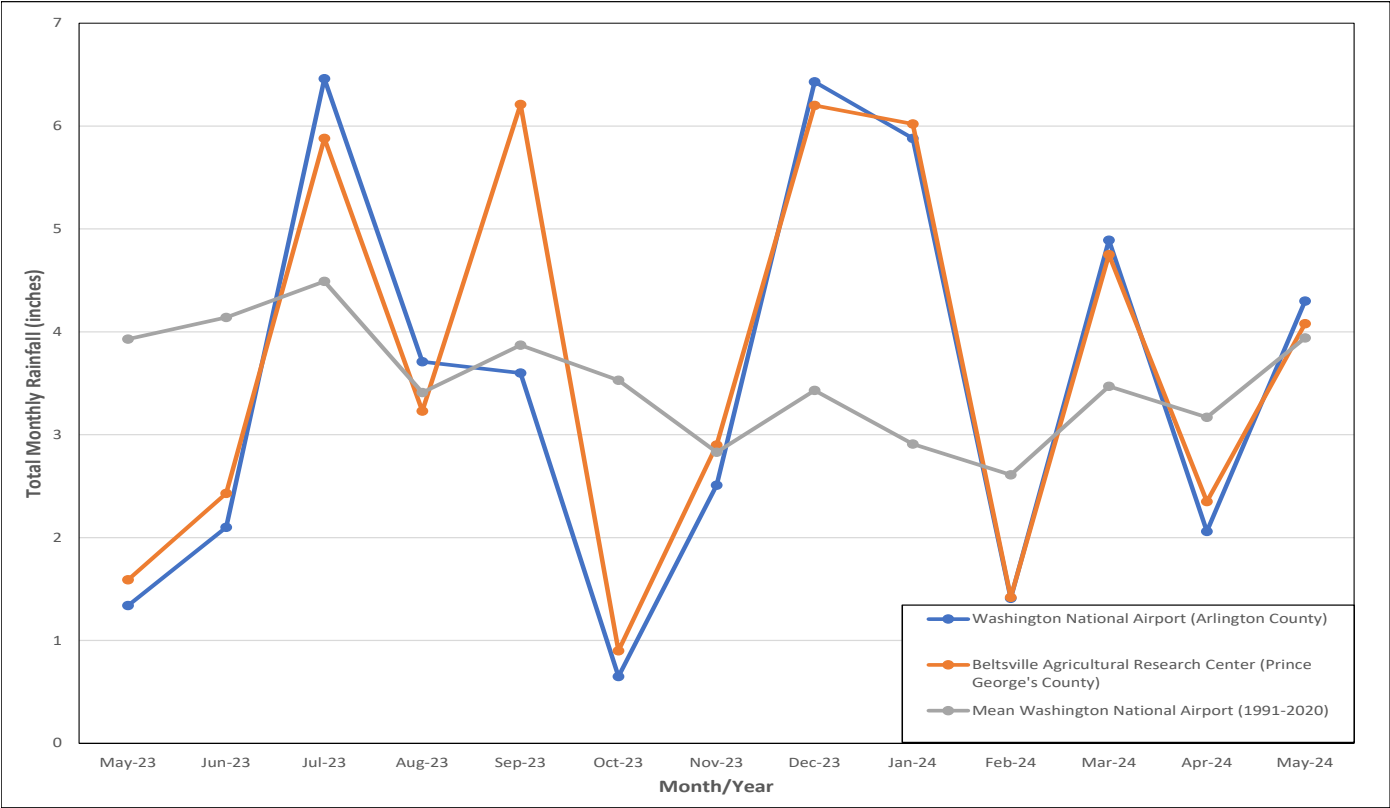
Figure 9. 2022-2024 Total Monthly Rainfall Data for Washington National Airport (DCA) and Beltsville Agricultural Research Center (BARC)

- Figure 9 shows monthly total rainfall at the DCA and BARC weather stations. DCA and BARC weather stations have similar levels of rain fall for most of the year, apart from September 2023, where DCA precipitation levels were less than BARC precipitation levels. Figure 10 shows the total yearly rainfall data for DCA and BARC Stations.

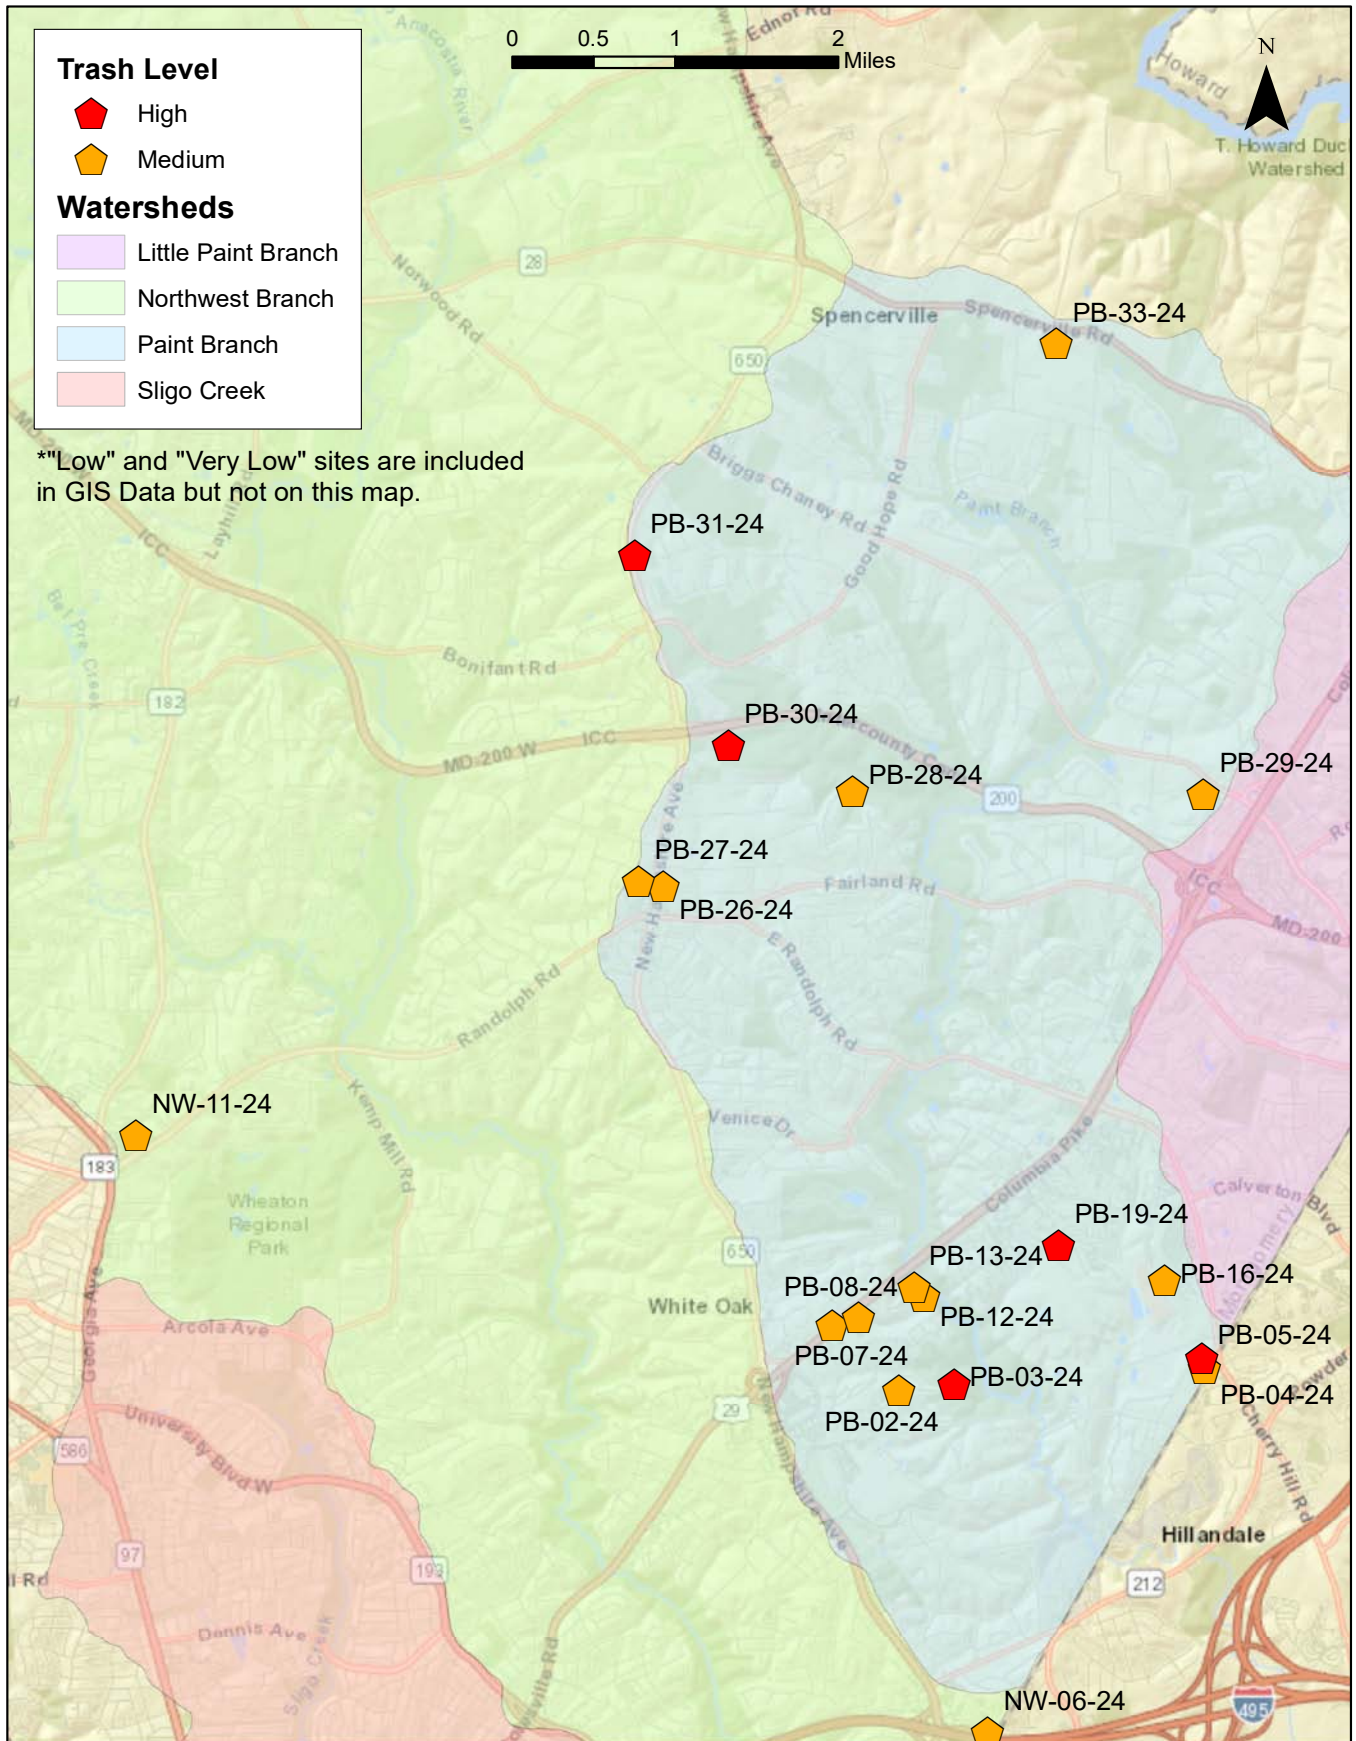
Figure 13. High and Medium HotSpots

- There were 11 sites with None to Very Low, 24 Low, 14 Medium and 5 with the High ranking (Table 10). Sites with the Medium/High ranking were found more frequently in the Pain Branch watershed (Figure 13).
- Tables 11 and 12 highlight the High and Medium ranked sites. Detailed descriptions of these sites including images, can be found in Appendix 3. None to Low ranking sites are included in the geographic database for reference.

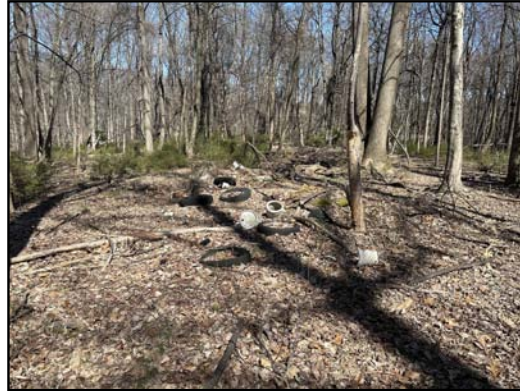
Site ID:PB-03-24
Trash Level:High
Subwatershed:Paint Branch
Nearest Address:1603 Regent Manor Ct,
Silver Spring, MD 20904
Lat/Long:39.043275; -76.975171

Description:Historical dumping household items and metal car parts.

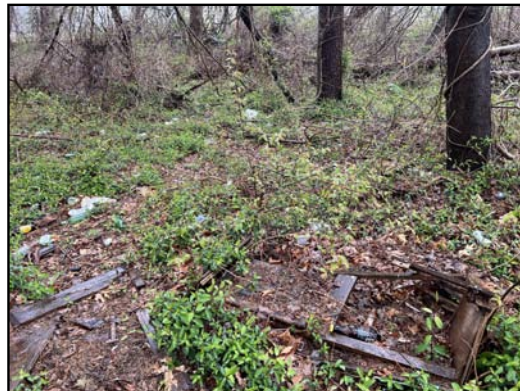
Site ID:PB-05-24
Trash Level:High
Subwatershed:Paint Branch
Nearest Address:11472 Cherry Hill Rd,
Beltsville, MD 20705
Lat/Long:39.045044; -76.953201

Description:Illegal dumping from parking lot; littering.

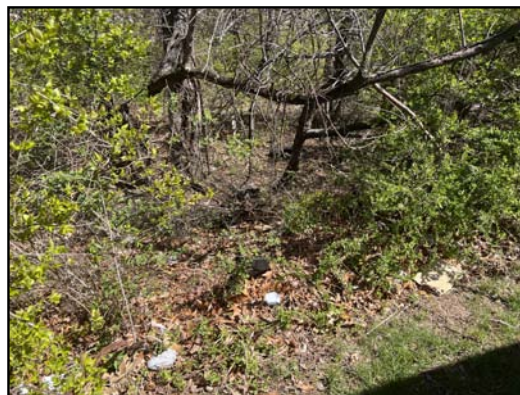
Site ID:PB-19-24
Trash Level:High
Subwatershed:Paint Branch
Nearest Address:2190 Industrial Pkwy,
Silver Spring, MD 20904
Lat/Long:39.052931; -76.96592

Description:Existing hotspot. Illegal dumping and possible parking lot litter overflow.

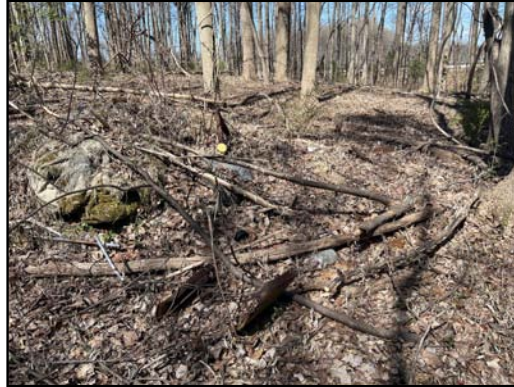
Site ID:PB-30-24
Trash Level:High
Subwatershed:Paint Branch
Nearest Address:14015 New Hampshire Ave
#158, Silver Spring, MD 20904
Lat/Long:39.087594; -76.99518

Description:Between Hobbs drive and
rt200; starting near New Hampshire Ave
dispersed eastward.

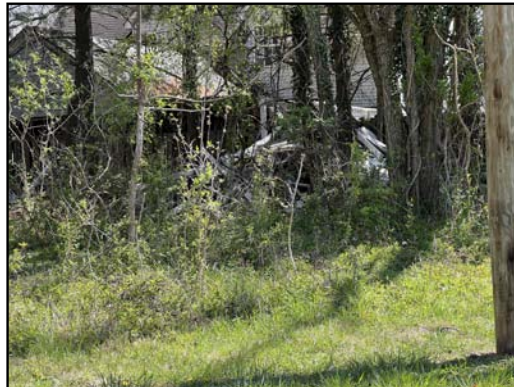
Site ID:PB-31-24
Trash Level:High
Subwatershed:Paint Branch
Nearest Address:214 Windridge Acres Ct,
Silver Spring, MD 20905
Lat/Long:39.10078; -77.003504

Description:The adjacent property owner
is dumping large strips of metal over their
fence. The pile is at least 6' tall and 10'
feet wide.

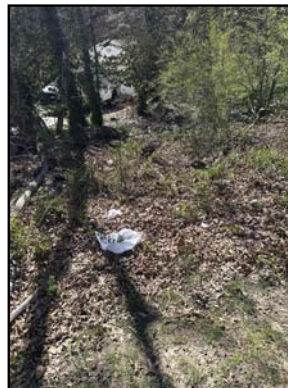
Site ID:NW-06-24
Trash Level:Medium
Subwatershed:Northwest Branch
Nearest Address:1751 Elton Rd # 300,
Silver Spring, MD 20903
Lat/Long:39.019121; -76.972182

Description:Litter and possible illegal
dumping. Trash coming off the beltway as
well possibly some litter from the business
next-door.

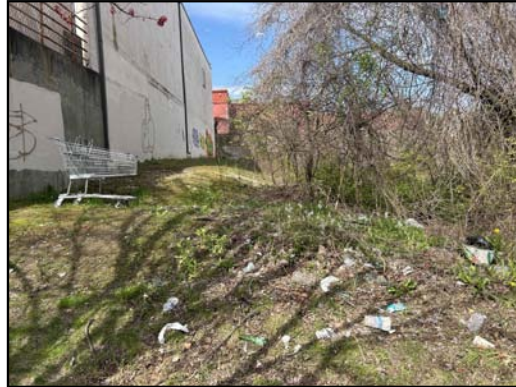
Site ID:NW-11-24

Description:Food packaging scattered through the woods in the area behind the shopping center, a few shopping carts as well. Extends all the way around the side and back of the shopping center.

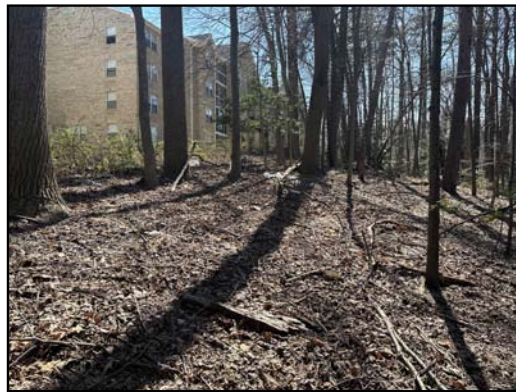
Site ID:PB-02-24

Description:Litter for 15 feet behind the apartments with a couple of concentrated areas. Moderate low.

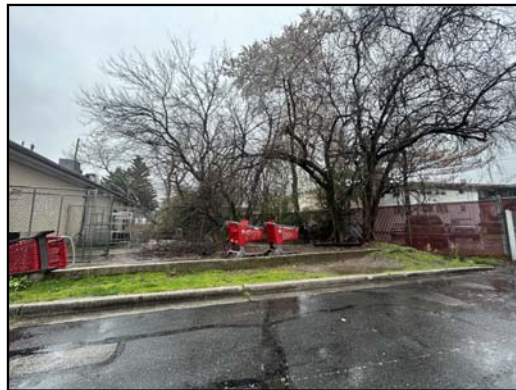
Site ID:PB-04-24

Description:Shopping carts seemingly dumped located behind the 7/11.

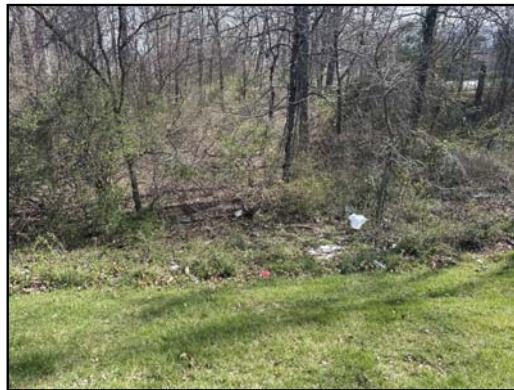
Site ID: PB-08-24
Trash Level: Medium
Subwatershed: Paint Branch
Nearest Address: 11501 Old Columbia Pike, Silver Spring, MD 20904
Lat/Long: 39.047888; -76.983642

Description: Lots of litter for approx. 100 feet along the grassy area near the road. Lots of distributed, litter, bottles bags, and food wrappers.

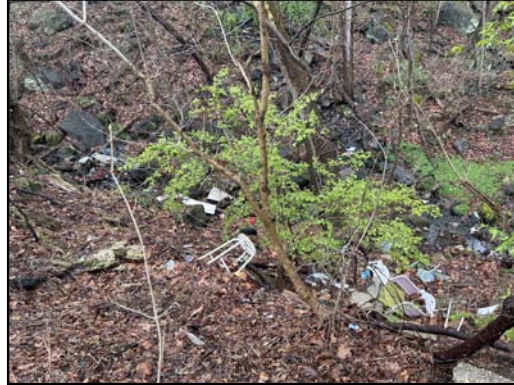
Site ID:PB-13-24
Trash Level:Medium
Subwatershed:Paint Branch
Nearest Address:11770 Carriage House Dr,
Silver Spring, MD 20904
Lat/Long:39.05; -76.978708

Description:Household trash, furniture,
and food packaging dumped behind the
guardrail into the Paint Branch Valley.

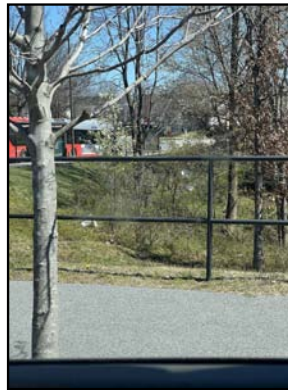
Site ID:PB-16-24
Trash Level:Medium
Subwatershed:Paint Branch
Nearest Address:11890 Healing Wy, Silver
Spring, MD 20904
Lat/Long:39.050498; -76.956526

Description:Dumped grocery carts.

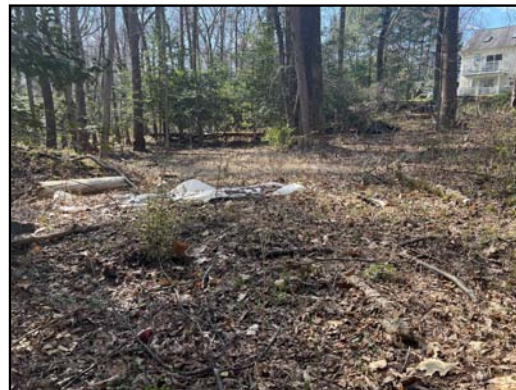
Site ID:PB-28-24
Trash Level:Medium
Subwatershed:Paint Branch
Nearest Address:1243 Crockett Ln Silver Spring, MD 20904 United States
Lat/Long:39.084413; -76.98419

Description:Several chairs, a couple trash bags of glass bottles and cans, XL tarp, tires, and other; all located just outside the homeowners property line and at the inflection of the hill top.

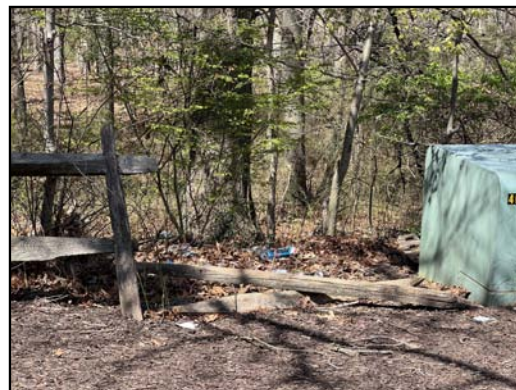
Site ID:PB-29-24
Trash Level:Medium
Subwatershed:Paint Branch
Nearest Address:2725 Briggs Chaney Rd, Silver Spring, MD 20905
Lat/Long:39.084191; -76.953081

Description:Dumping and litter localized litter in the parking lot and near curb, dispersed in the woods, and localized along storm pond fence. Possible homeless encampment near pond.

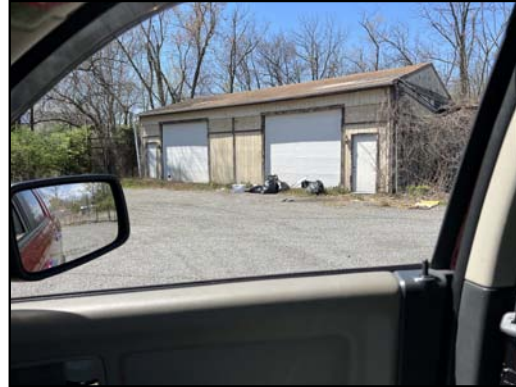
Site ID: PB-33-24

Description: Five large trash bags, bottles, carry out, plastic, and large metal item dispersed around lot.
