Quantifying the Ecological uplift and effectiveness of differing stream restoration approaches in Maryland

Joe Acord¹, Robert H. Hilderbrand¹, Tim Nuttle², Ray Ewing², Jennifer Hein²

¹Appalachian Laboratory, University of Maryland Center for Environmental
Science

²Civil & Environmental Consultants Inc, Pittsburgh, PA

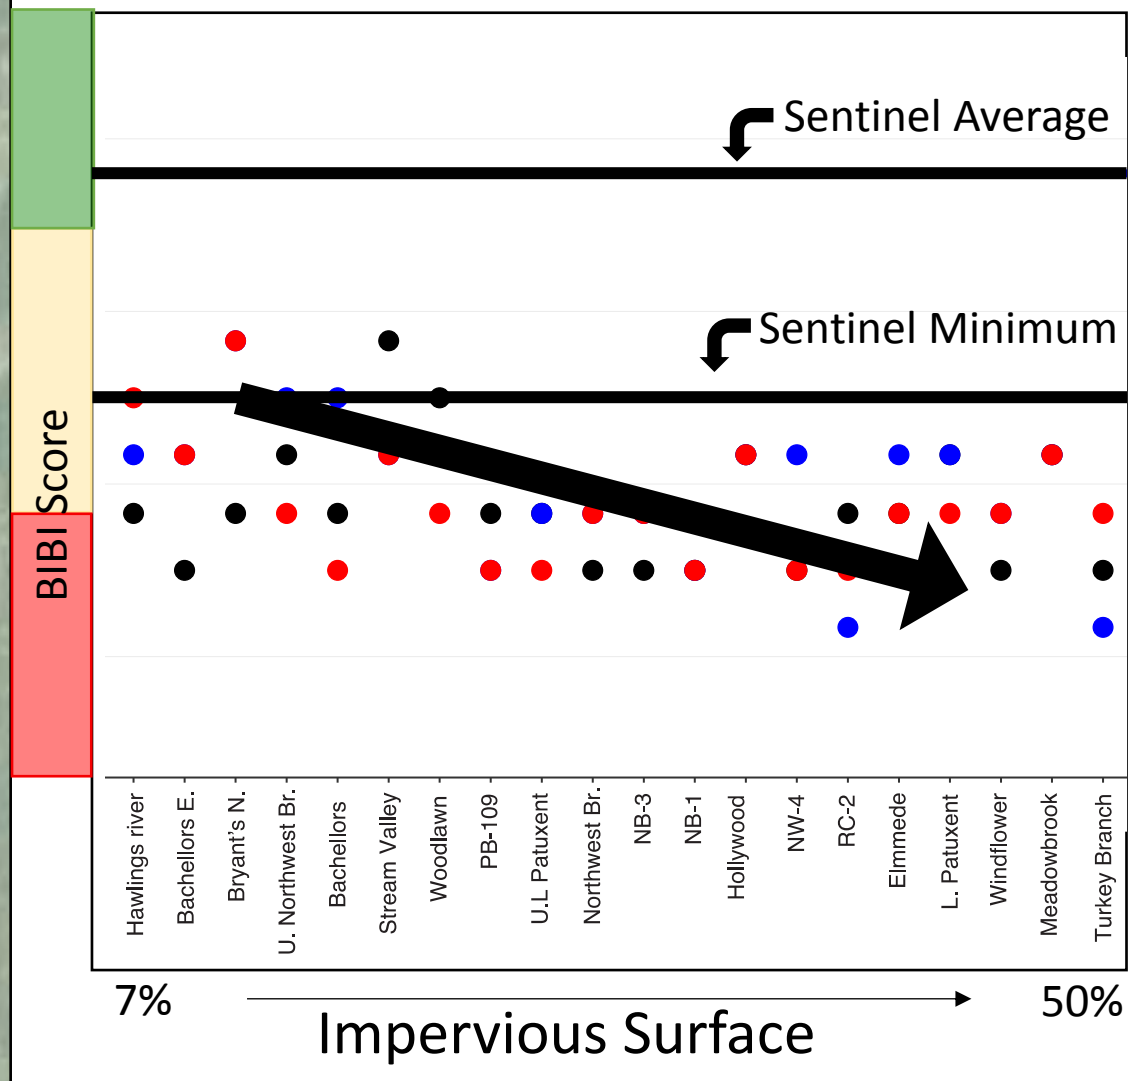
Piedmont

Watershed Characteristics Likely Limiting

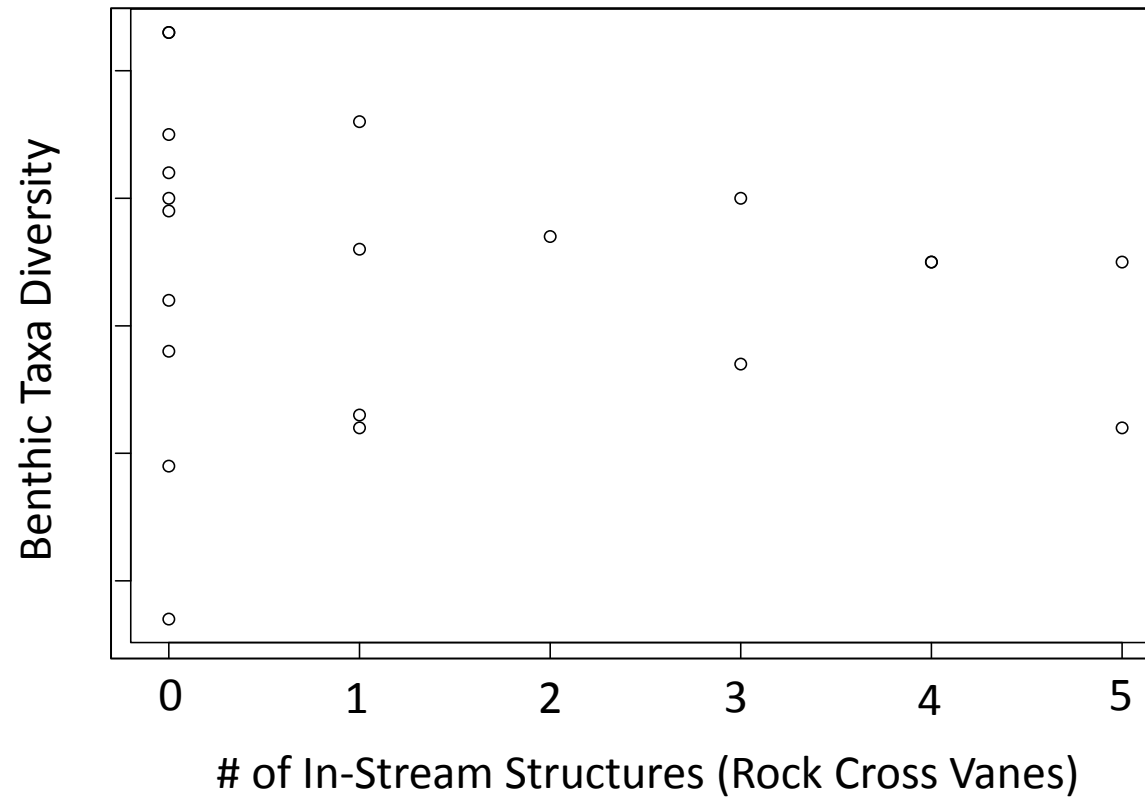
of In-stream Structures Inconclusive
