Effectiveness of urban stream restorations for improving habitat and benthic invertebrates

Robert H. Hilderbrand & Joe Acord, UMCES Appalachian Lab

Timothy J. Nuttle & Raymond Ewing, CEC Inc

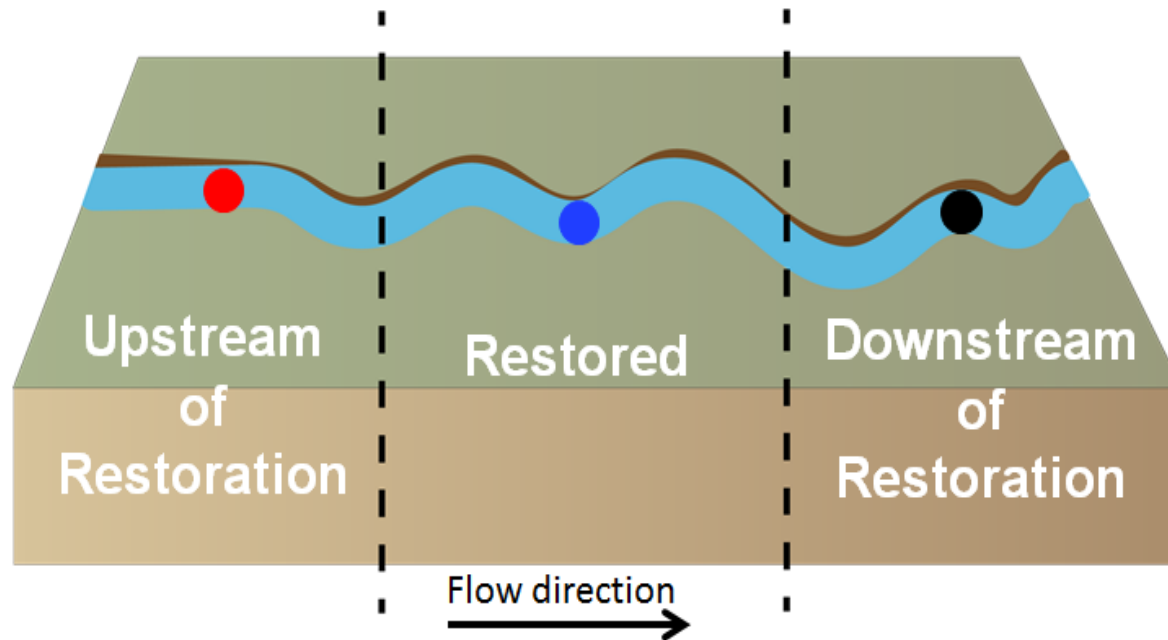
Triplet sampling design

- Physical attributes using EPA rapid assessment
- Ecological attributes using benthic macroinvertebrates

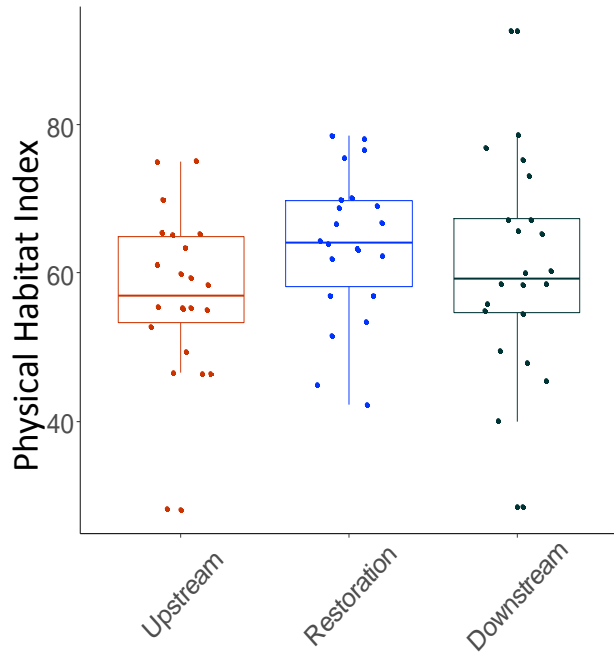
Overall habitat improvement in Coastal Plain, but not in Piedmont

Habitat Attribute	Restored vs Upstream	Restored vs Downstream	Downstream vs Upstream
Epifaunal Substrate	NS	NS	NS
Embeddedness	NS	NS	NS
Velocity Depth Pool Variability	NS	NS	NS
Channel Alteration	-	-	NS
Sediment Deposition	+	+	NS
Riffle Frequency Channel Sinuosity	+	NS	+
Total Bank Stability	+	+	+
Total Bank Vegetative Protection	+	+	NS
Total Width Undisturbed Vegetative Zone	NS	NS	NS
Pool Substrate Characterization	NS	NS	NS
Pool Variability	NS	NS	NS
Sinuosity	NS	NS	NS
% Fines	NS	NS	NS
% Sand	-	-	NS
% Sand and Silt	-	-	NS
% Gravel	NS	NS	NS
% Cobble	NS	NS	NS
% Boulder	NS	NS	NS
D50	+	+	NS
D84	NS	NS	NS

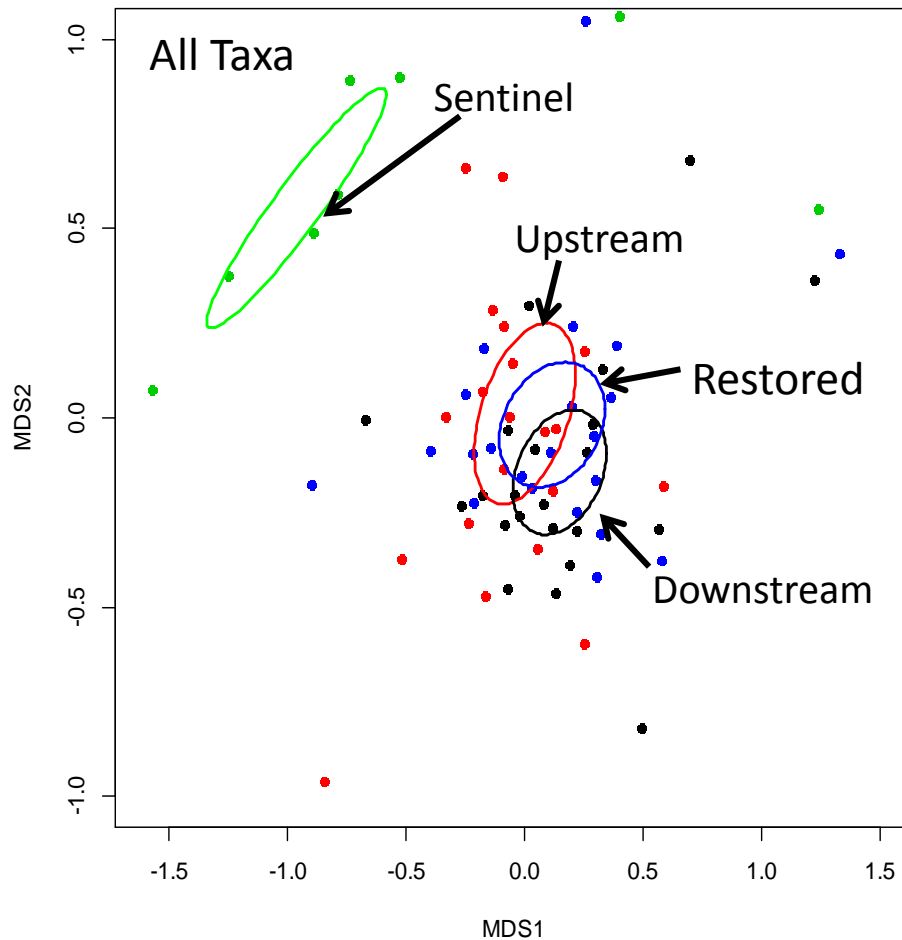
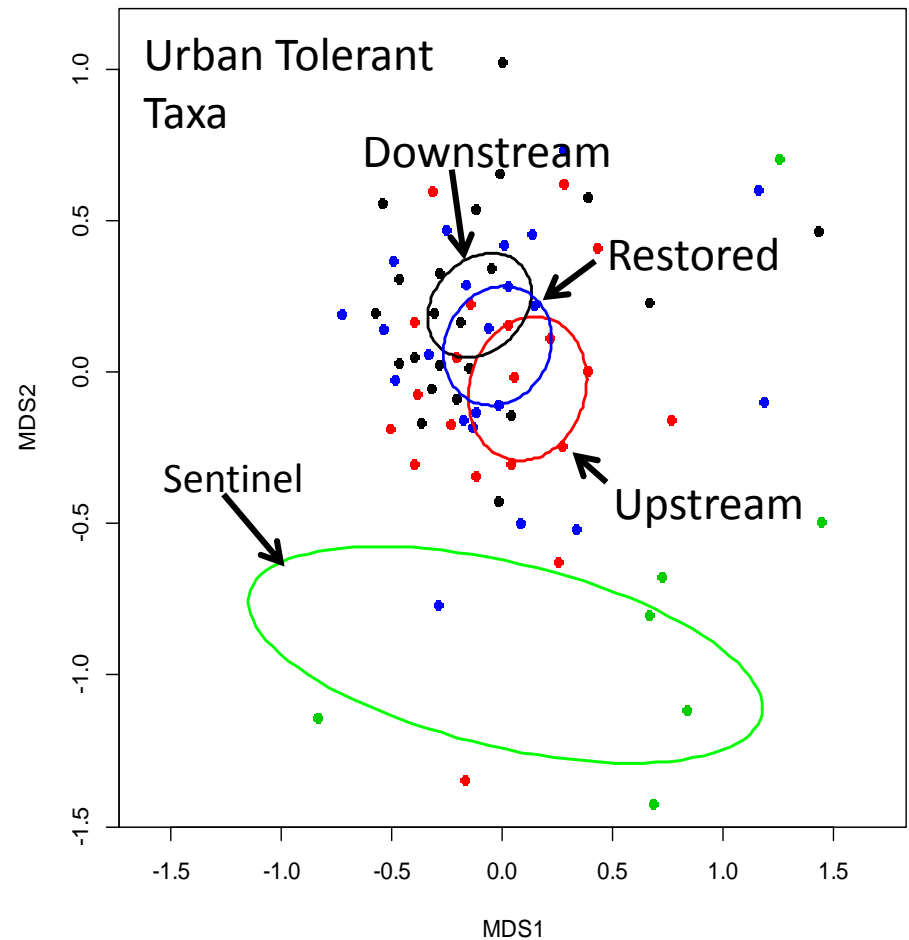
Big differences between lesser disturbed stream communities and restored Piedmont streams.

No differences between restored and unrestored

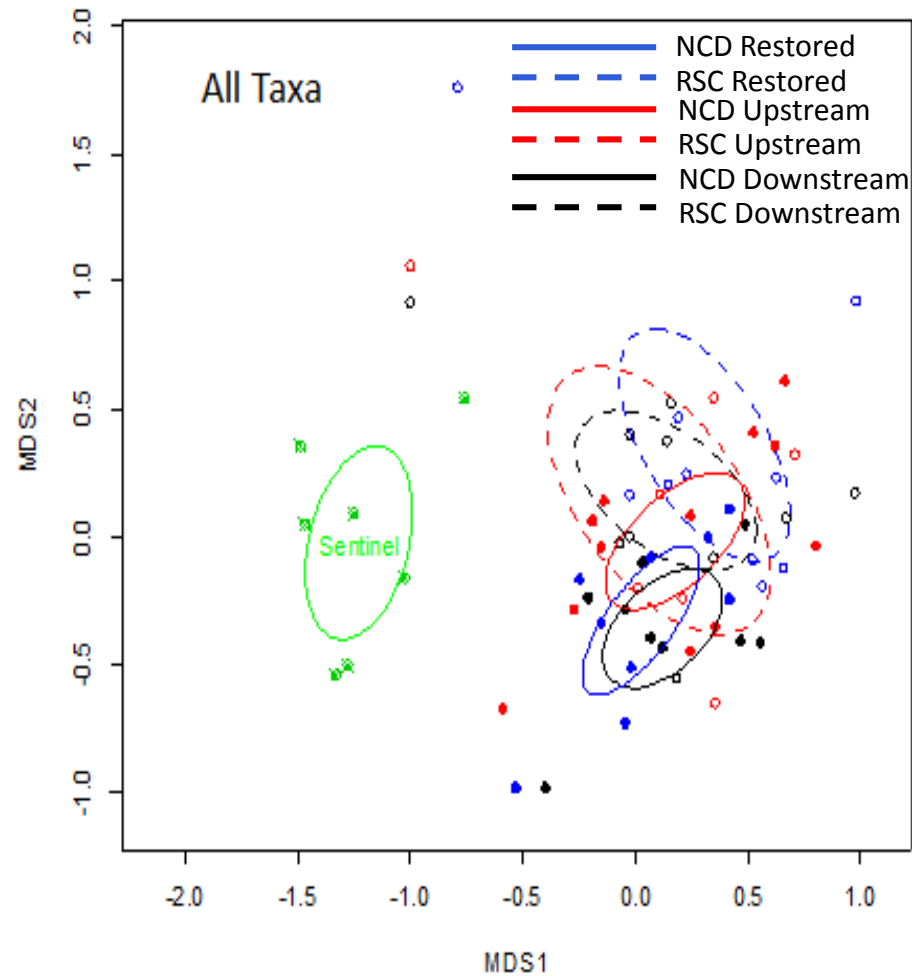
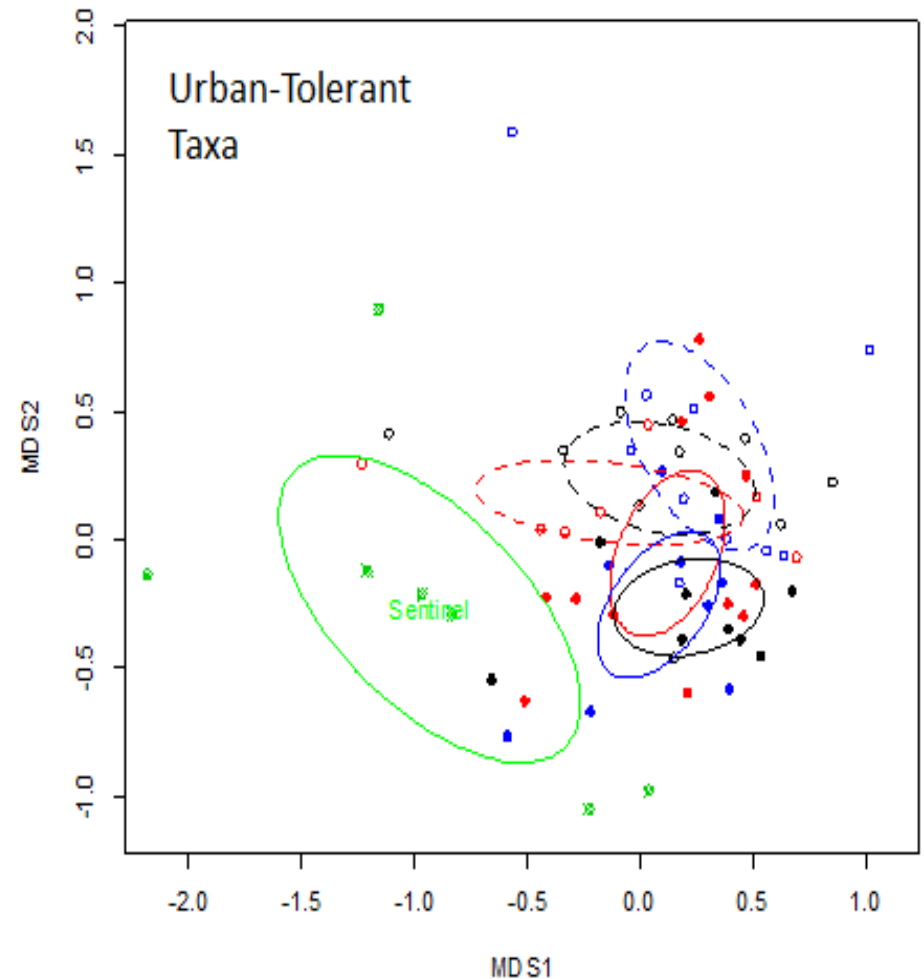
Big differences between lesser disturbed stream communities and the rest in Coastal Plain streams

No differences between restored and unrestored

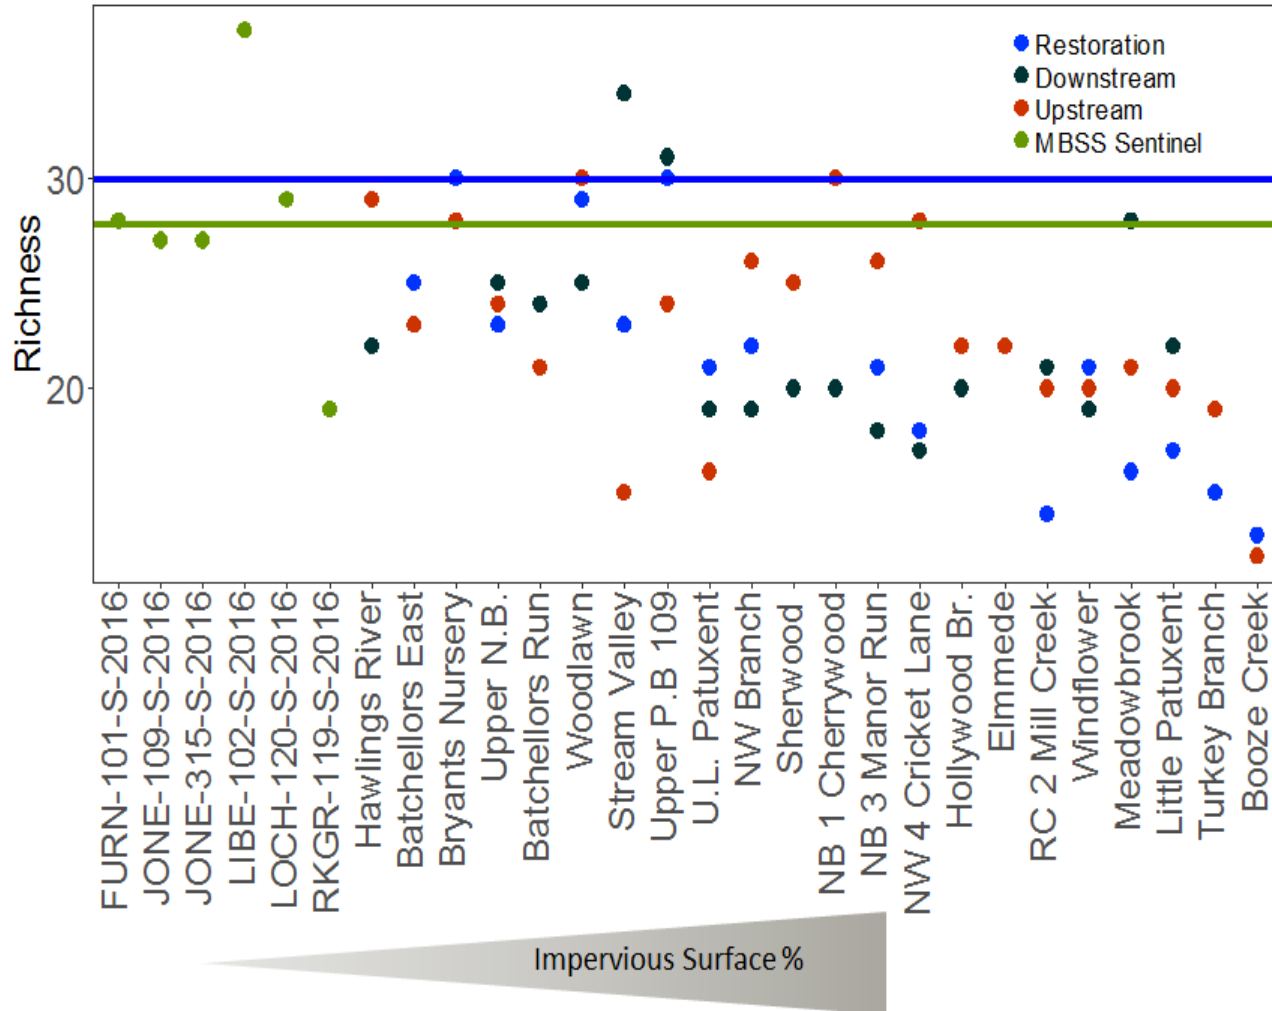
Condition and lack of improvements in Piedmont restorations associated with Impervious Surface Cover (ISC)

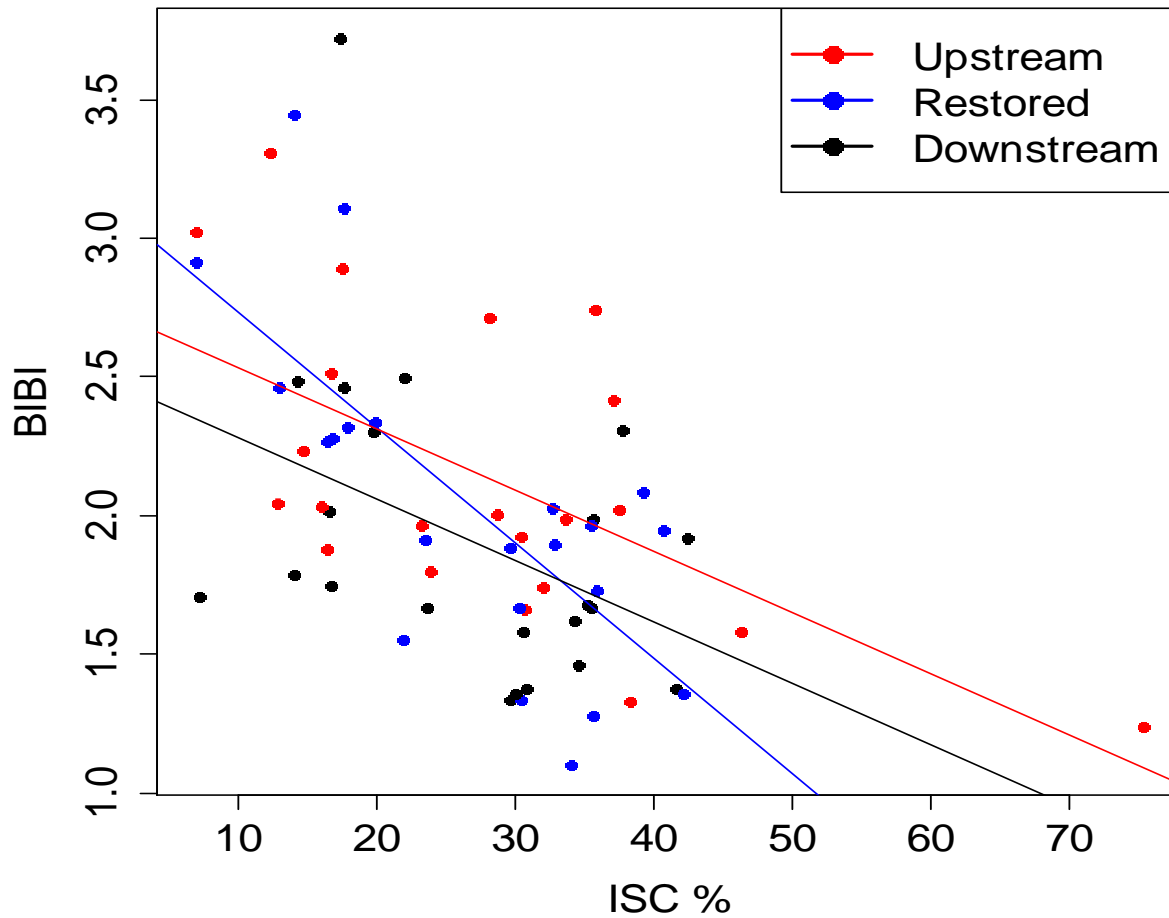
Piedmont restored streams less resilient to increasing ISC

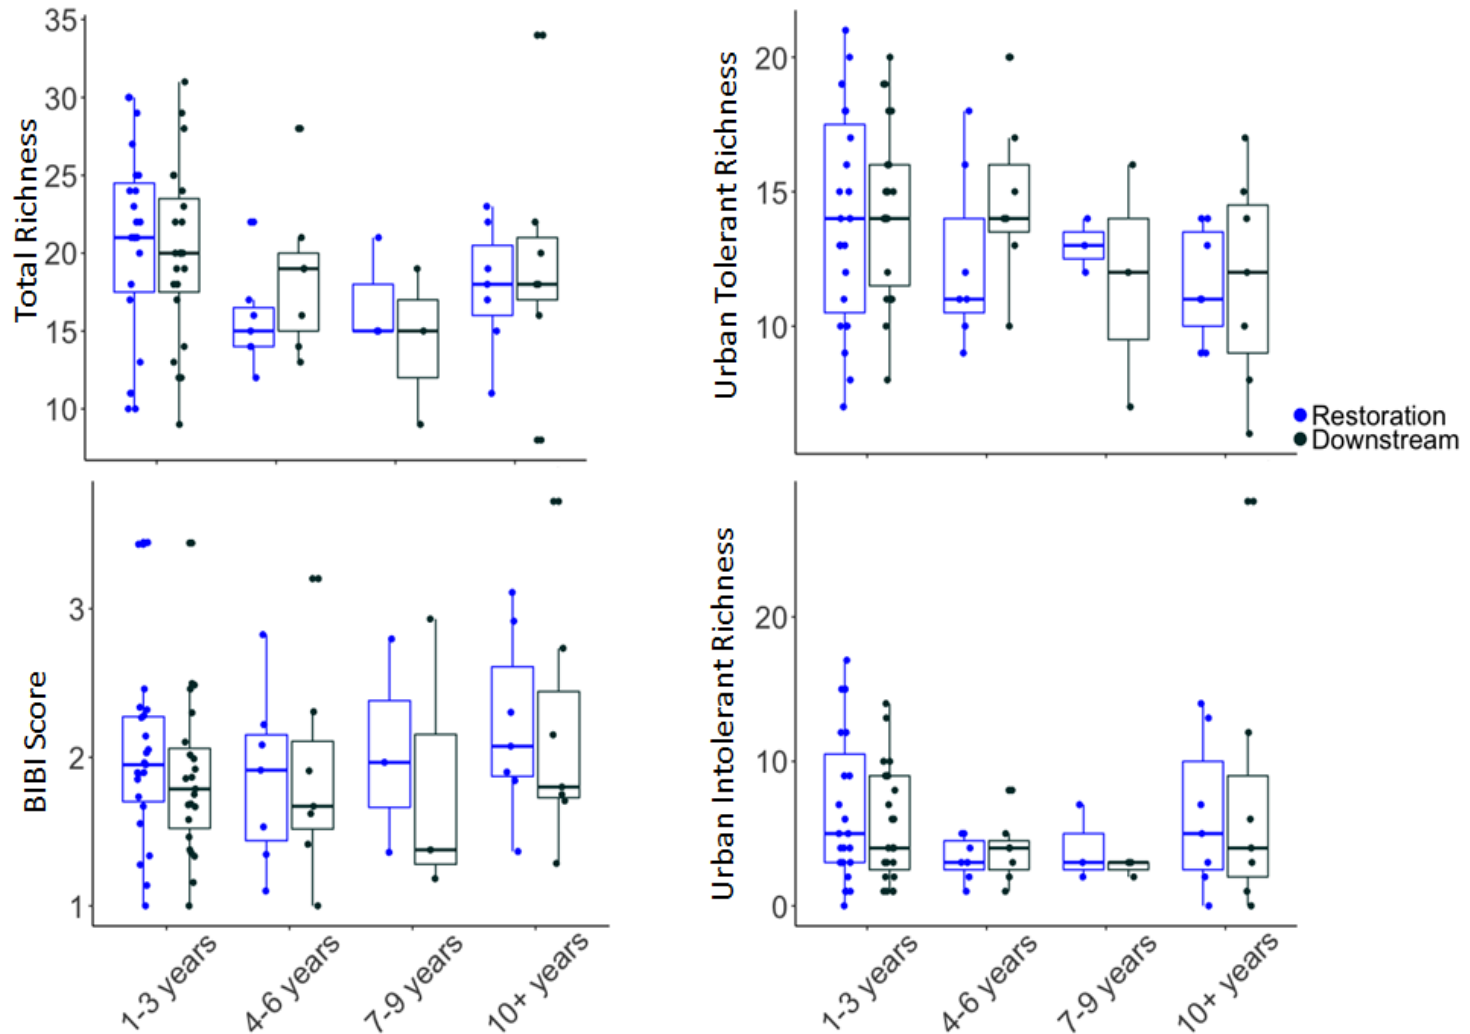
Ecological recovery not improved with time since restoration

- Time since restoration (not related to benthics in this study)
- Recolonization potential (not examined)
- More/longer restoration not necessarily better
- Factors that may be difficult to address with stream restoration alone, but that could be limiting (not examined)
- Watershed condition (likely important – especially Piedmont)

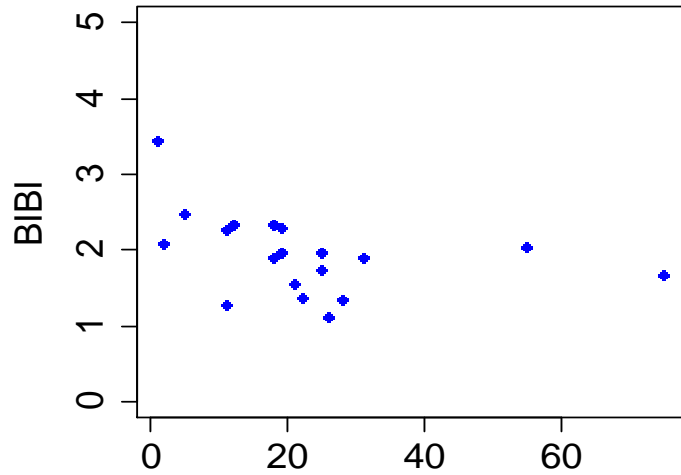
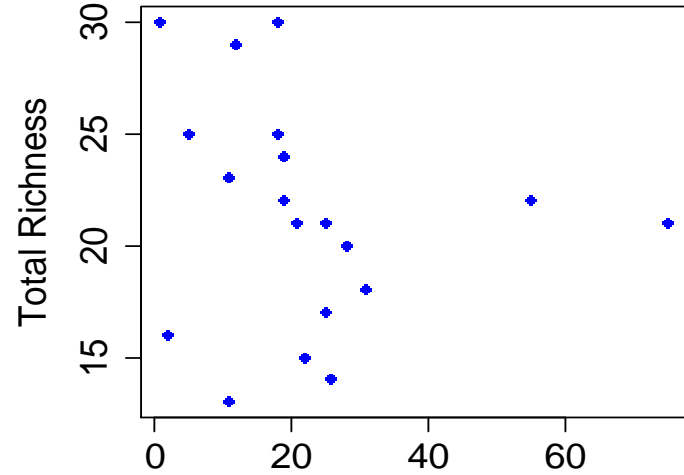
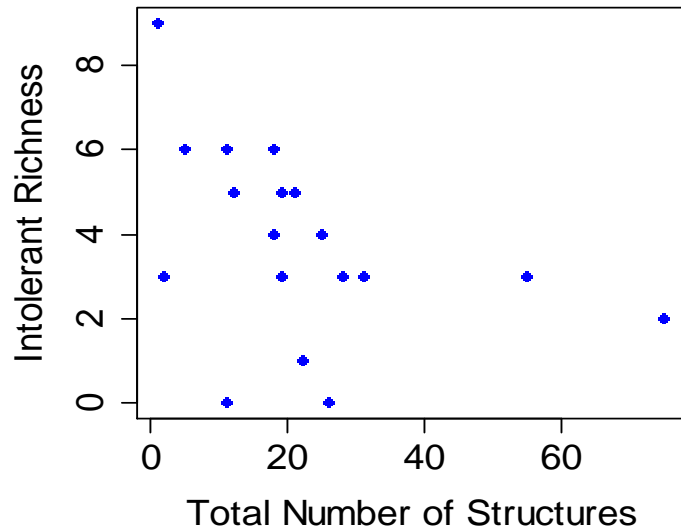
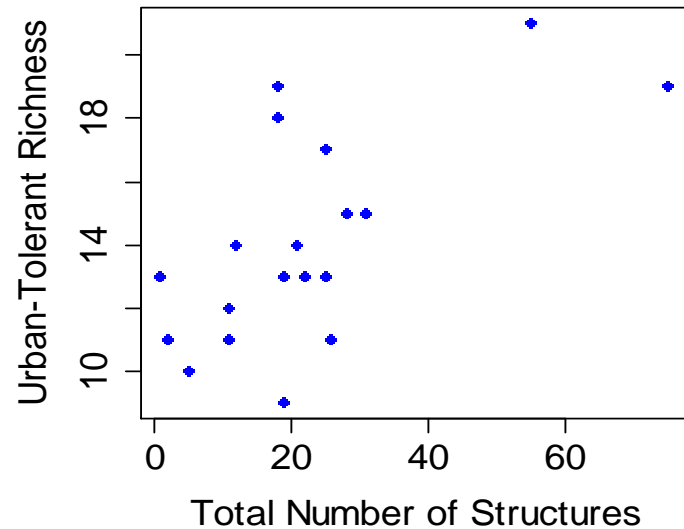
More installed structures associated with declines in ecological health

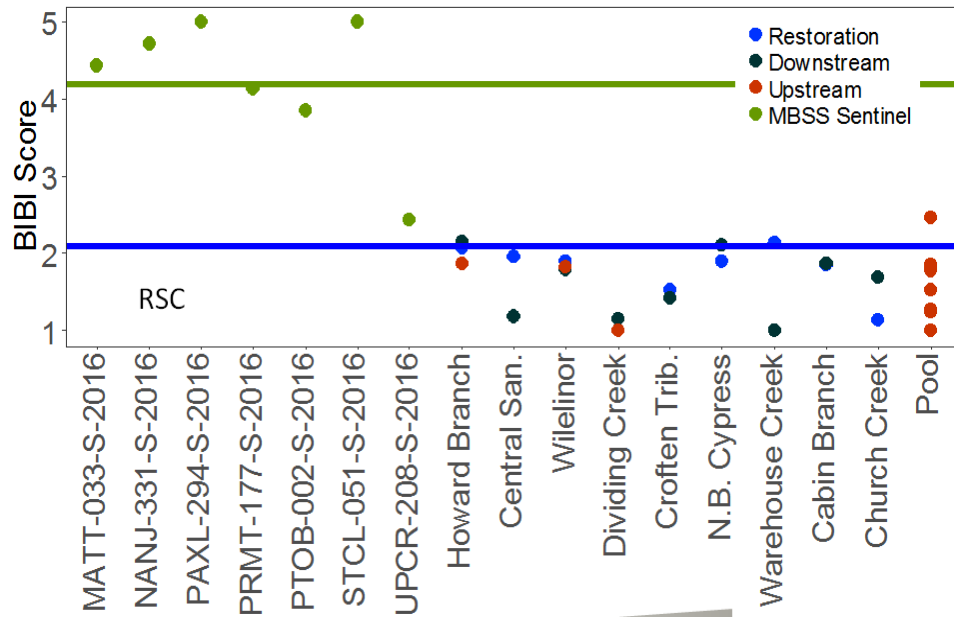
Not much improvement in Coastal Plain restorations
